Road Network Investigation Report
For
Wagait Shire Council

Date: November 2018

Road Network Investigation Report for Wagait Shire Council

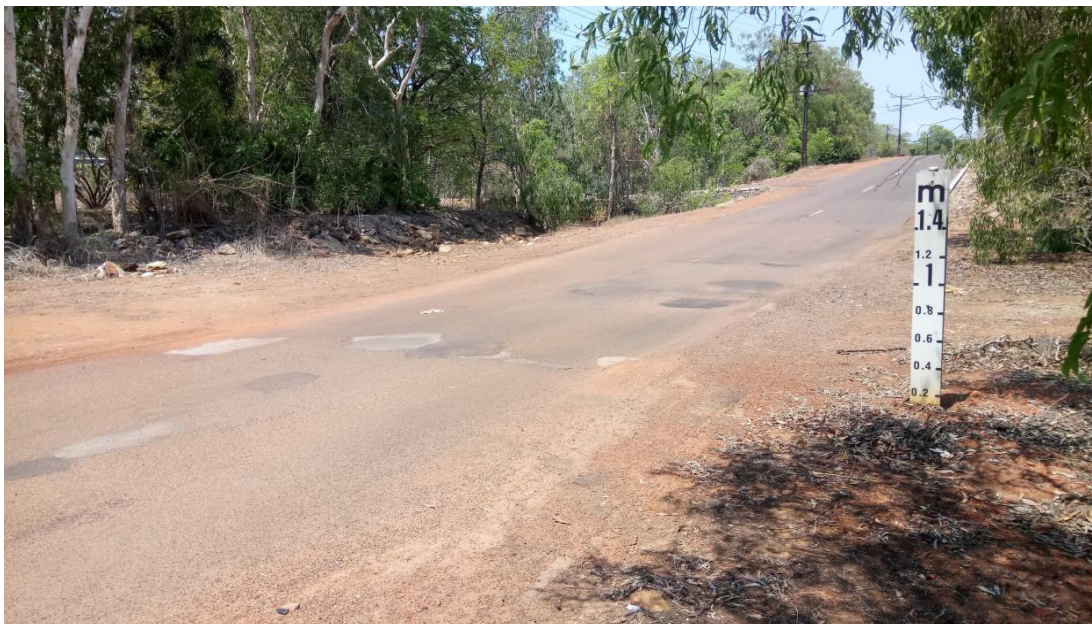
- **92 Cox Drive** – Large frequency of pothole repairs – refer to **Appendix C** for a standard floodway section that could be applied to remediate area
- **Erickson Crescent (between Massey St and Brisbane St)** – Large frequency of cracking, effect on ride quality noticeable, envisaged that resheeting is required as pavement surface has lost some consistency
- **Mungalo Road and Forsyth Crescent** – large frequency of raveling – review whether pavement enrichment is appropriate, resheet may be required

Photo: 92 Cox Drive

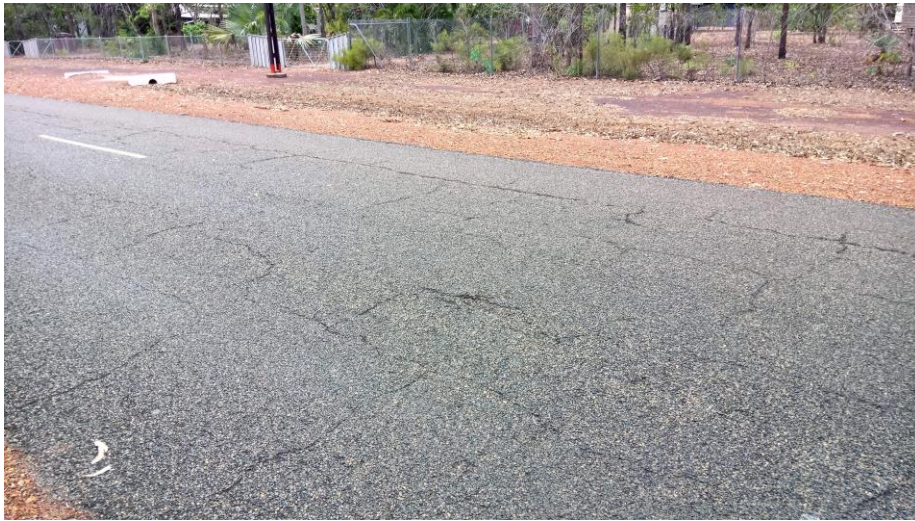
Photo: Erickson Crescent Pavement Cracking

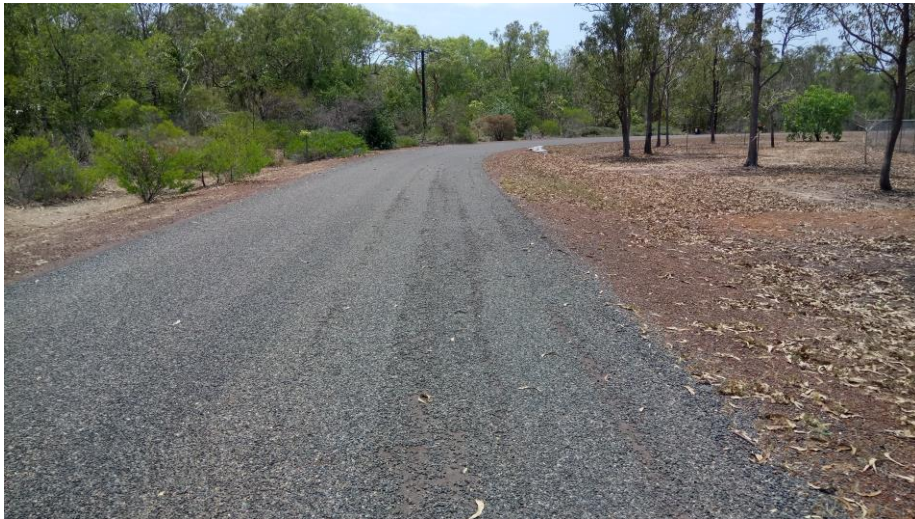
Photo: Mungalo Road Raveling

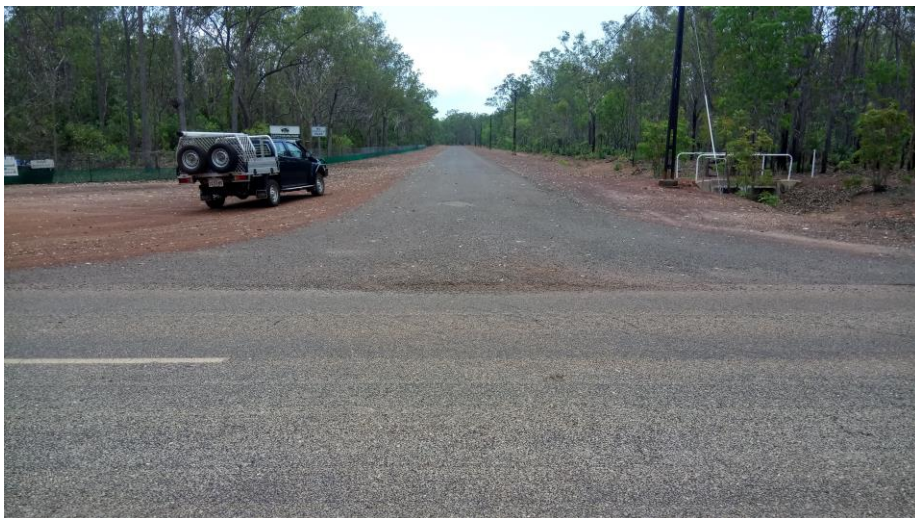
Photo: Forsyth Road Raveling

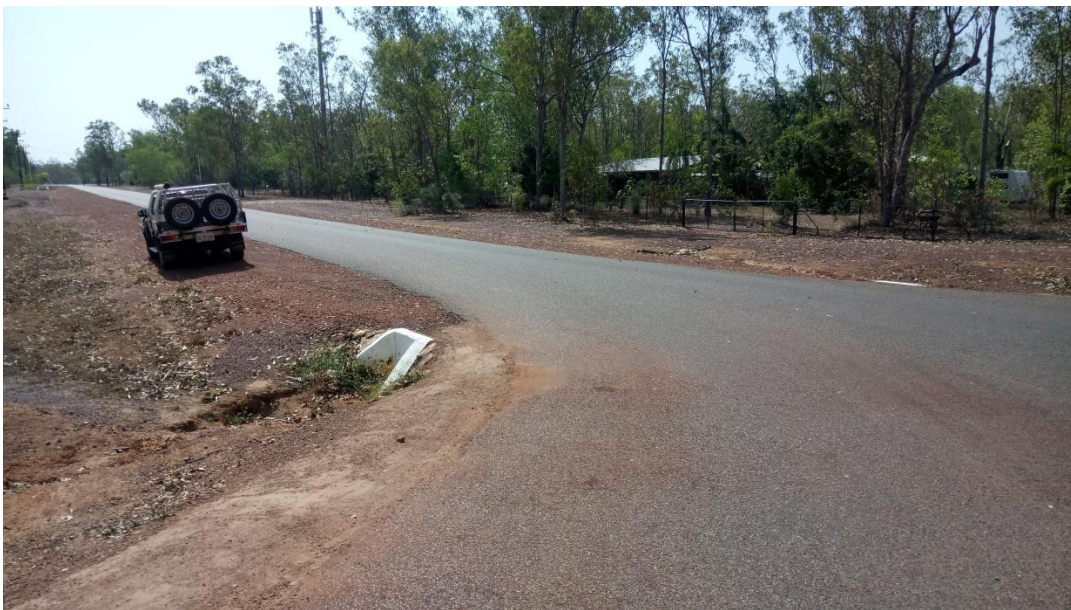
The issues of exposed drainage structures are an immediate liability to council. Protection for road users around these structures may be able to be sourced through the Black spot program particularly around larger drainage and culvert structures that are located within close proximity to the roadway. There are funding allocations within the Black Spot program dedicated to road safety audit recommendations that may be an avenue for WSC to access funding.

Photo: Unprotected Culvert Wagait Tower Road and Dalmeny Street Intersection

LGANT recommends that these issues should be further investigated from a road and pedestrian safety perspective to provide an adequate indication of the current risk profile and potential funding avenues.

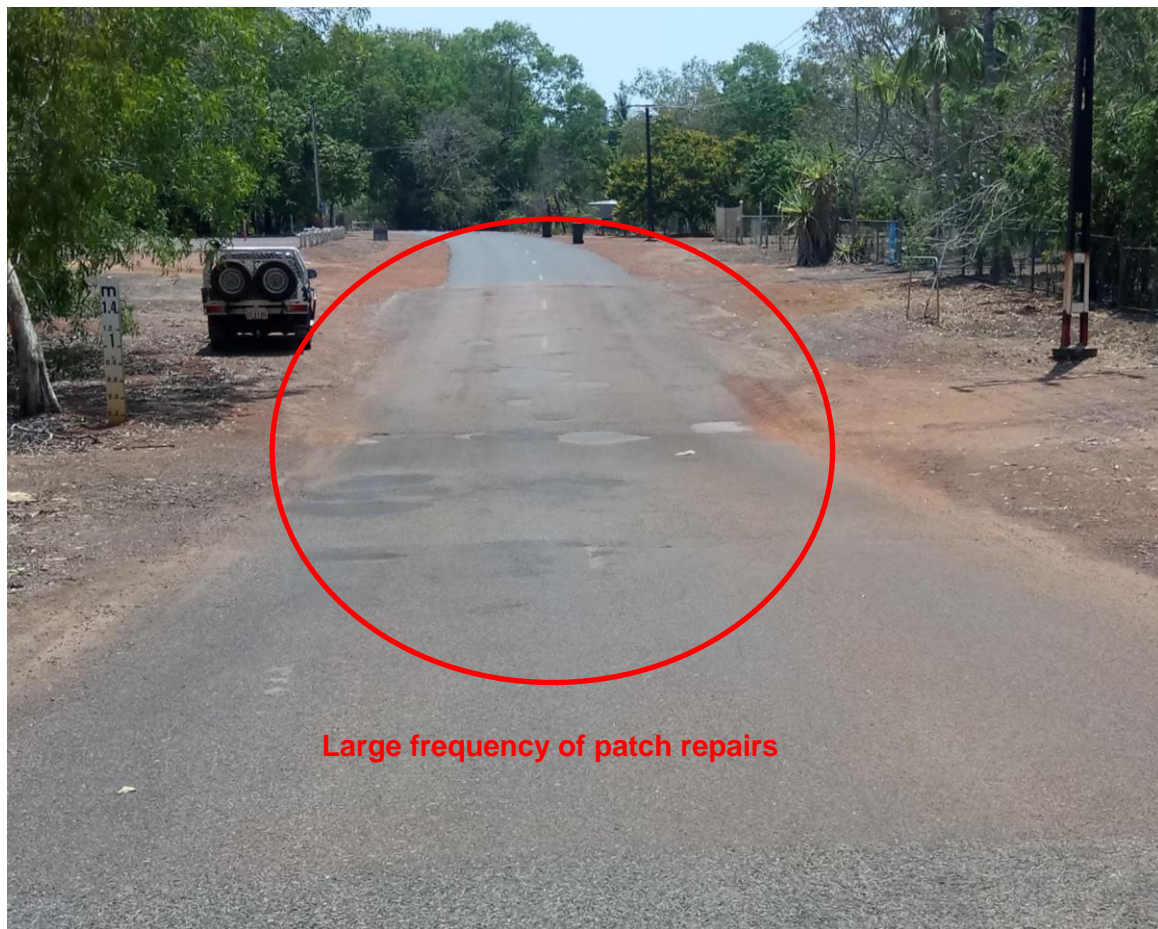
A road section adjacent to 92 Cox Drive has been identified as a maintenance concern, requiring patch repairs following every wet season. This section of road appears to function as a floodway and has been noted to be inundated for approximately 3 months during wet season periods. Please refer to the following **Figure 4** for a photo of the identified area of maintenance concern.

Figure 4 – Road section of maintenance concern, 92 Cox Drive

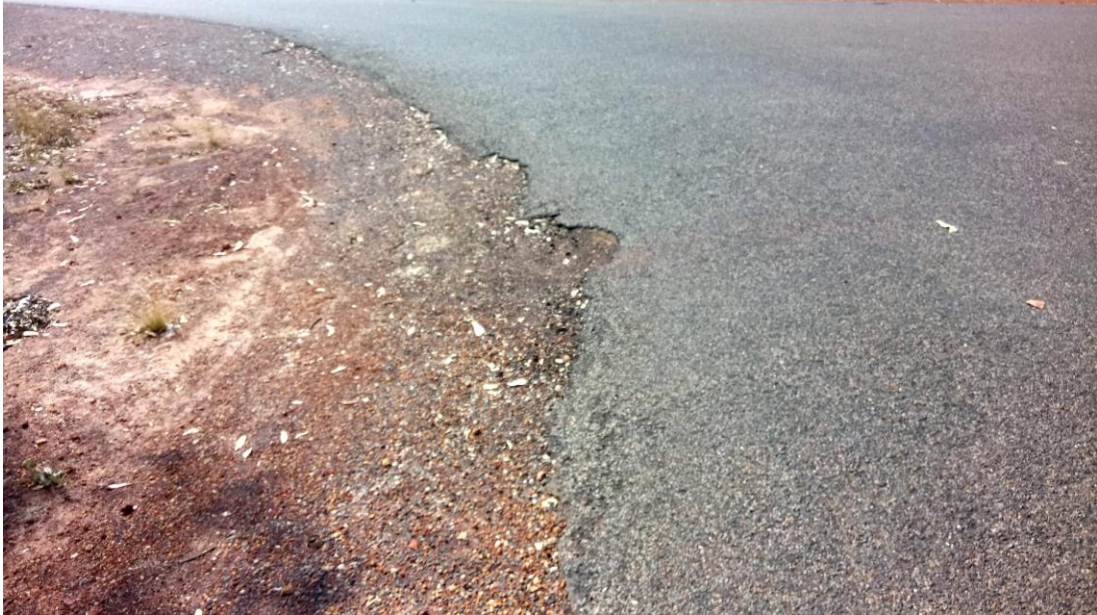
Edge breaks at Sachse Intersection			
Cracking	Yes	Affected Area	Cracks along road section, most pronounced within CH0.0-0.4

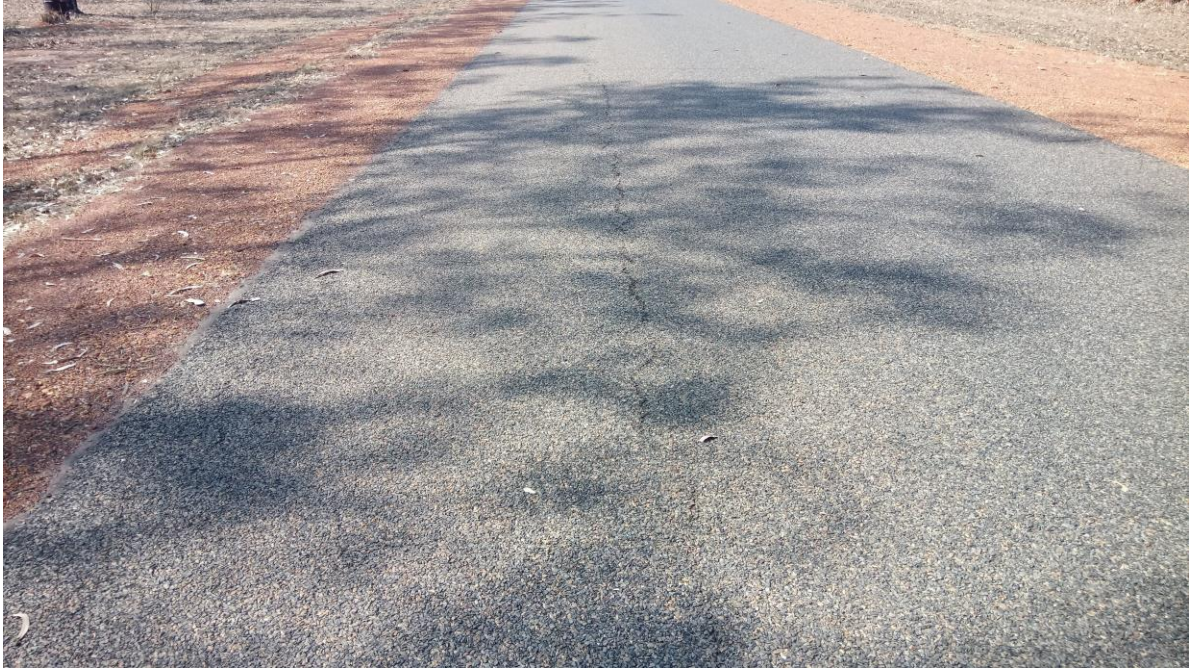
Longitudinal Cracking between Erickson Crescent and Dalmeny Road

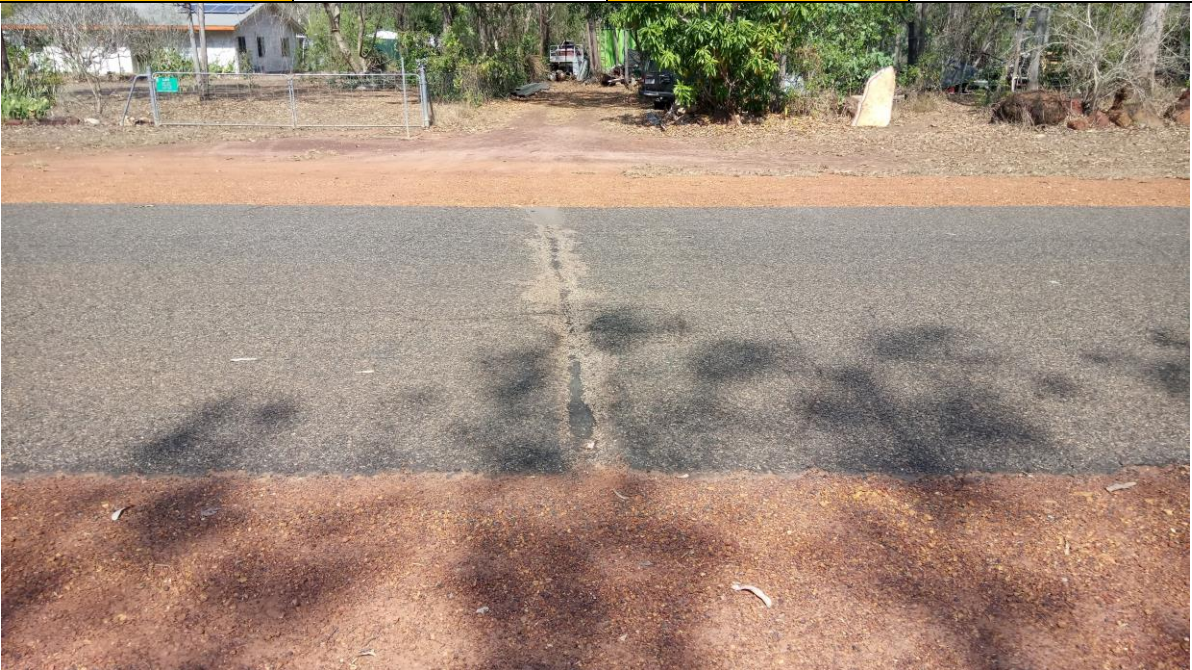
Service crossing approximate Chainage 0.25

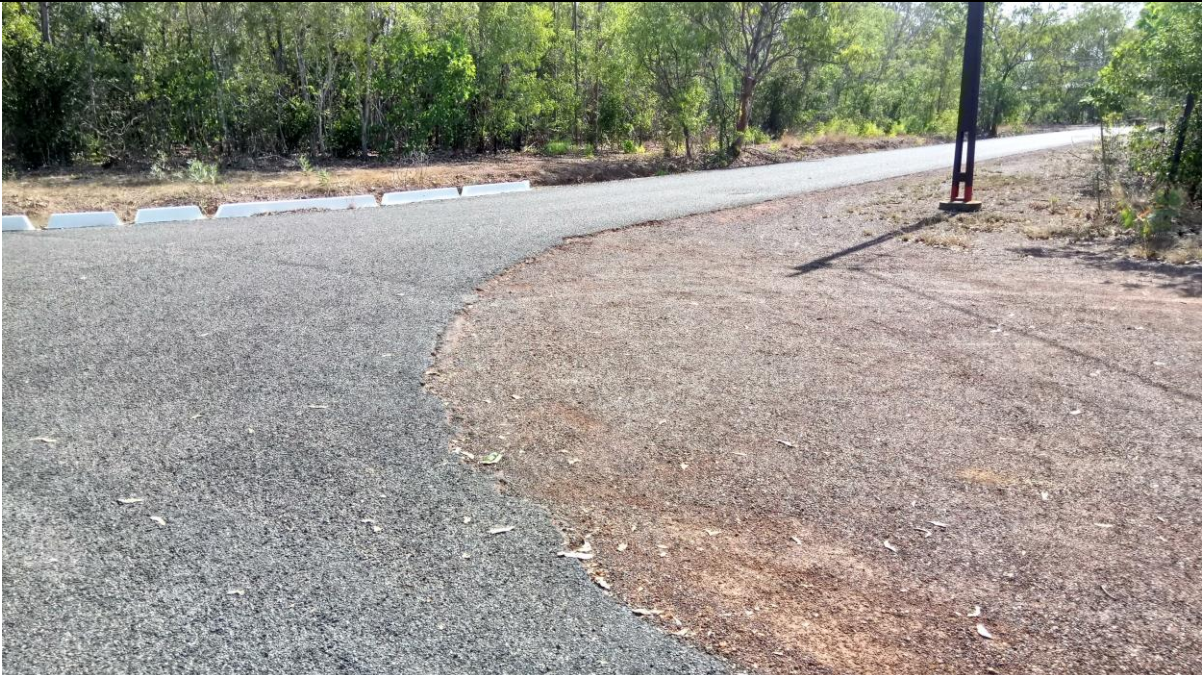
Edge drop at Baluria Road Intersection			
Edge Break	Yes	Affected Area	Refer to Edge drop
Cracking	No	Affected Area	NA
Service Crossing	Yes	Affected Area	Baluria Road Intersection

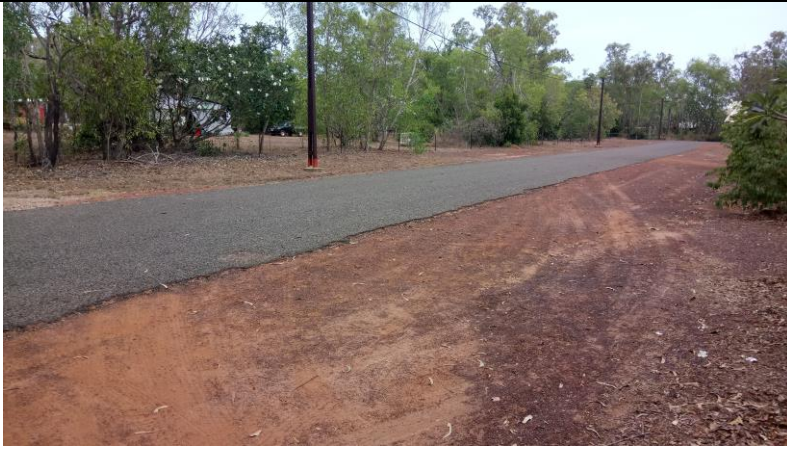
Edge drop off residential driveway			
Edge Break	Yes	Affected Area	CH0.1

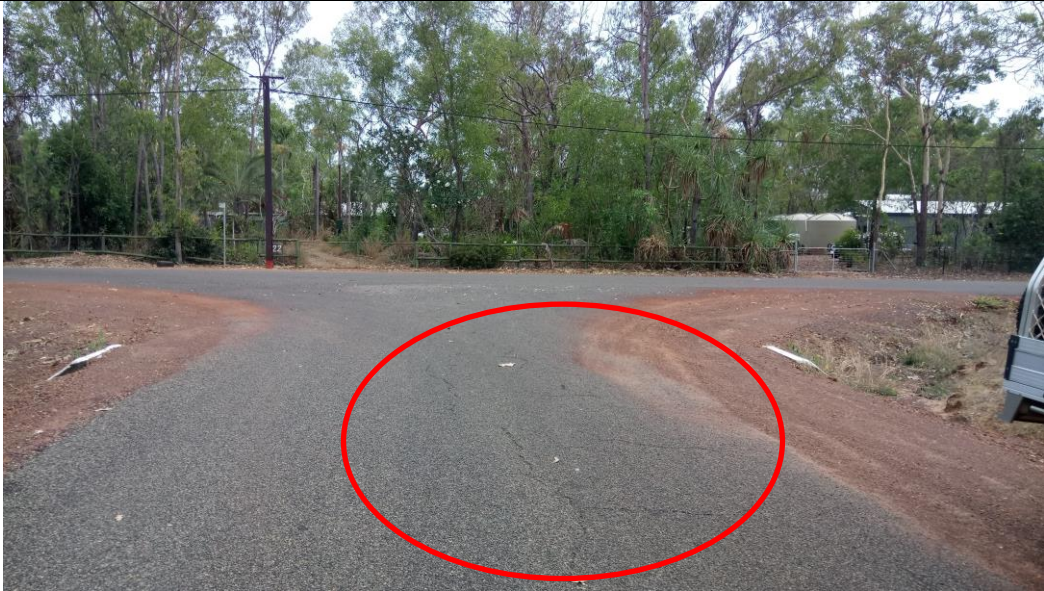
Longitudinal Cracking near Uhr Road			
Service Crossing	No	Affected Area	NA
Ravelling	Yes	Affected Area	Uhr Road Intersection and cul-de-sac

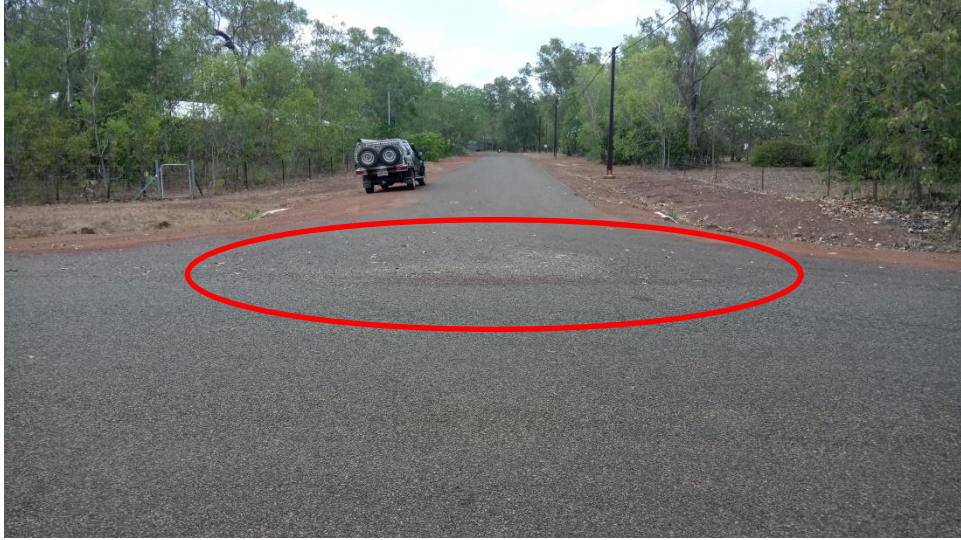
Ravelling adjacent to Uhr Road

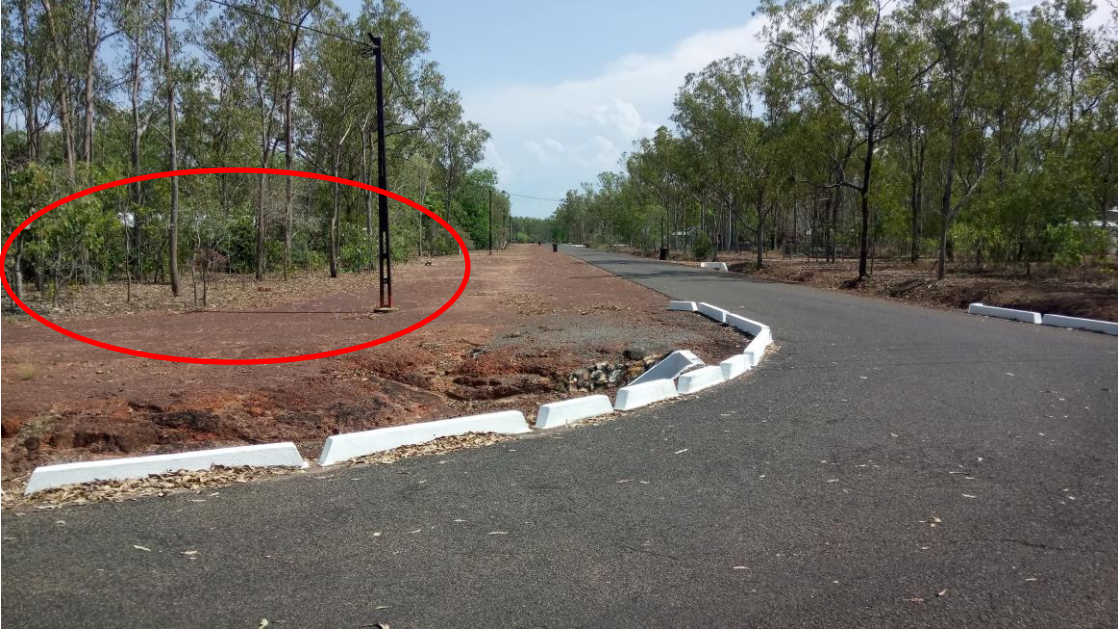
Residence location of flooding complaint			
Edge Drop	Yes	Affected Area	Refer to Edge Break
Edge Break	Yes	Affected Area	Majority of eastern side of roadway

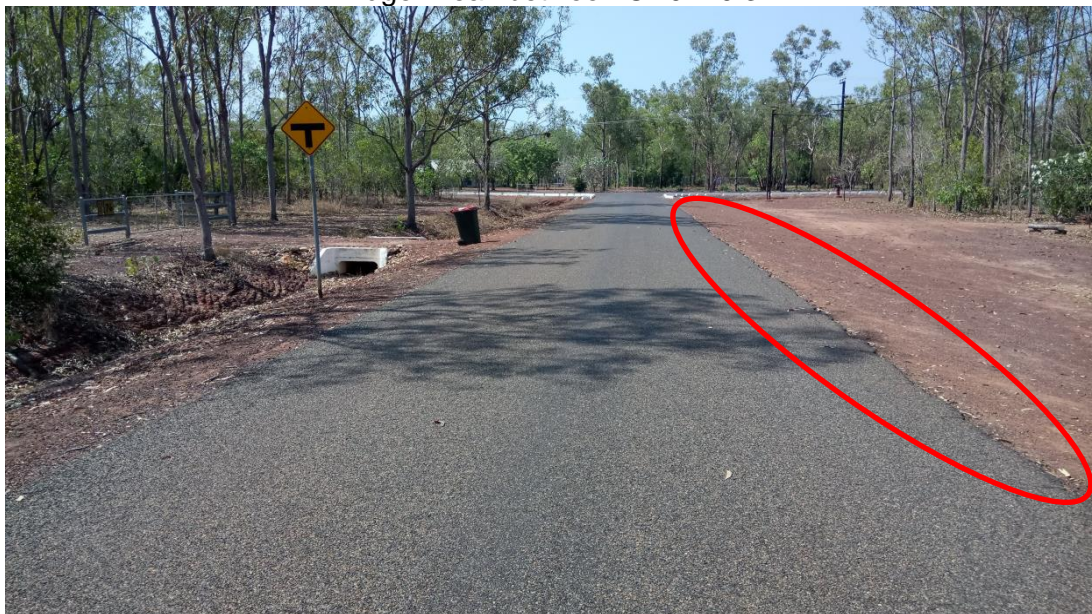
Edge break between CH0.4-0.5

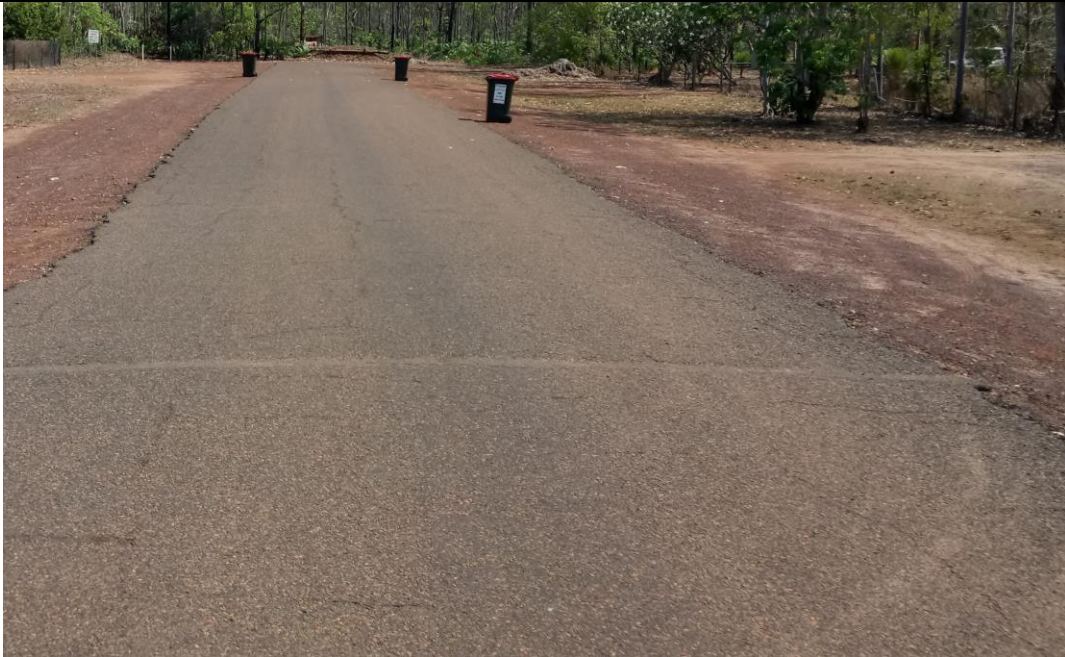
Cracking between CH0.0-CH0.1

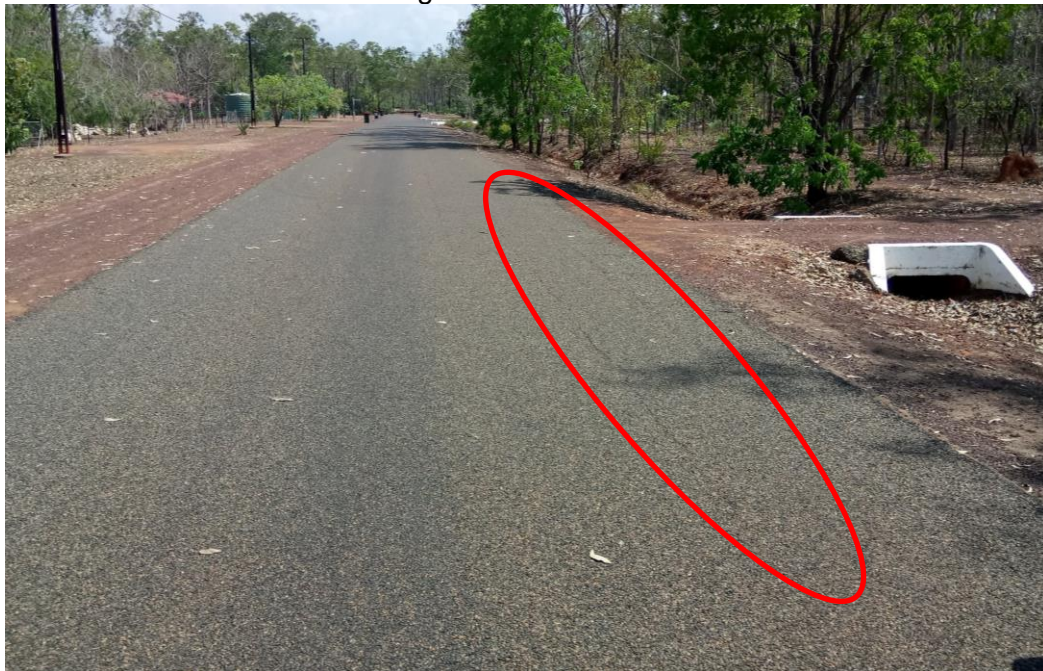
Cracking between CH0.1-CH0.2

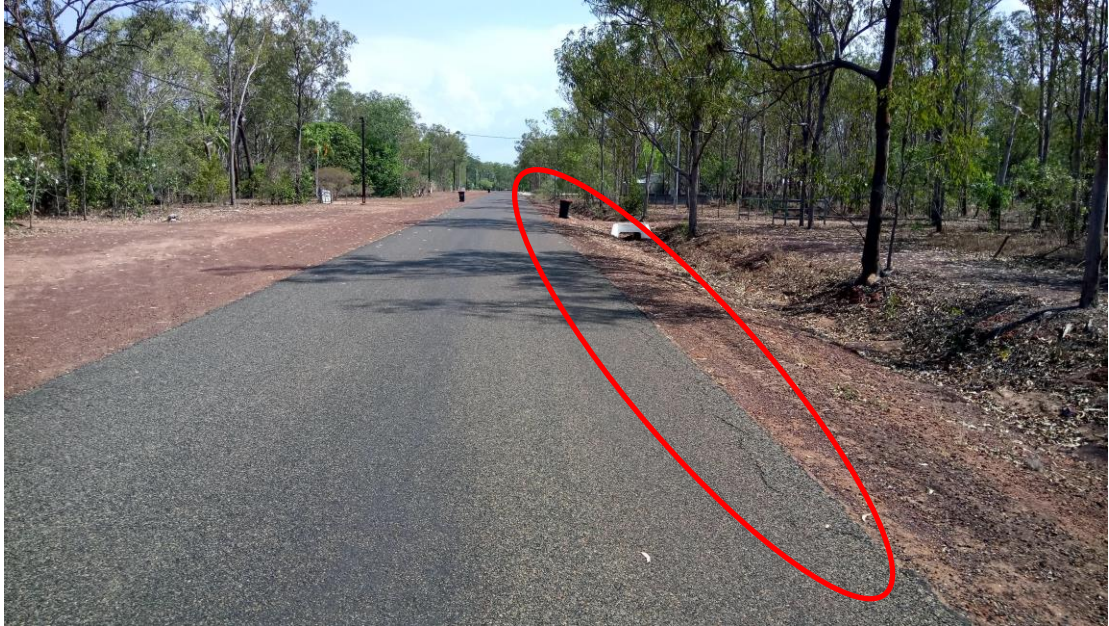
Cracking between CH0.4-CH0.5

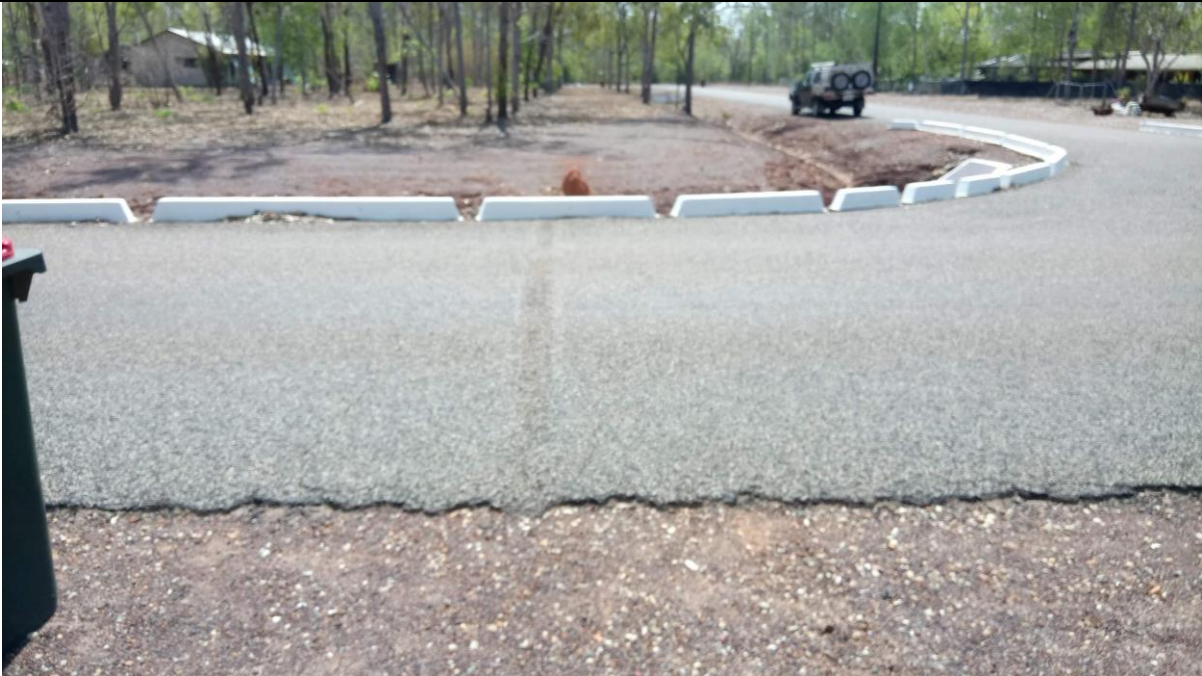
Service Crossing adjacent to Kathleen Circuit

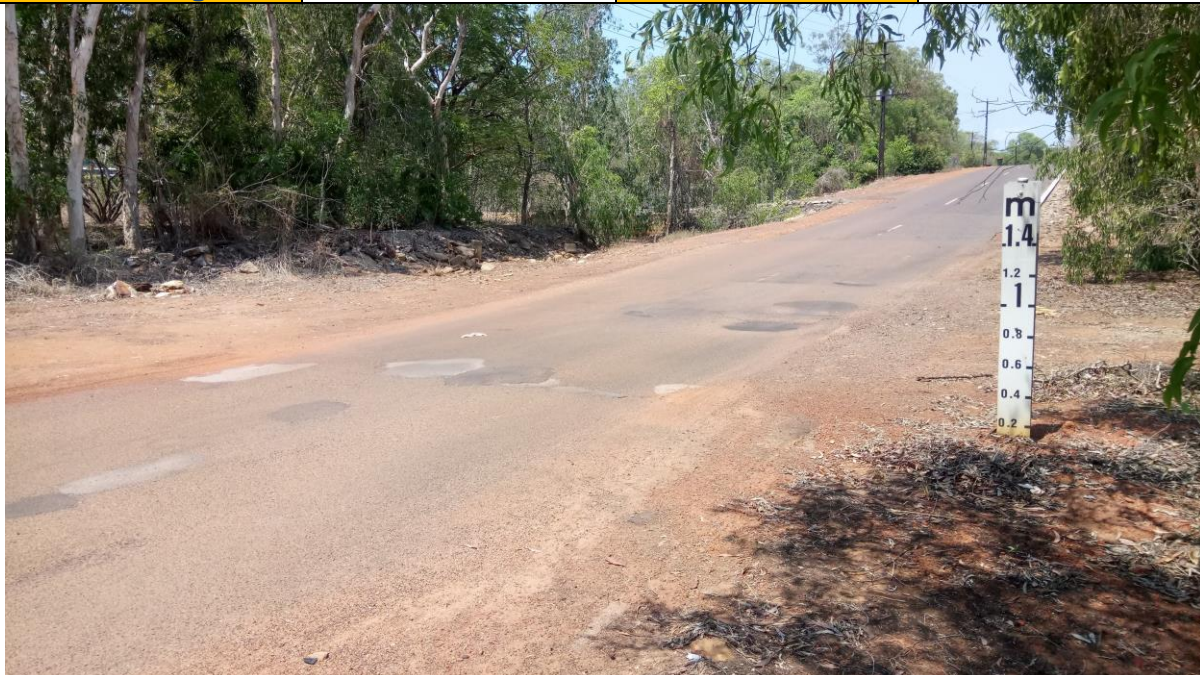
Floodway crossing at approximate Chainage 0.9			
Edge Drop	Yes	Affected Area	Refer to Edge break
Edge Break	Yes	Affected Area	Ch0.7

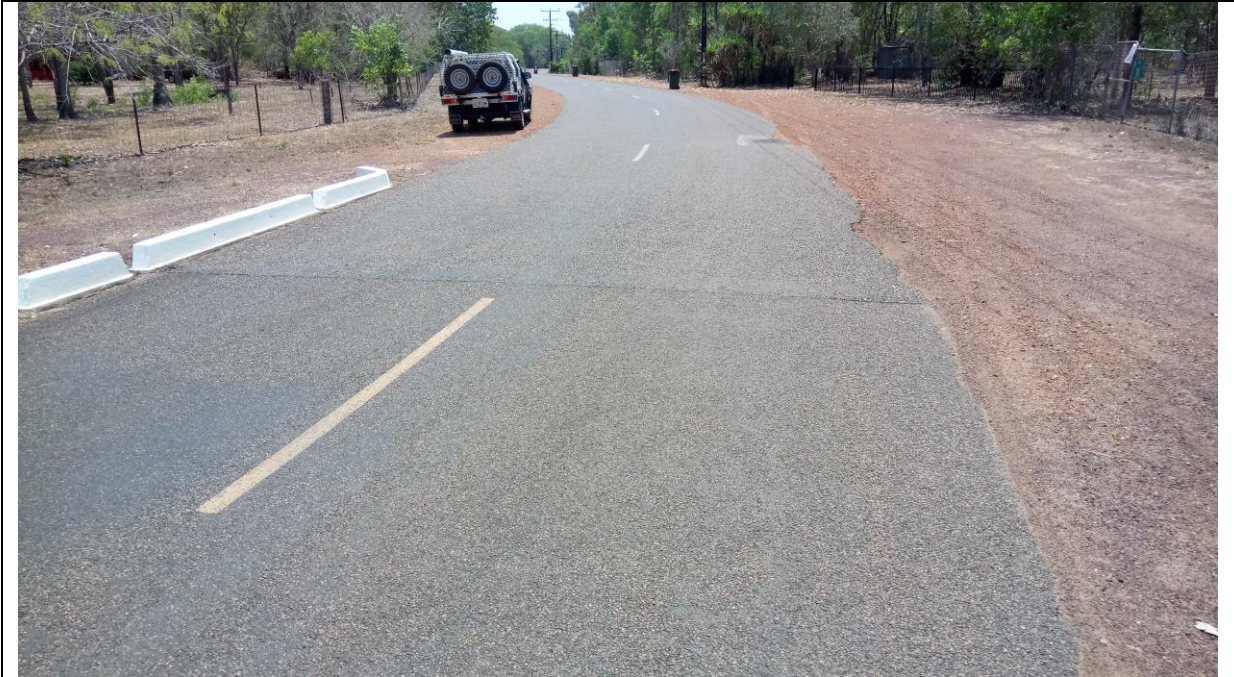
Edge break at approximate chainage 0.7

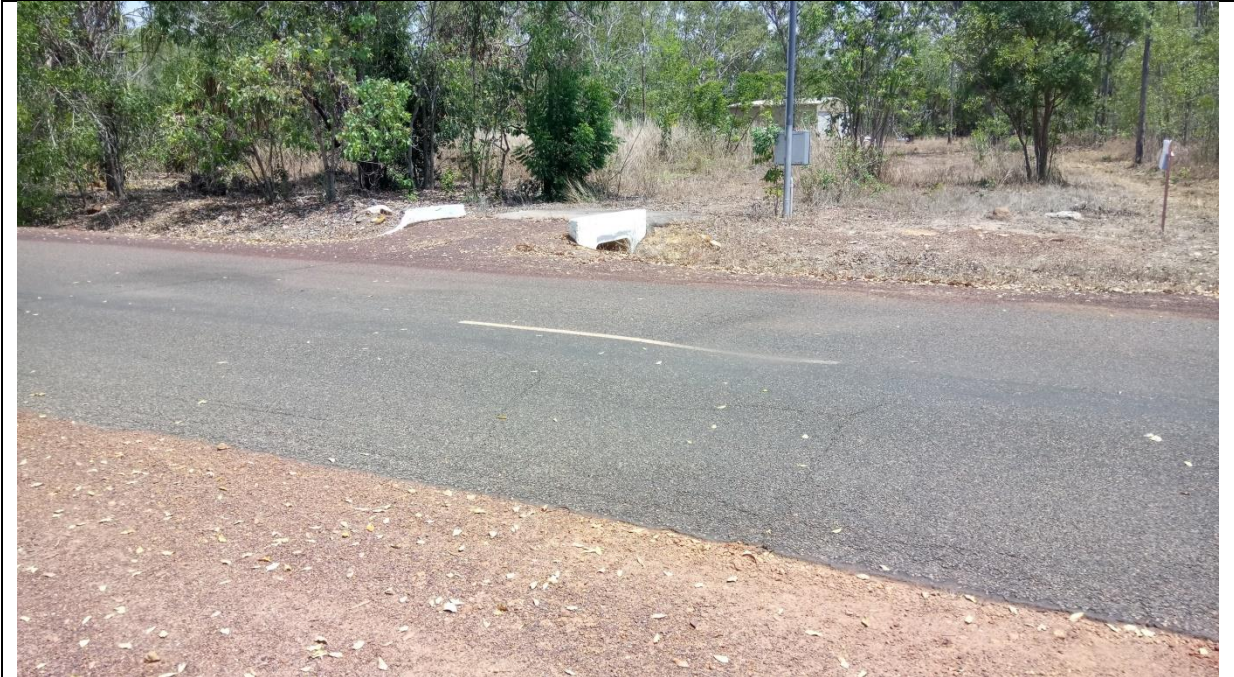
Cracking and undulation of pavement at chainage 0.25

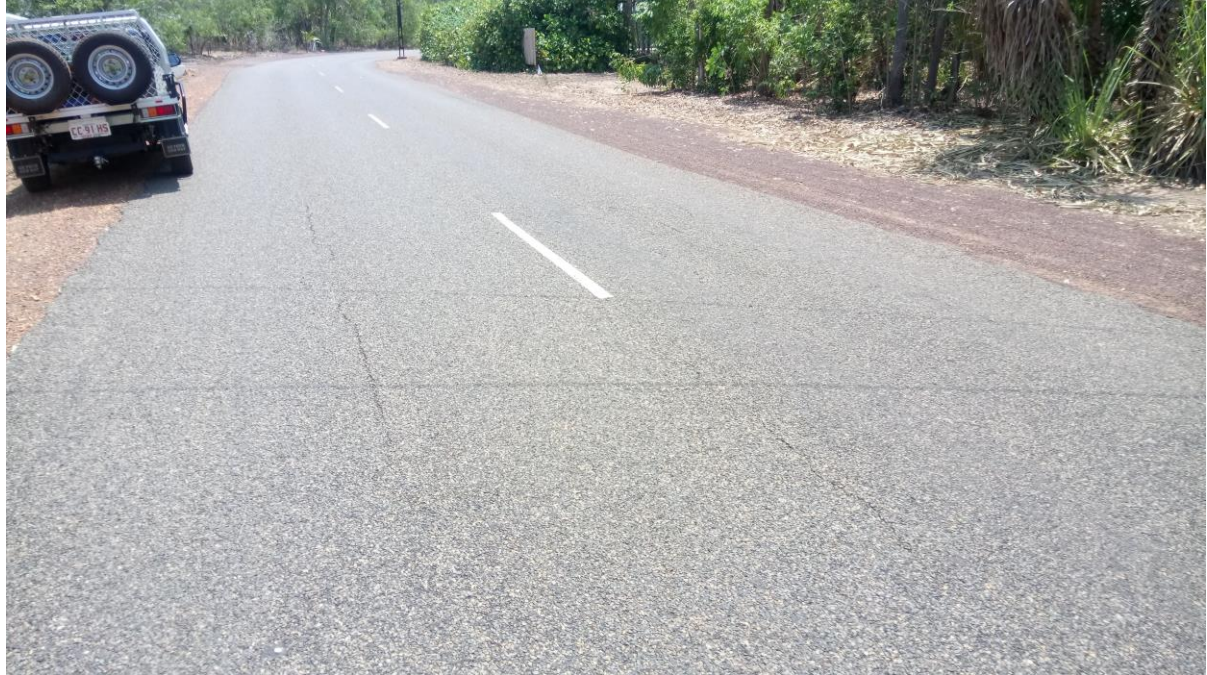
Longitudinal cracking at approximate chainage 0.3

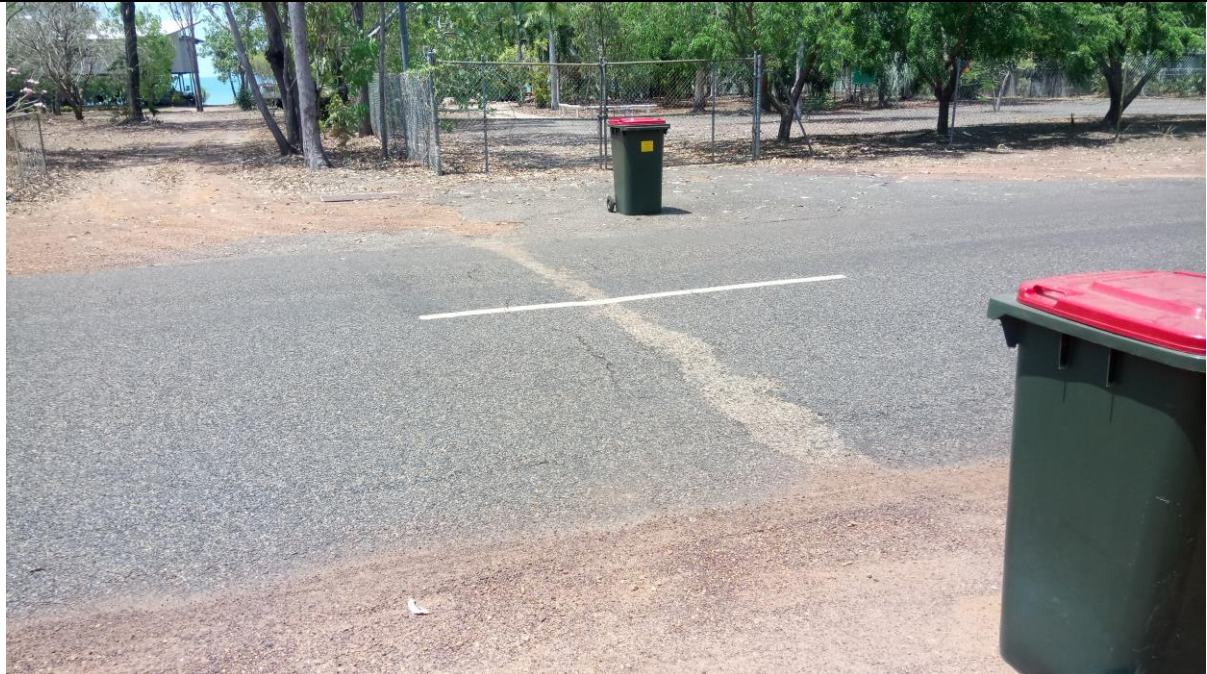
Service Crossing approximate chainage 0.4

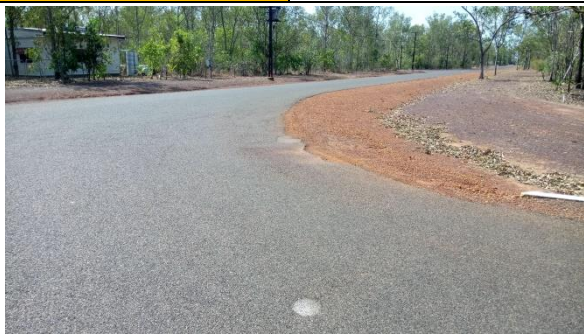
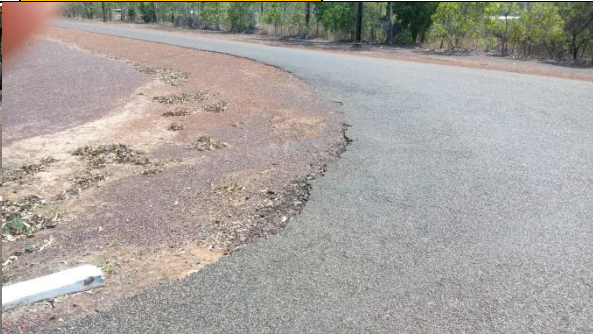
Edge breaks at Baluria Street Intersection			
Cracking	Yes	Affected Area	CH0.4-CH0.6

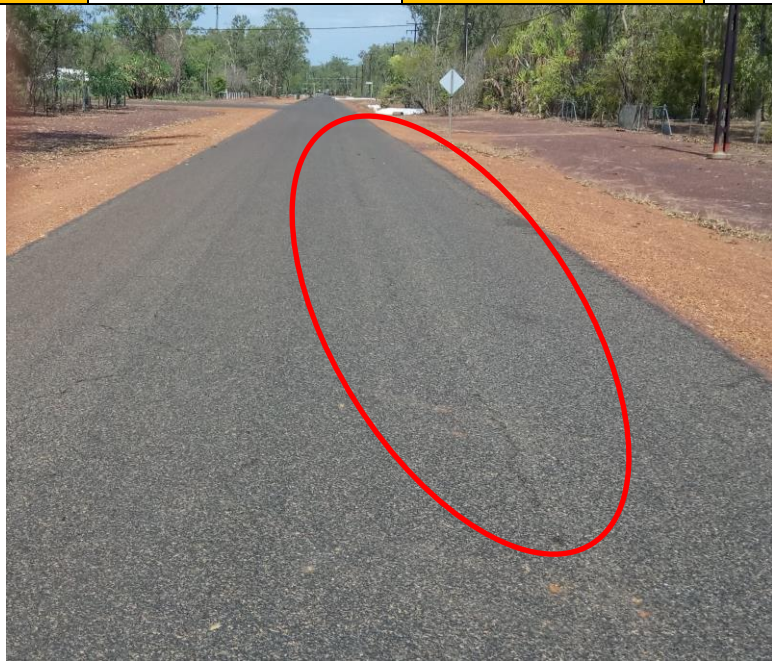
Cracking at CH0.5

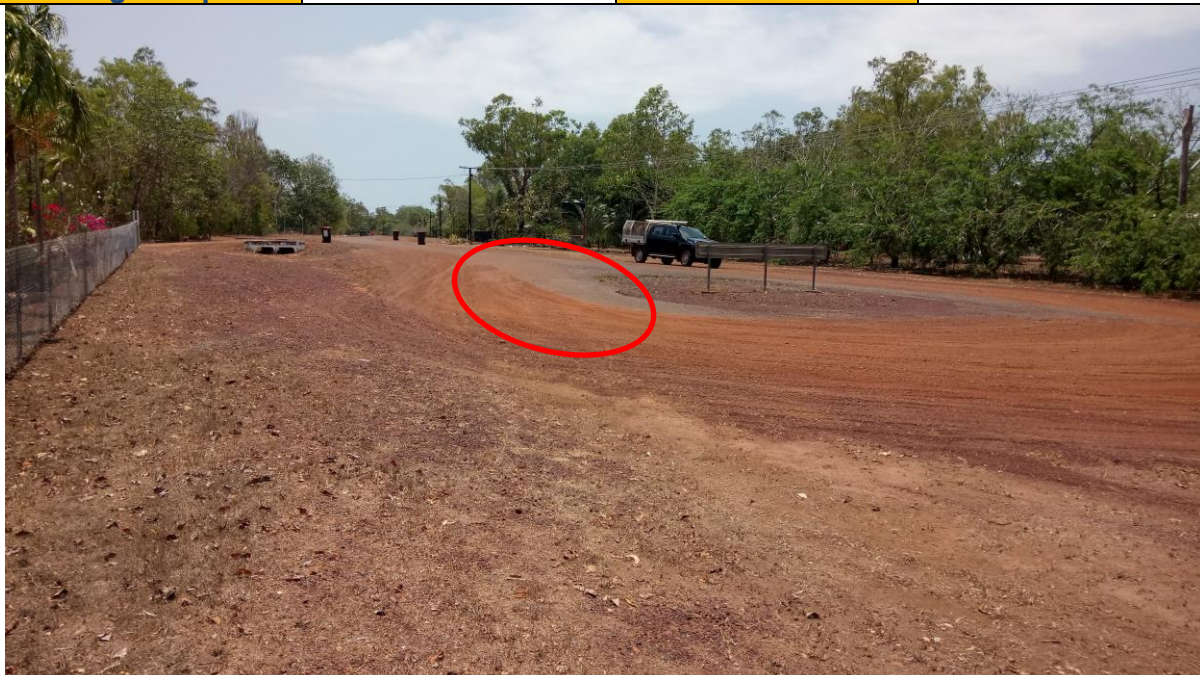
Area affected by regular edge drop at cul-de-sac			
Edge Break	No	Affected Area	NA
Cracking	Yes	Affected Area	CH0.0-0.3

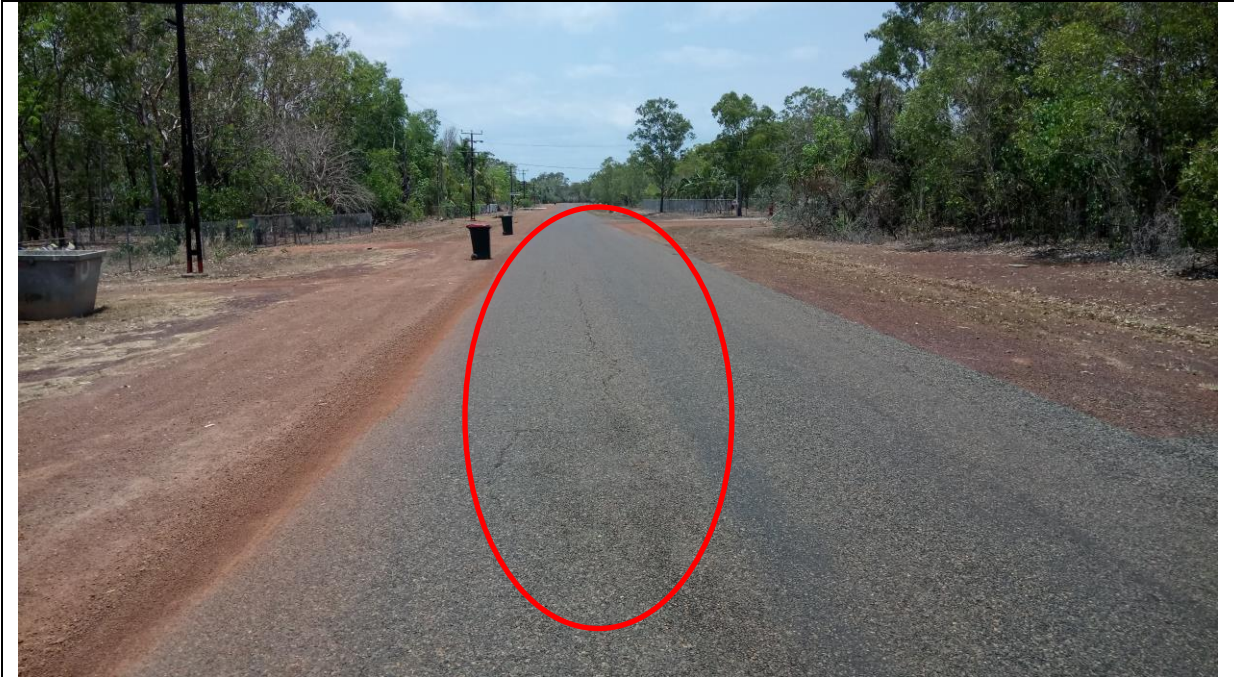
Pavement cracking approximate chainage 0.2

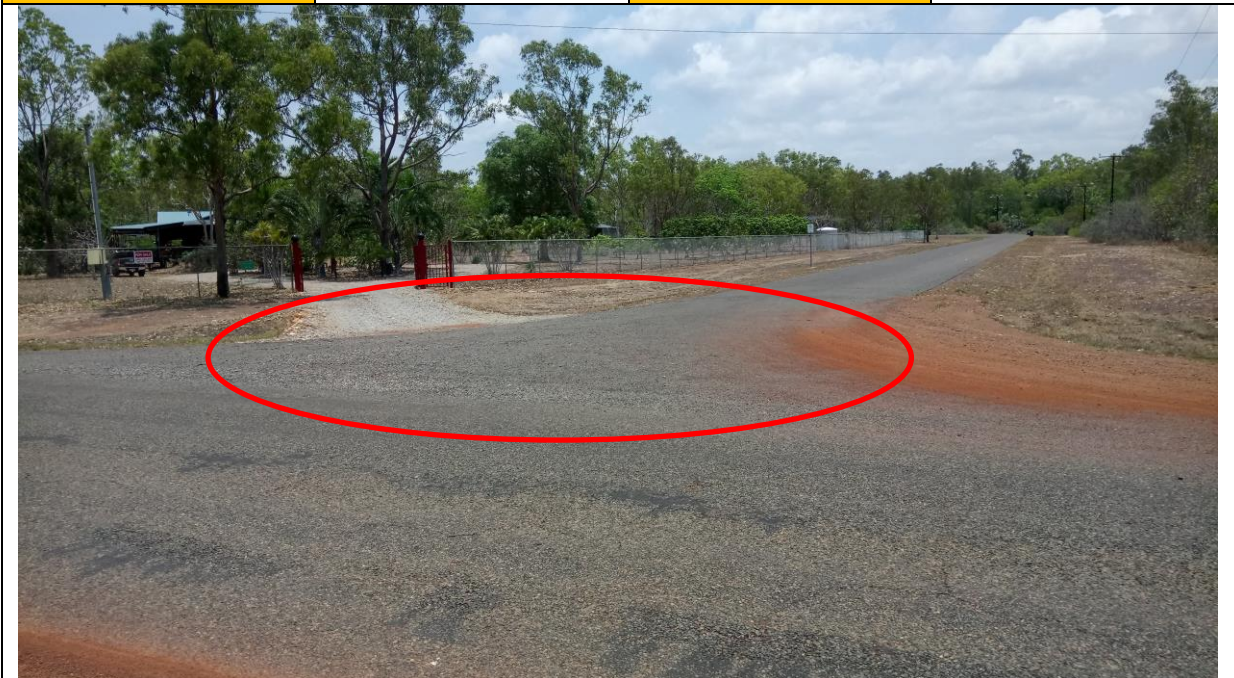
Raveling at Mungalo Road Intersection

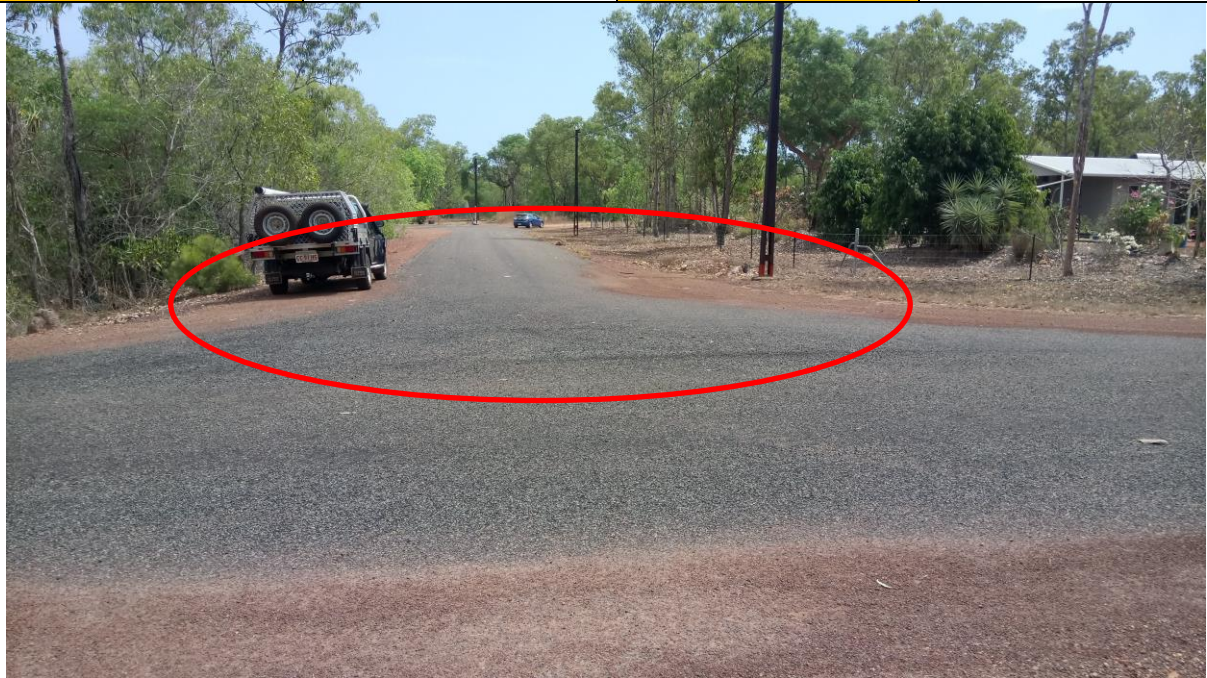
Raveling at Harney Street Intersection

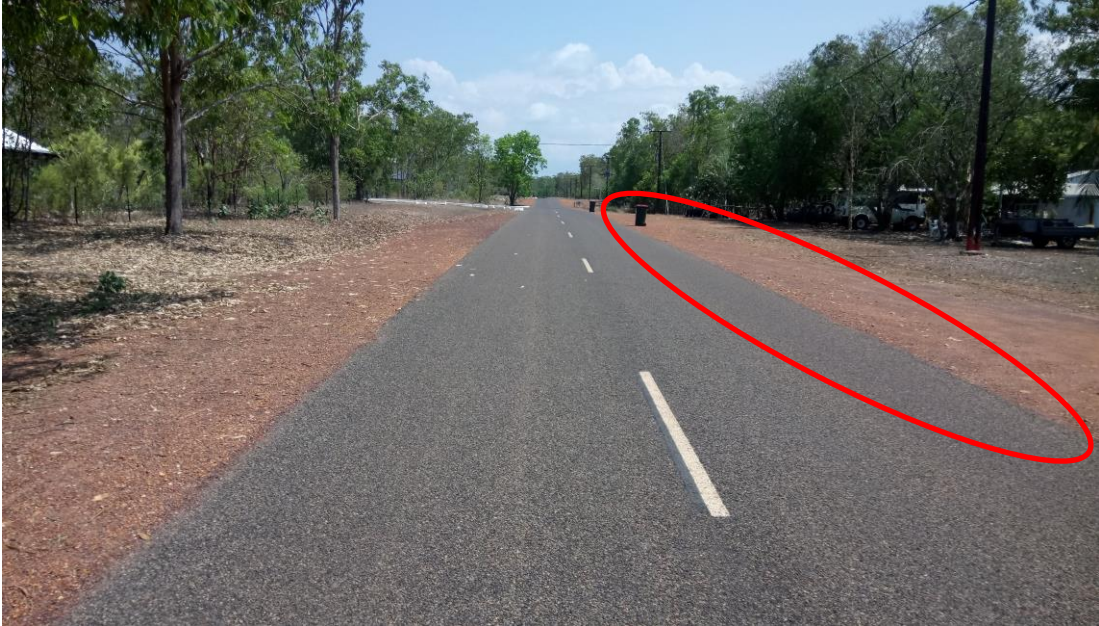
Edge drop approximate chainage 0.3
