Road Network Investigation Report
For
Wagait Shire Council

Date: November 2018

Road Network Investigation Report for Wagait Shire Council

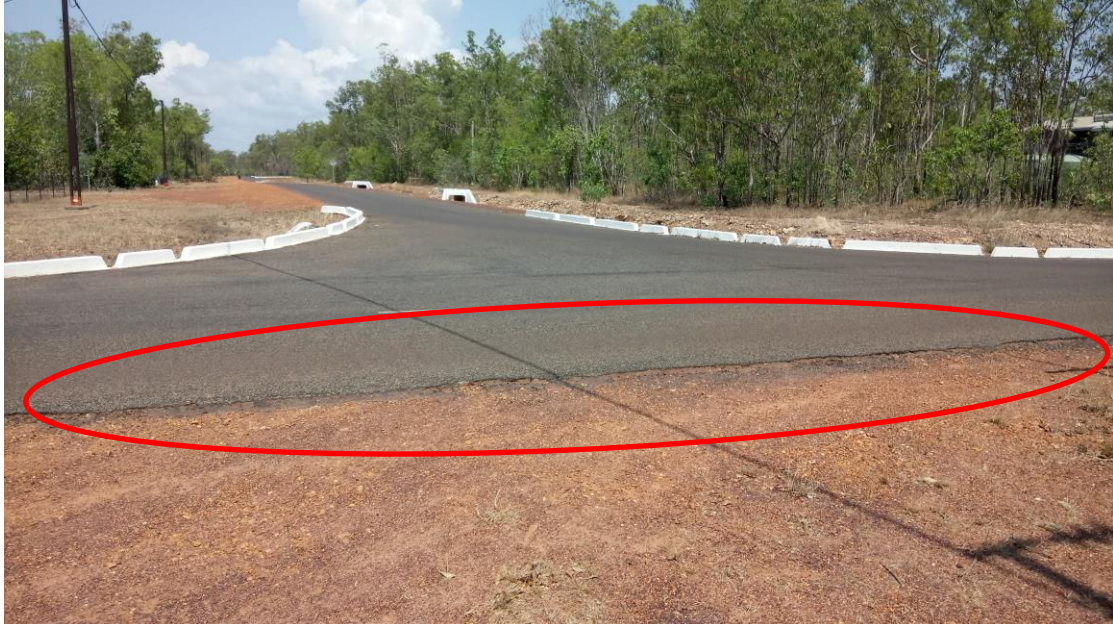
Edge drop approximate chainage 0.4

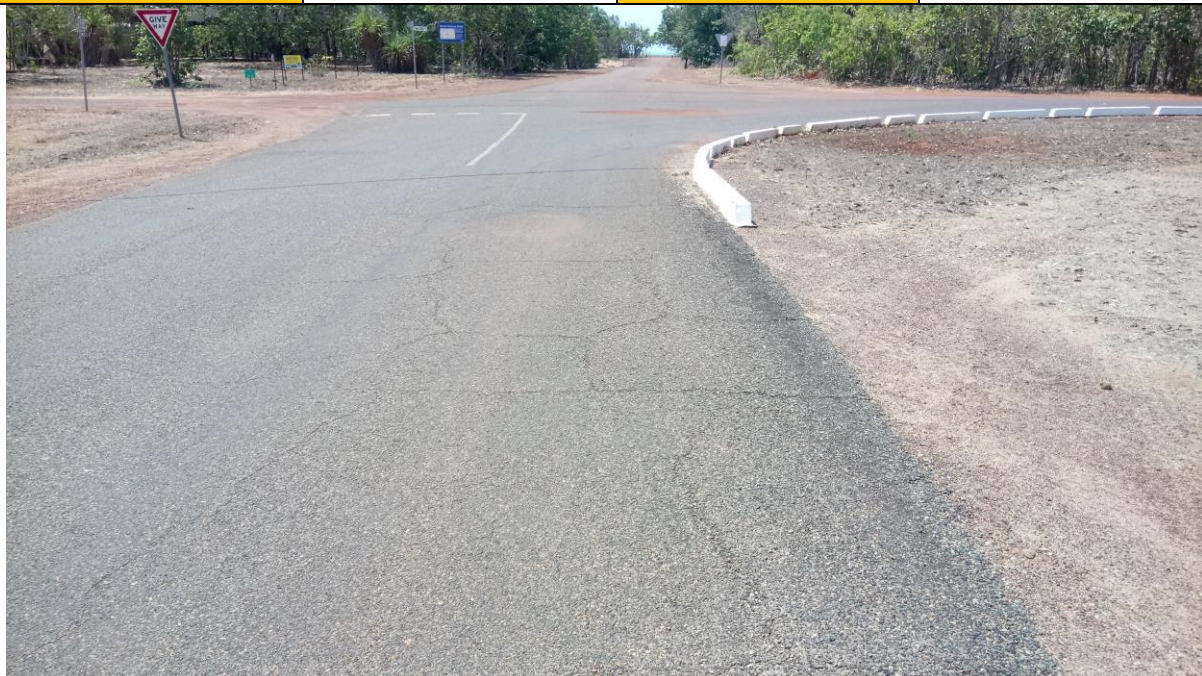
Cracking Cox Drive Intersection

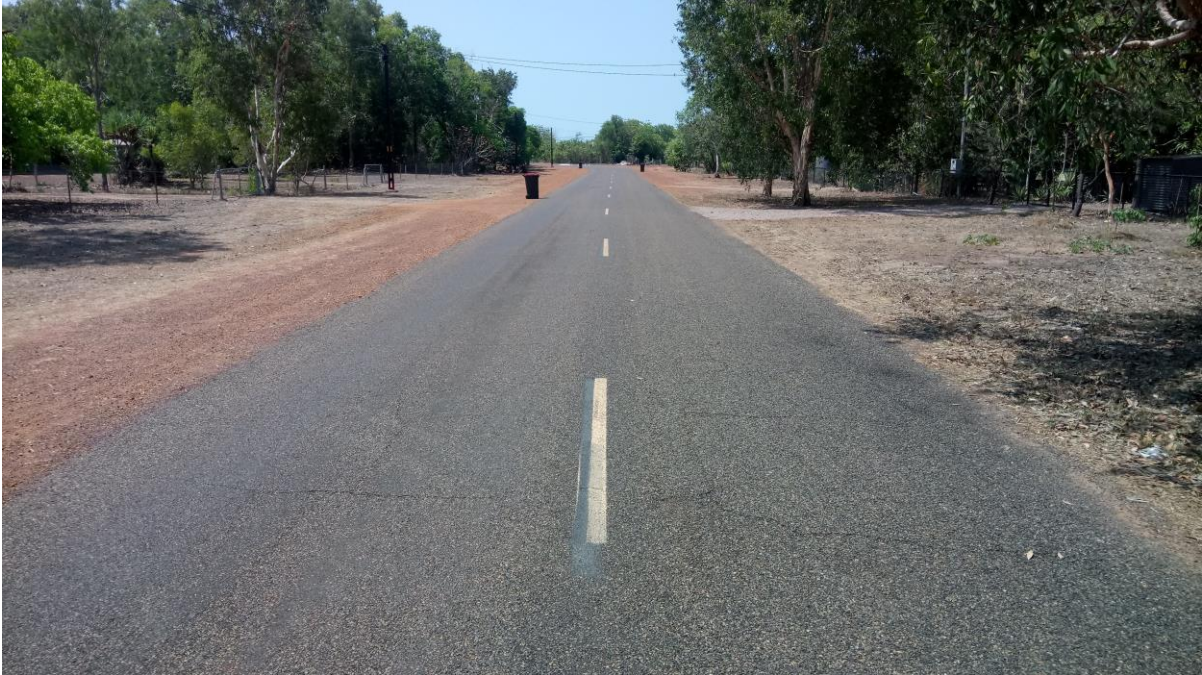
Cracking approximate chainage 0.2

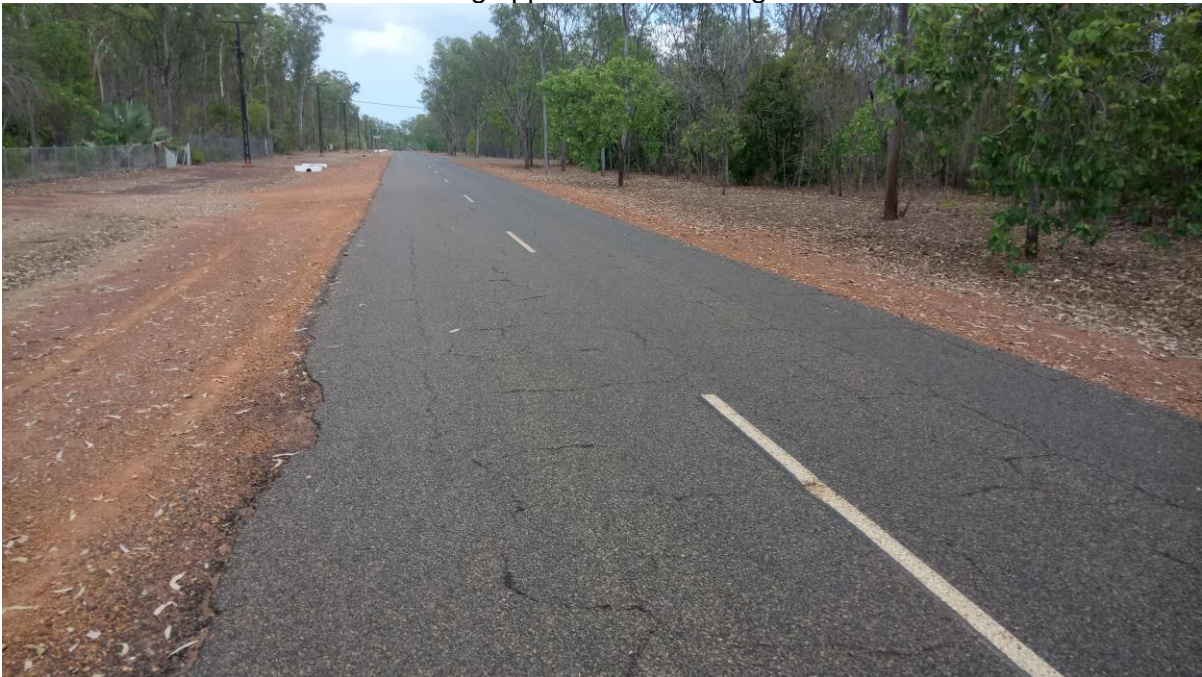
Cracking approximate chainage 1.6

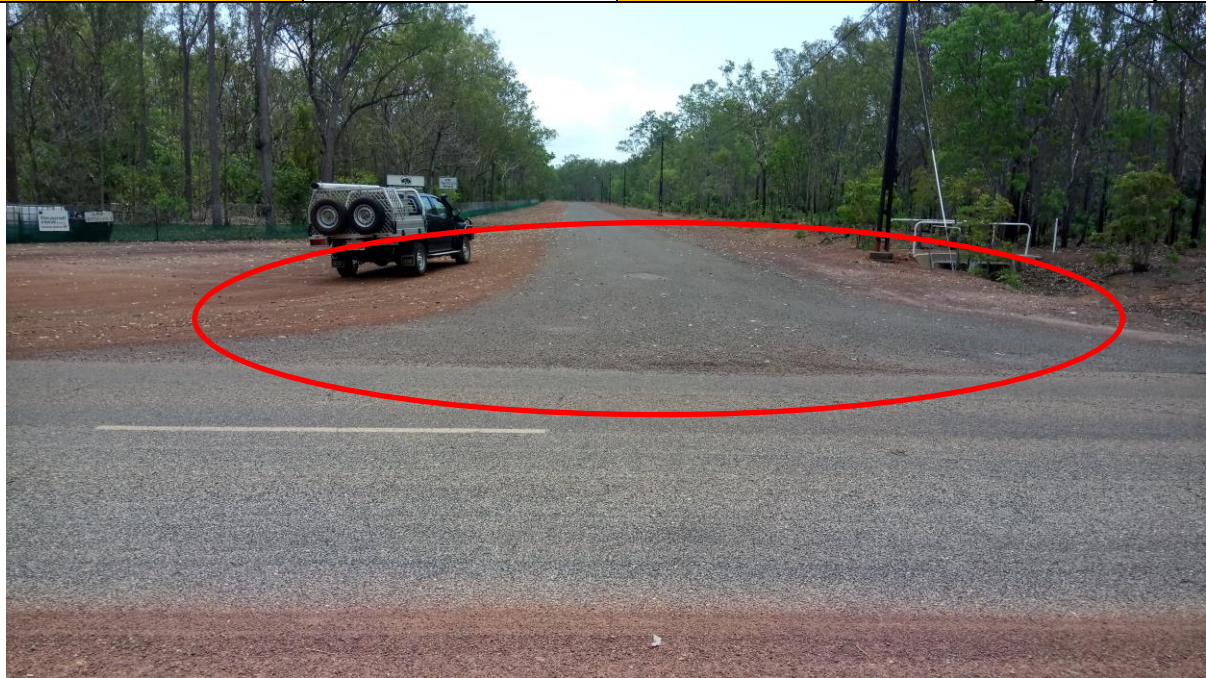
Raveling at Wagait Tower Road Intersection

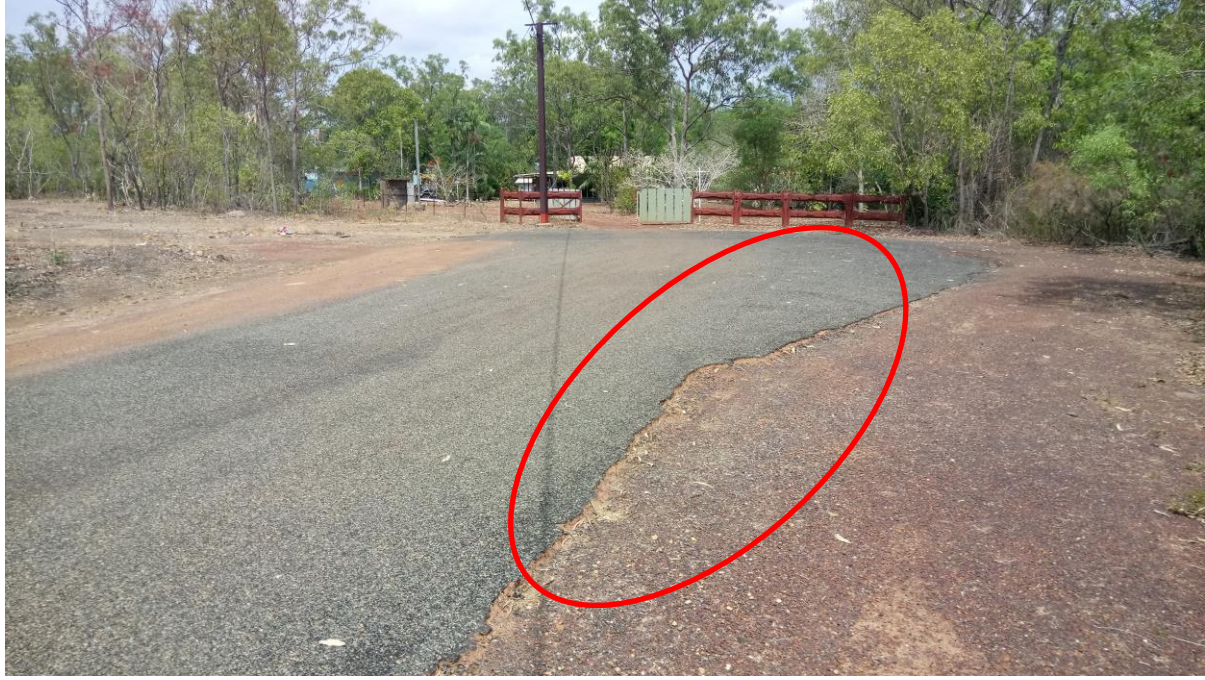
Edge drop and break at cul-de-sac			
Cracking	Yes	Affected Area	Length of Road

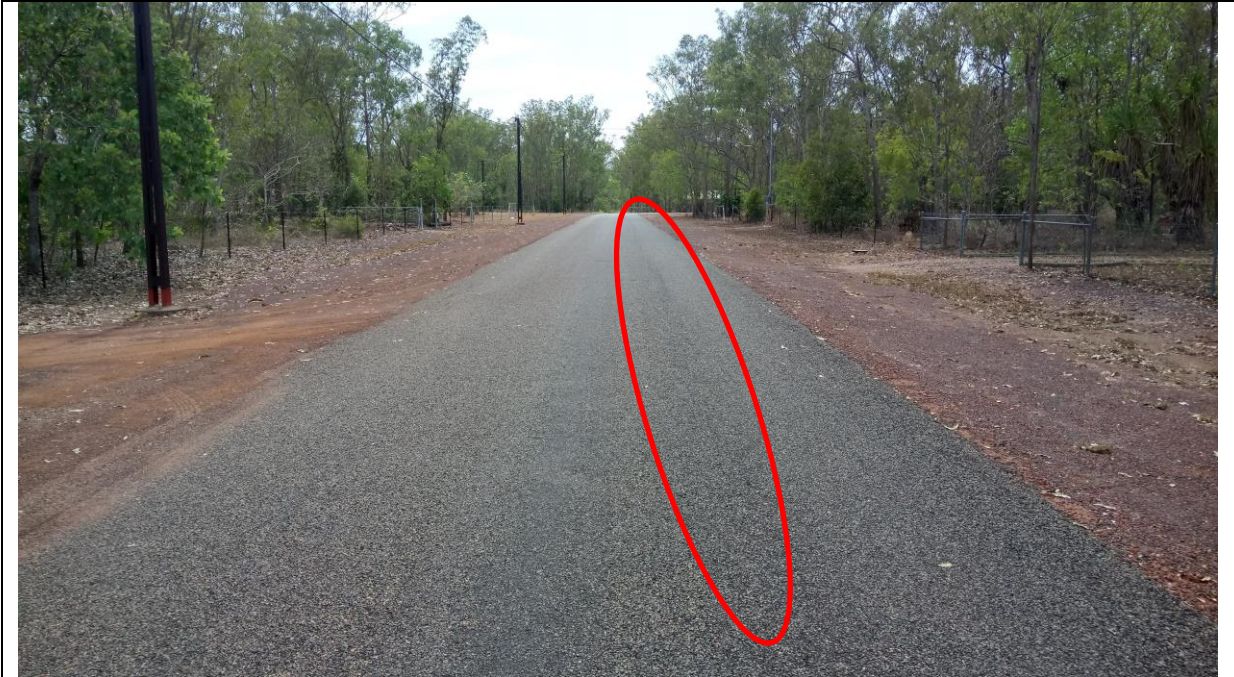
Pavement cracking at approximate chainage 0.1

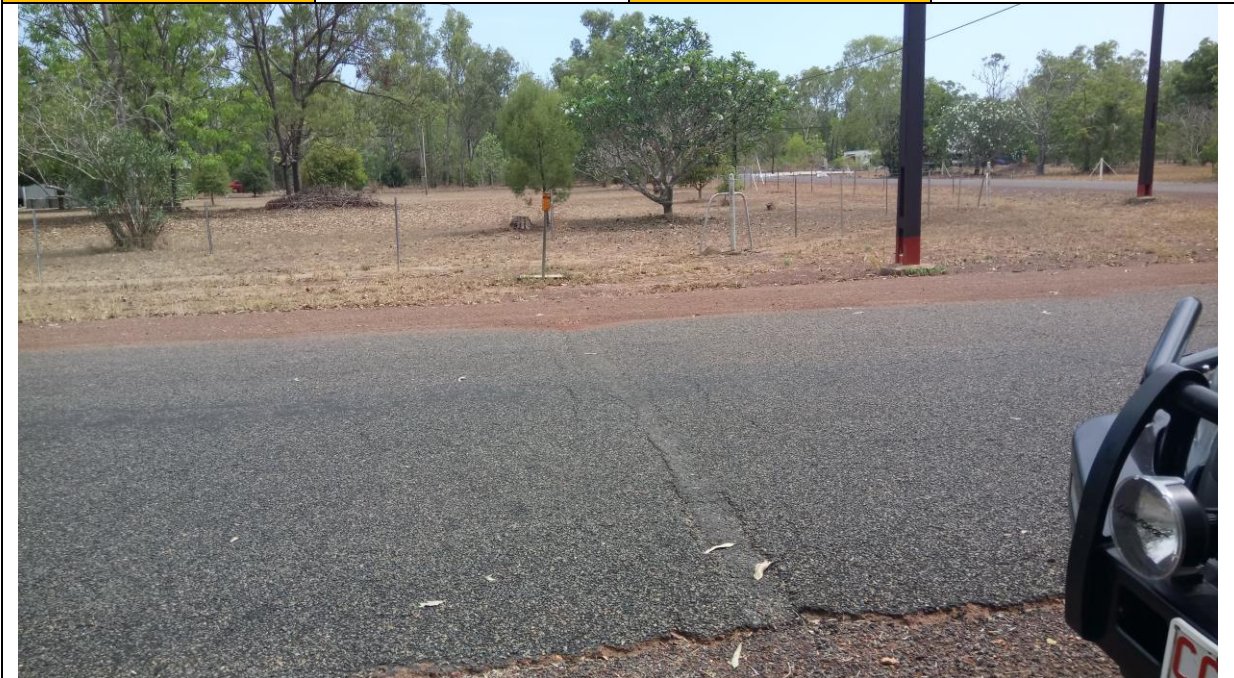
Service Crossing near Baluria Road Intersection

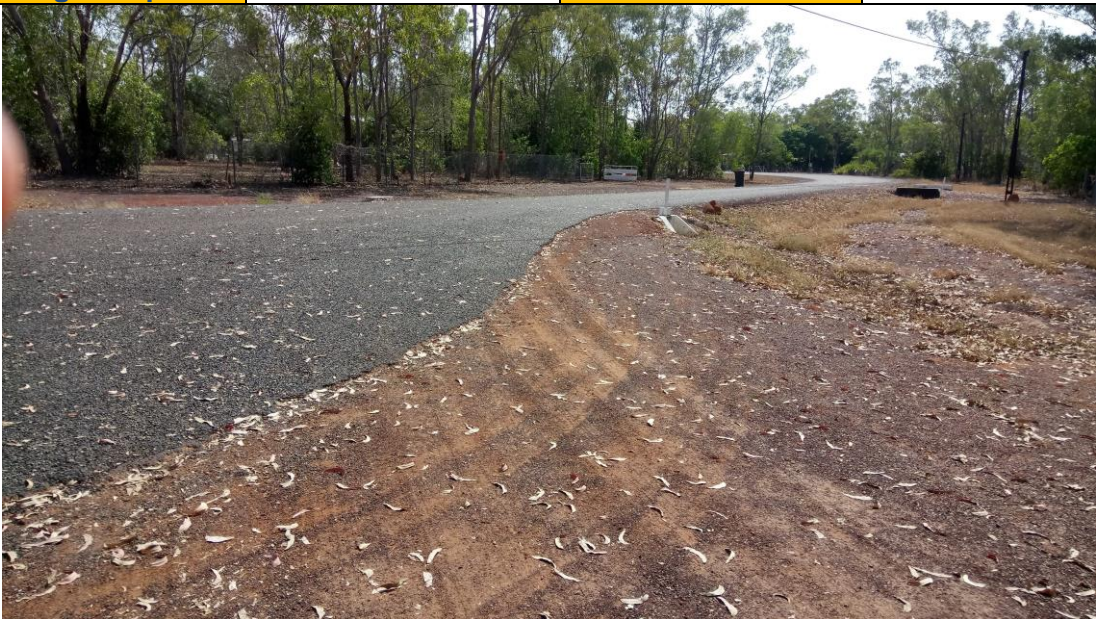
Edge drop at cul-de-sac			
Edge Break	No	Affected Area	NA
Cracking	Yes	Affected Area	CH0.1

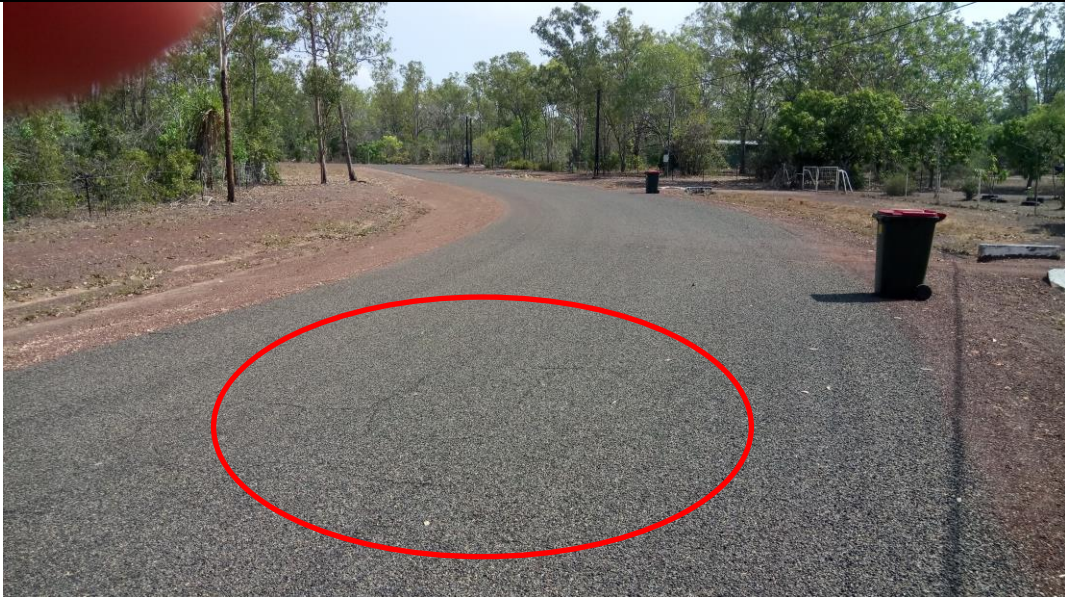
Cracking approximate chainage 0.1

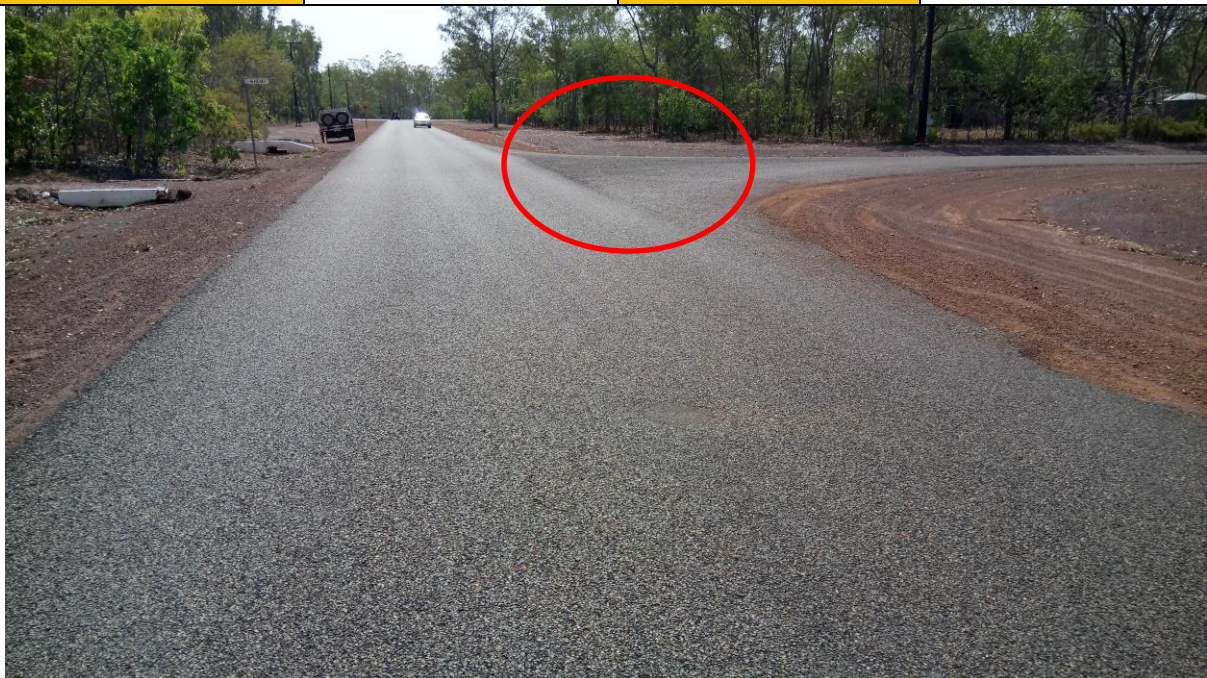
Raveling at Dalmeny Street Intersection

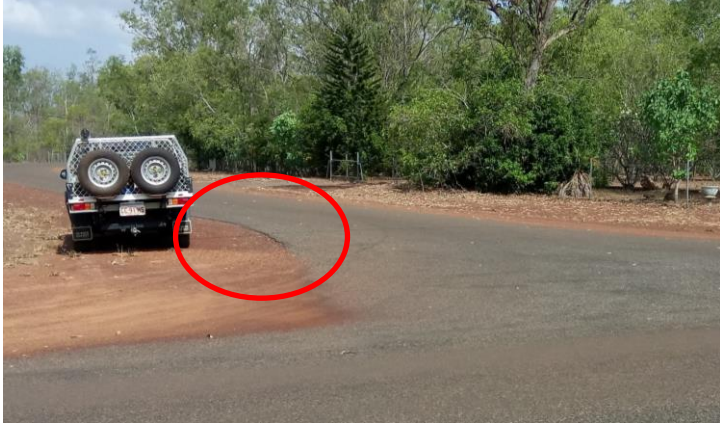
Edge drop at Erickson Crescent Intersection			
Edge Break	No	Affected Area	NA
Cracking	No	Affected Area	NA
Service Crossing	Yes	Affected Area	CH0.15

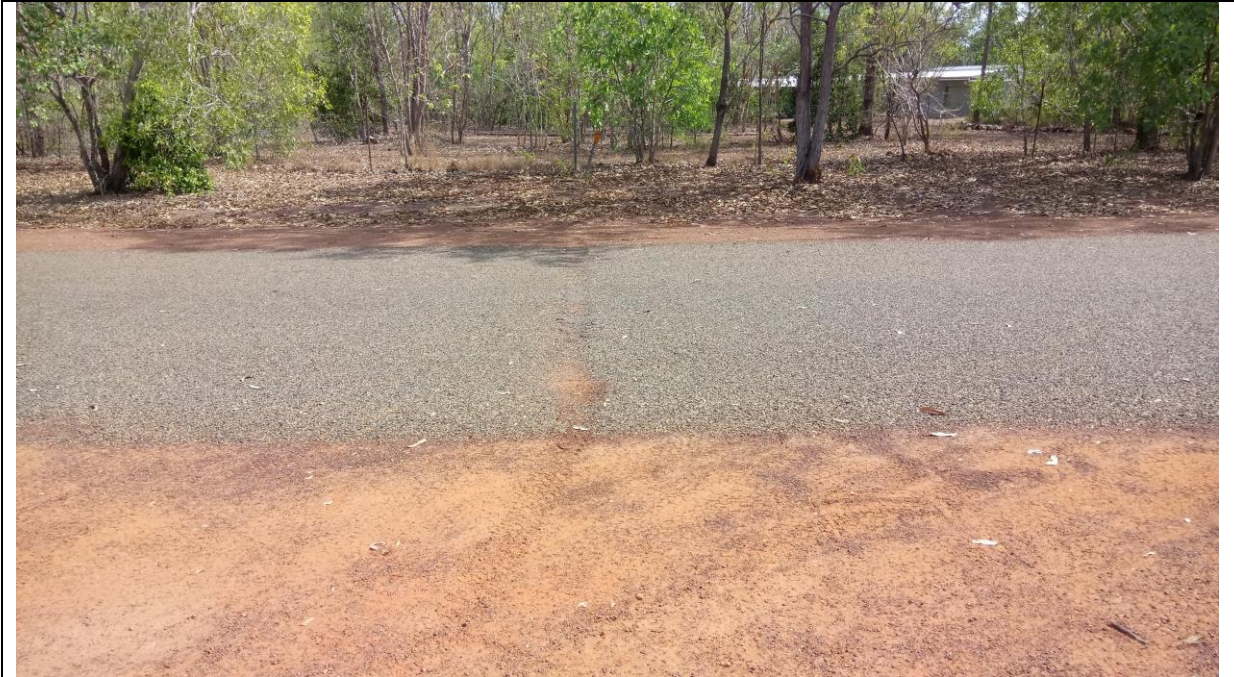
Service Crossing approximate chainage 0.15

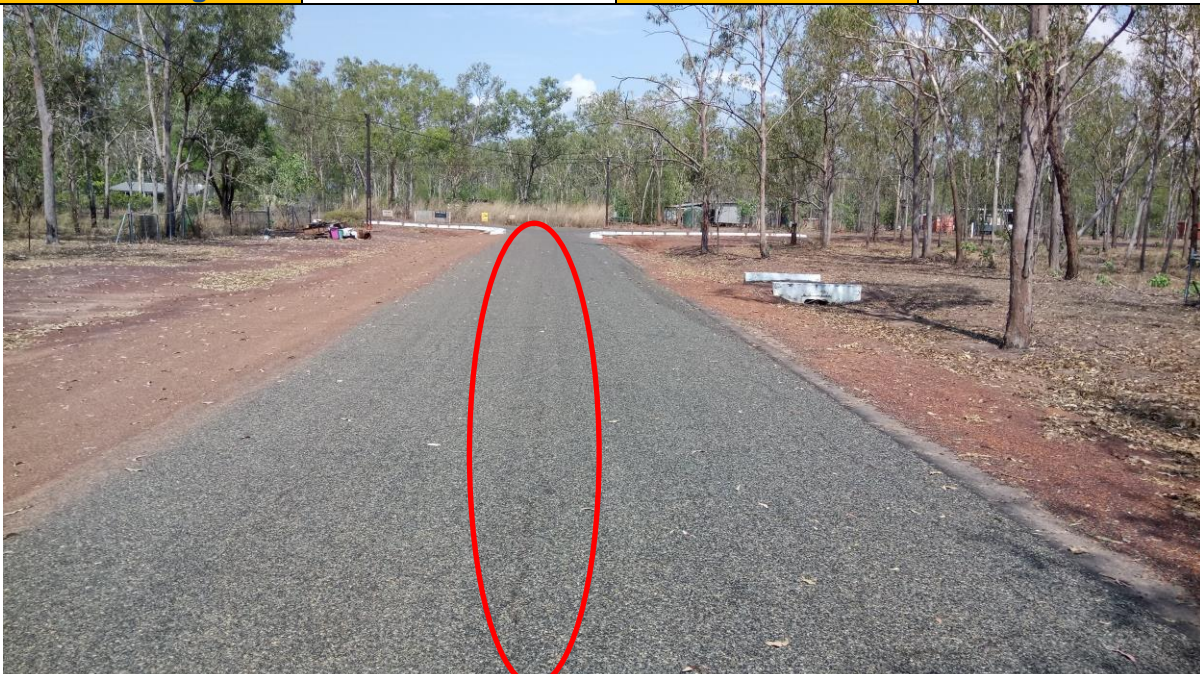
Cracking at approximate chainage 0.05			
Service Crossing	No	Affected Area	NA
Raveling	Yes	Affected Area	Harney Street Intersection and cul-de-sac

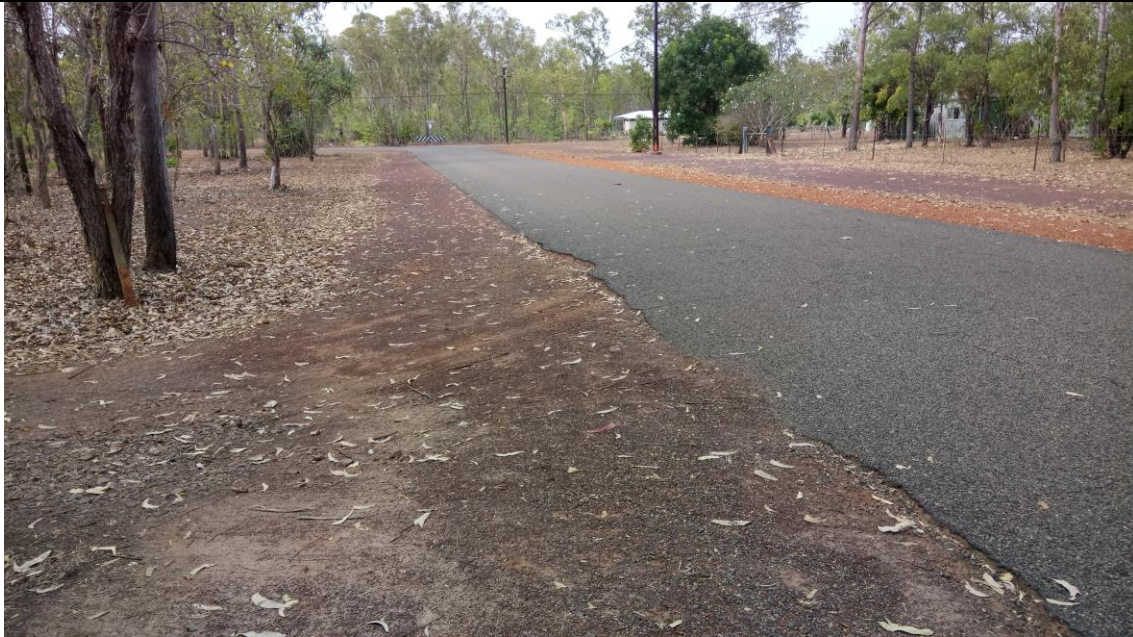
Edge break approximate chainage 0.35

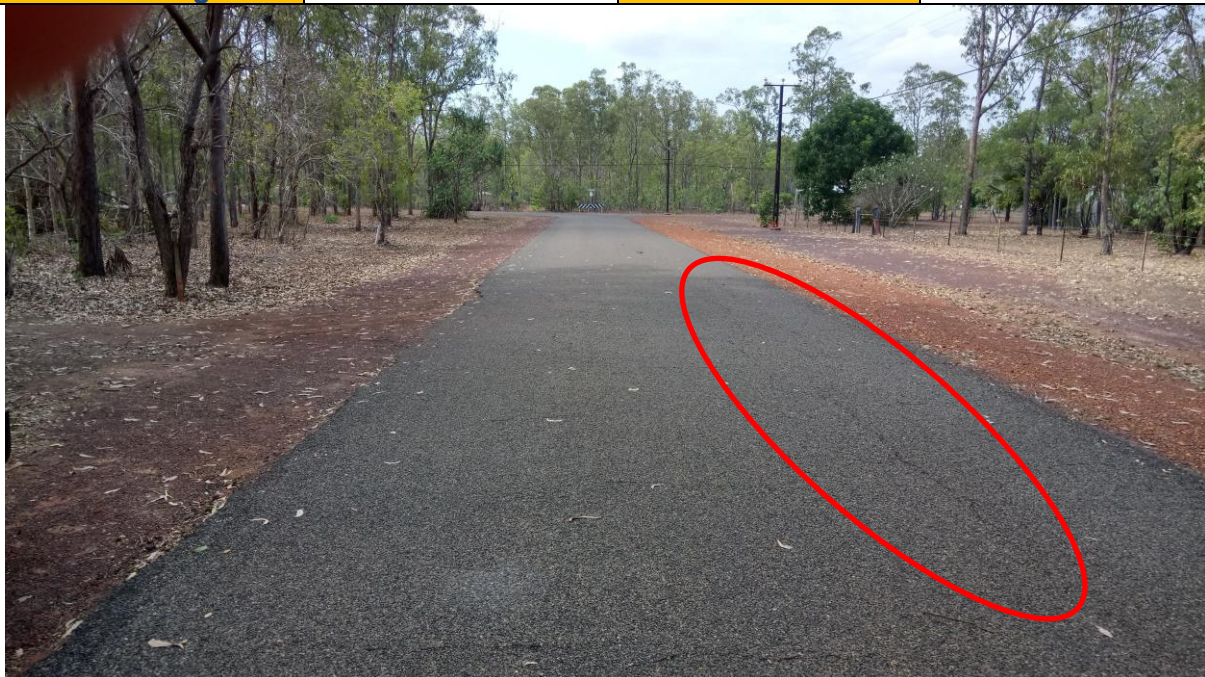
Cracking at approximate chainage 0.3

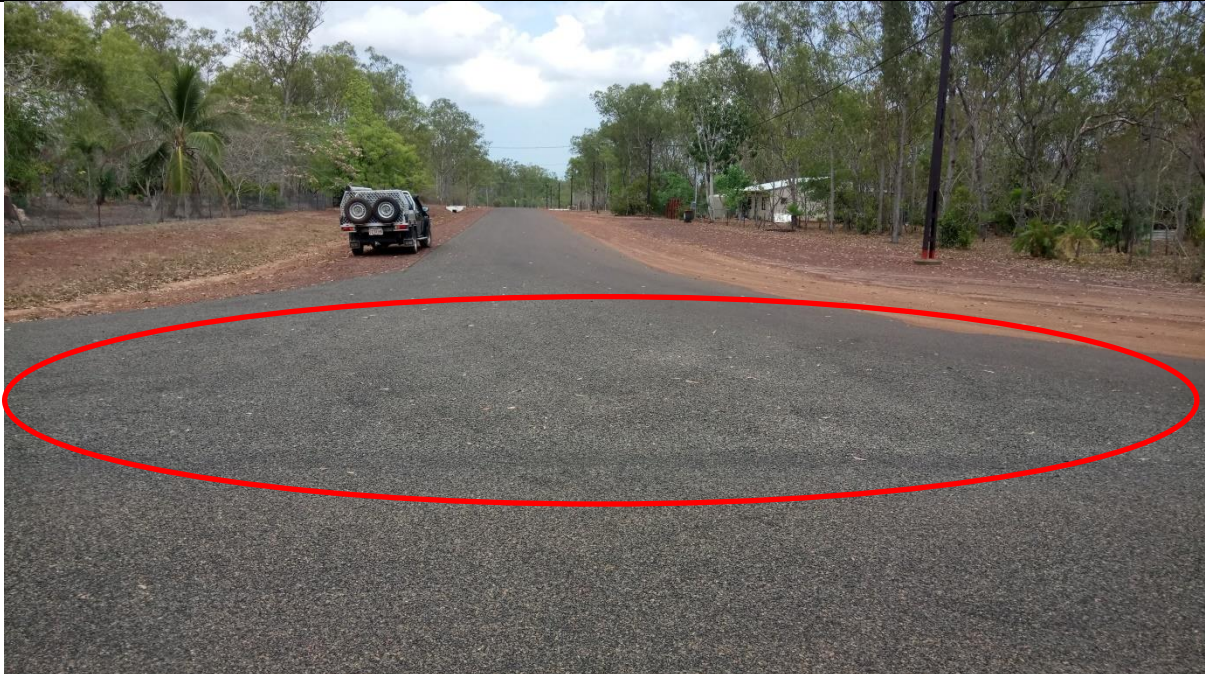
Raveling at Massey Street Intersection

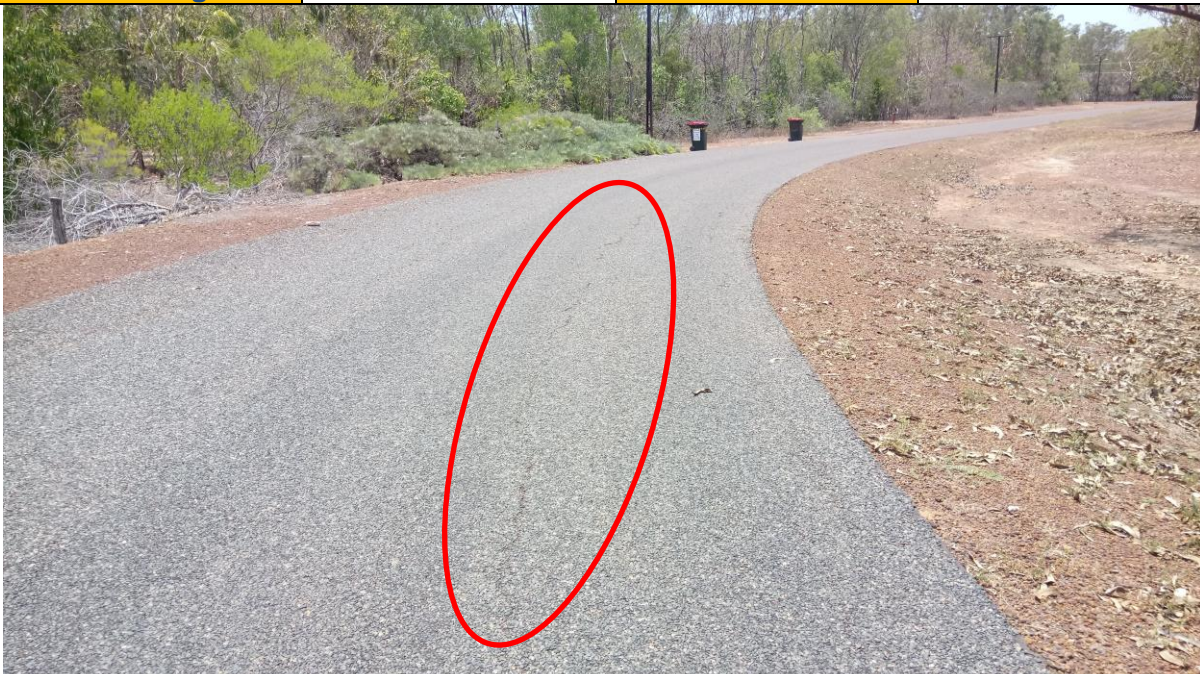
Cracking at approximate chainage 0.15			
Service Crossing	No	Affected Area	NA
Raveling	Yes	Affected Area	Road length

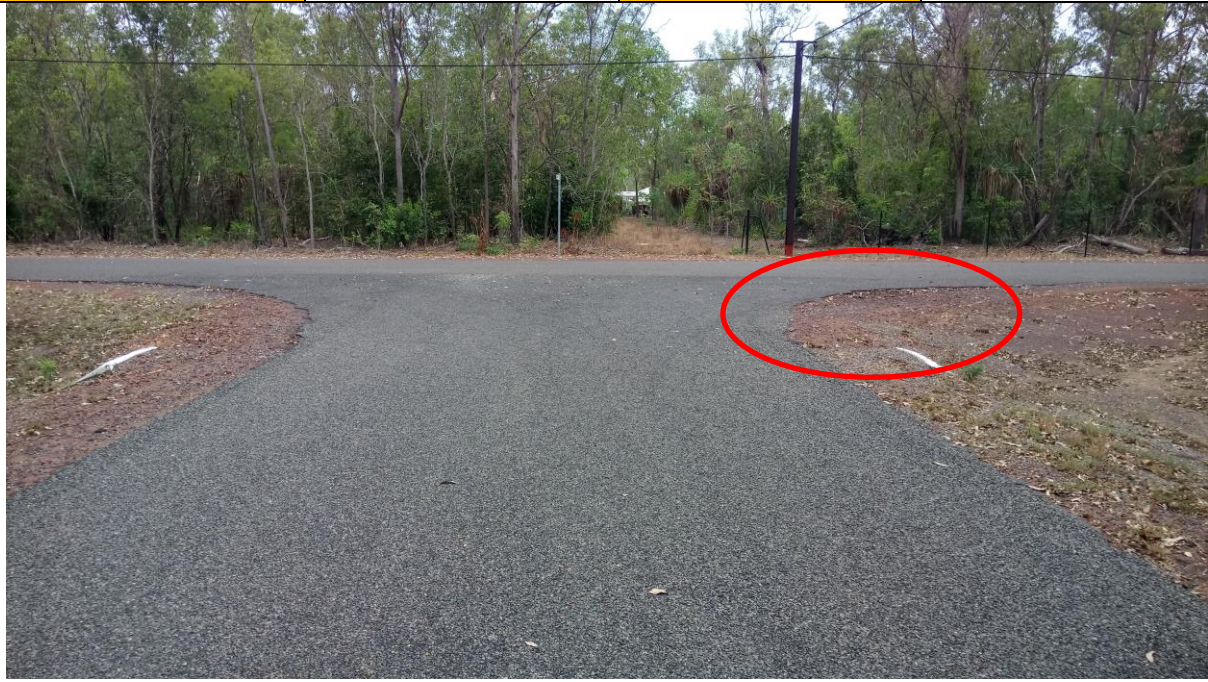
Edge break at Uhr Road Intersection			
Cracking	No	Affected Area	NA
Service Crossing	No	Affected Area	NA
Raveling	Yes	Affected Area	Uhr Road Intersection and cul-de-sac

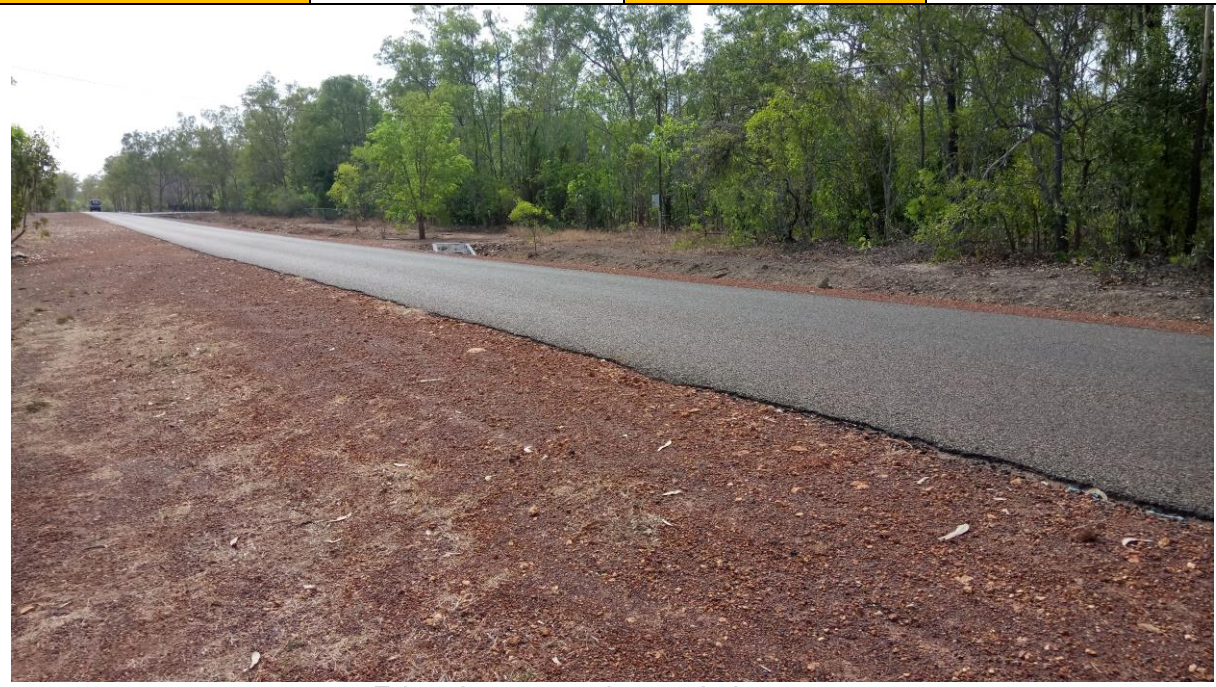
Edge drop approximate chainage 0.1

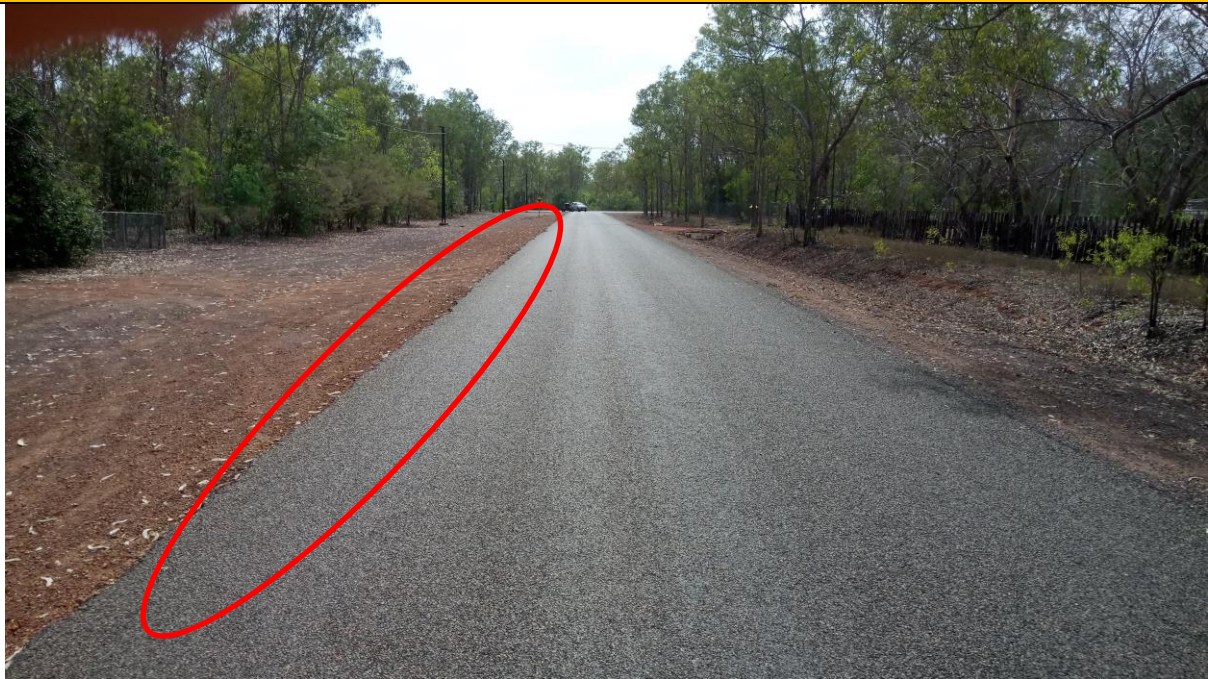
Edge drop approximate chainage 0.3

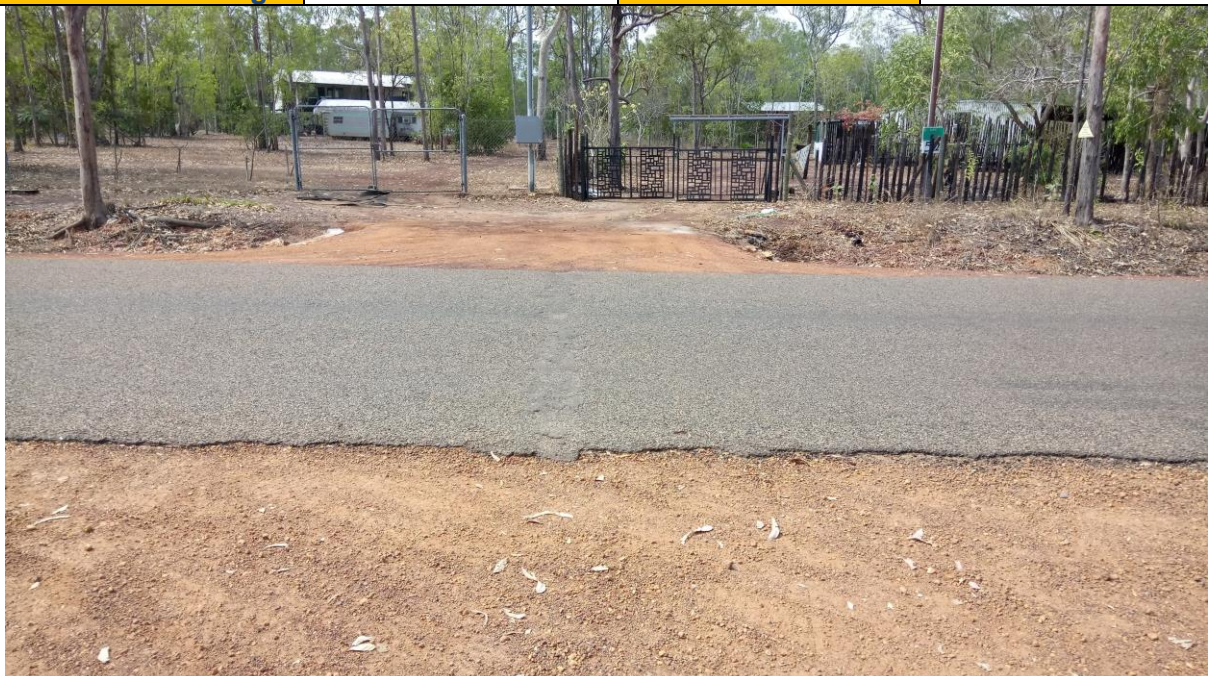
Service Crossing approximate chainage 0.35

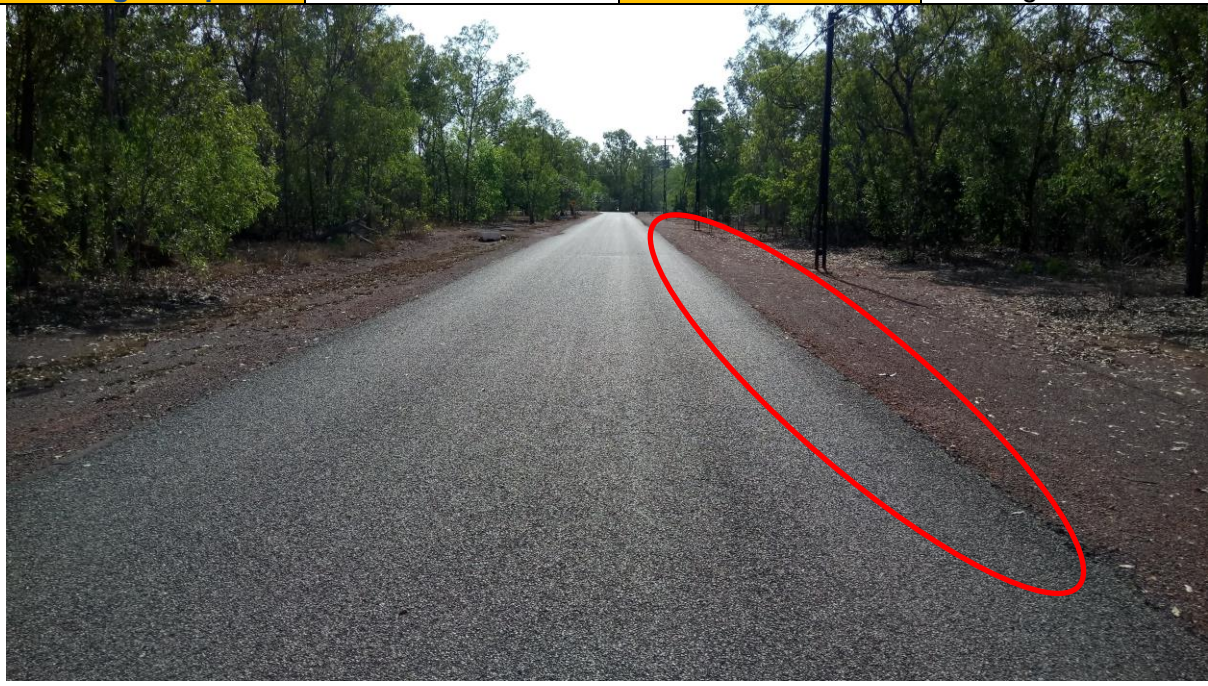
Edge drop approximate chainage 0.2			
Edge Break	No	Affected Area	NA
Cracking	No	Affected Area	NA
Service Crossing	Yes	Affected Area	CH0.35 and Wagait Tower Road Intersection

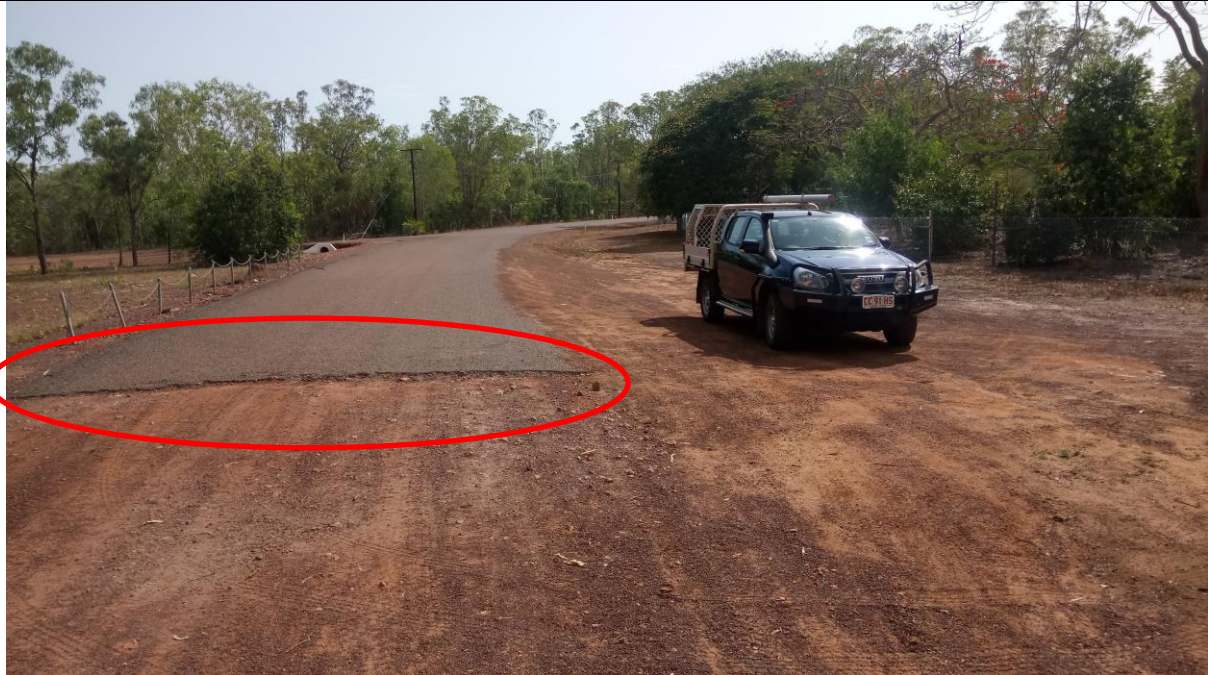
Edge drop at approximate chainage 0.2			
Edge Break	No	Affected Area	NA
Cracking	No	Affected Area	NA
Service Crossing	Yes	Affected Area	CH0.15

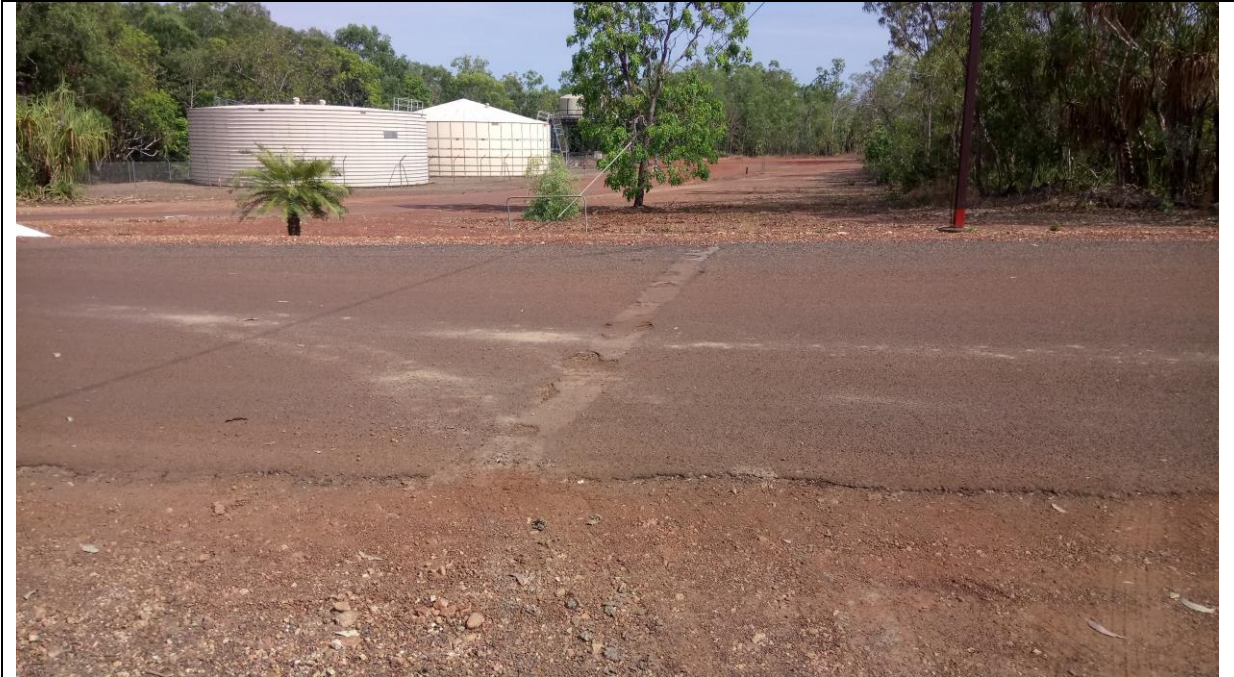
Service crossing approximate chainage 0.15

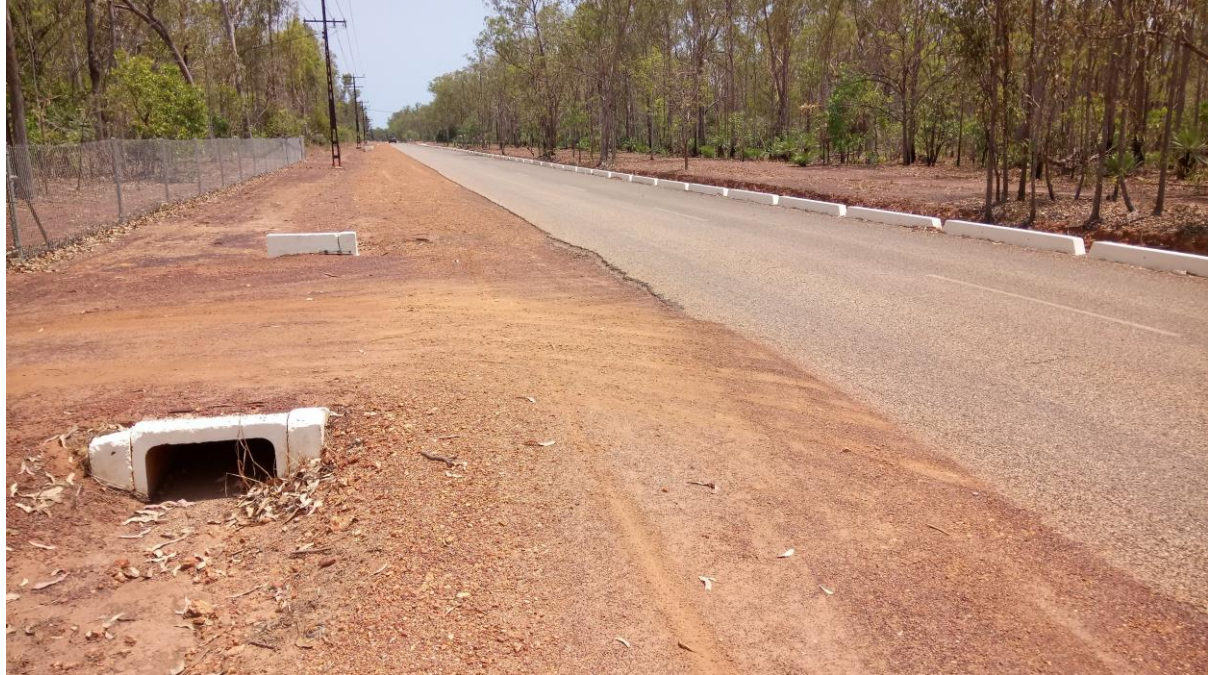
Edge drop and break at approximate chainage 0.2

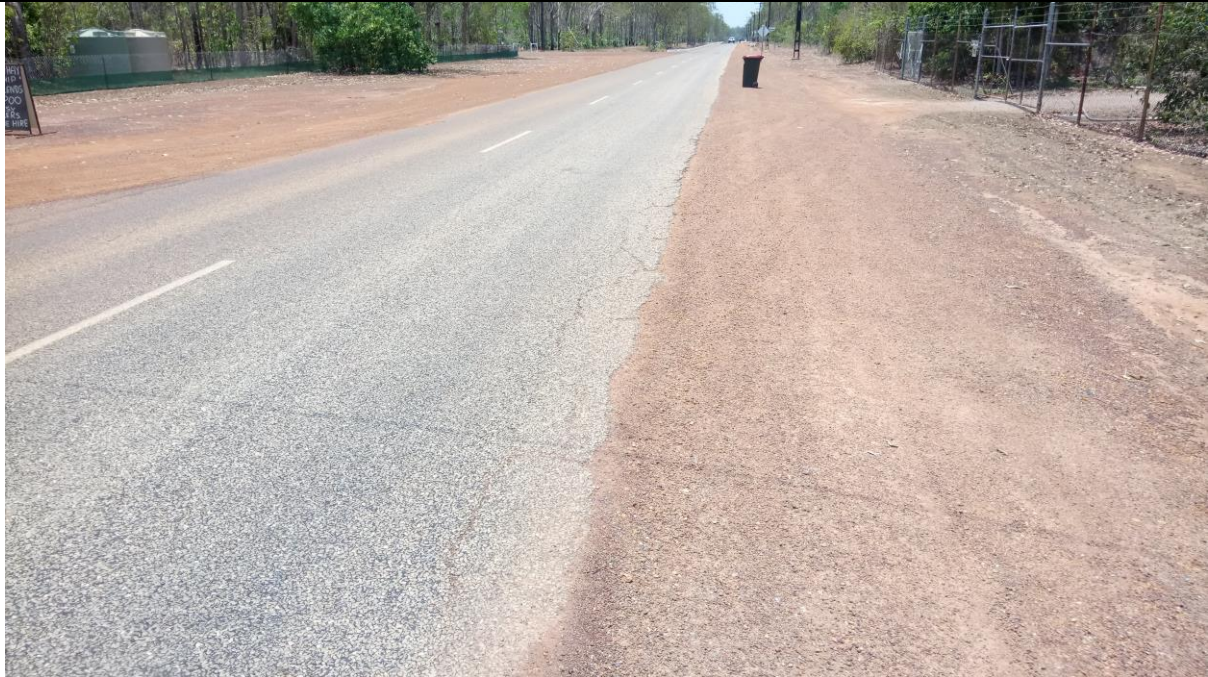
Edge breaks and cracking at approximate chainage 0.6

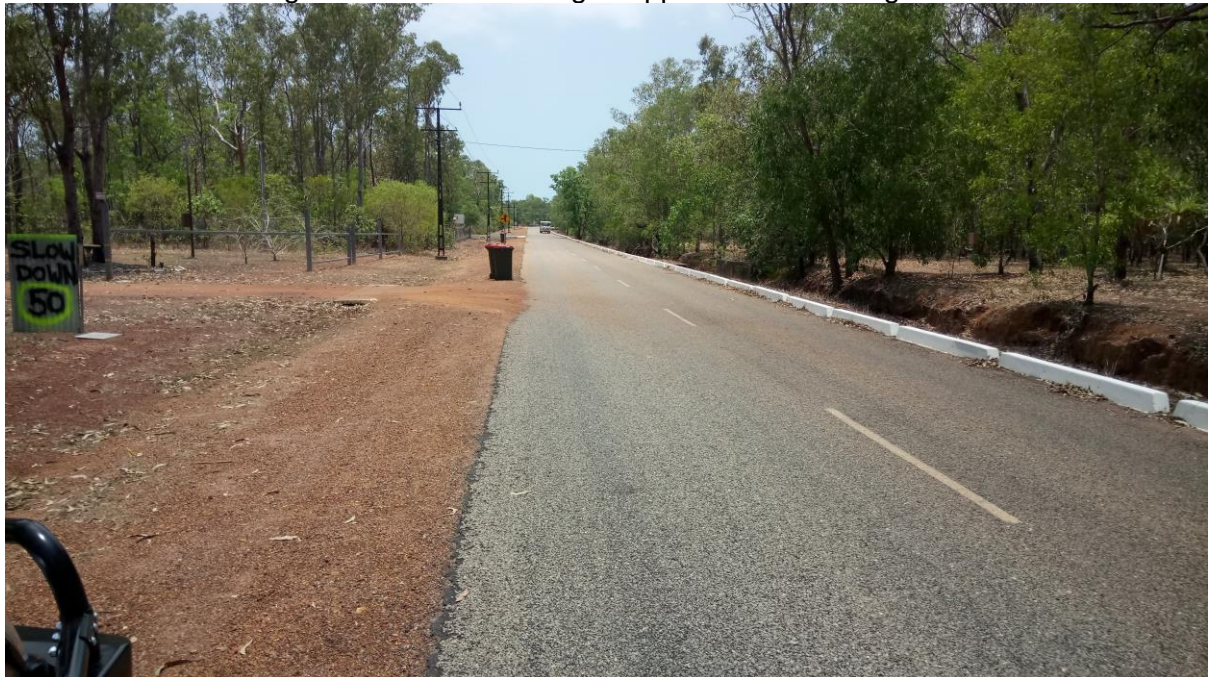
Edge breaks at approximate chainage 1.0

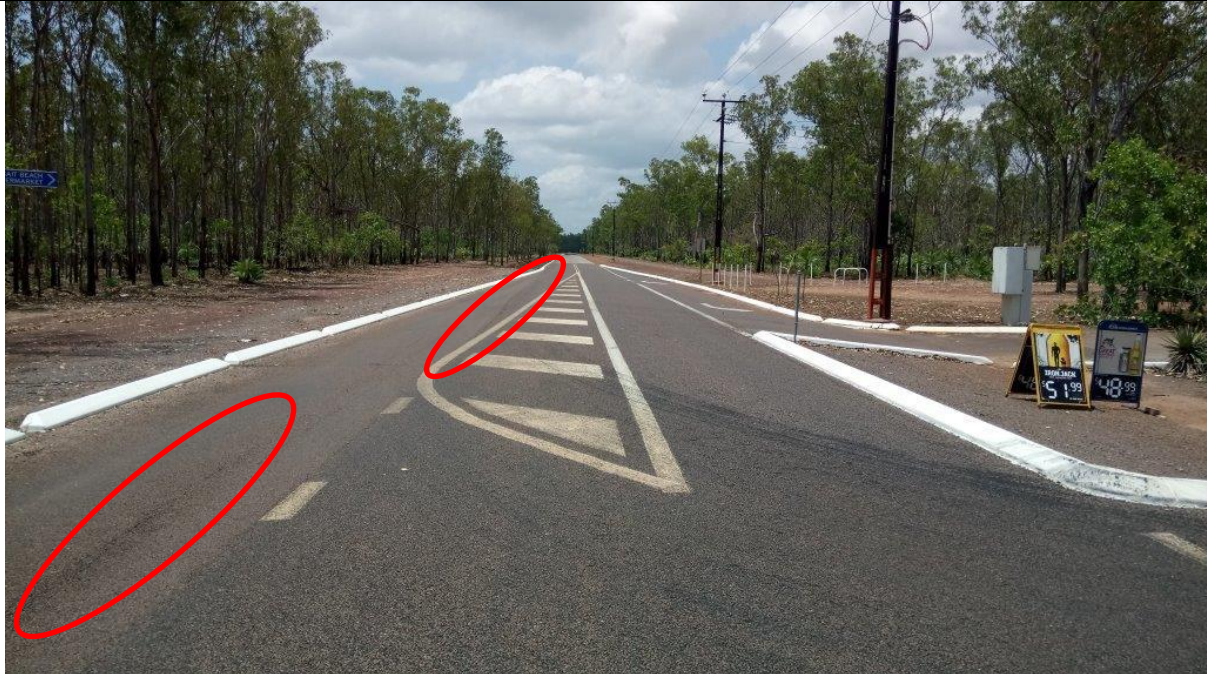
Cracking at approximate chainage 0.1
