Road Network Investigation Report
For
Wagait Shire Council

Date: November 2018

Road Network Investigation Report for Wagait Shire Council

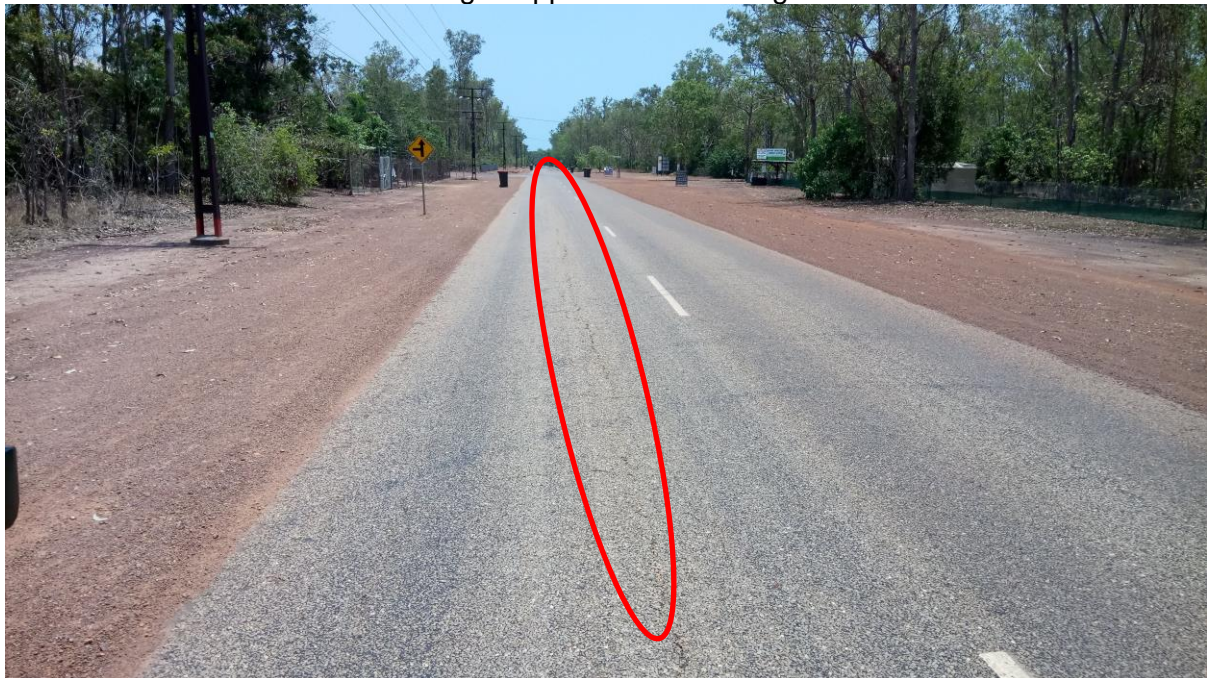
Cracking at approximate chainage 0.5

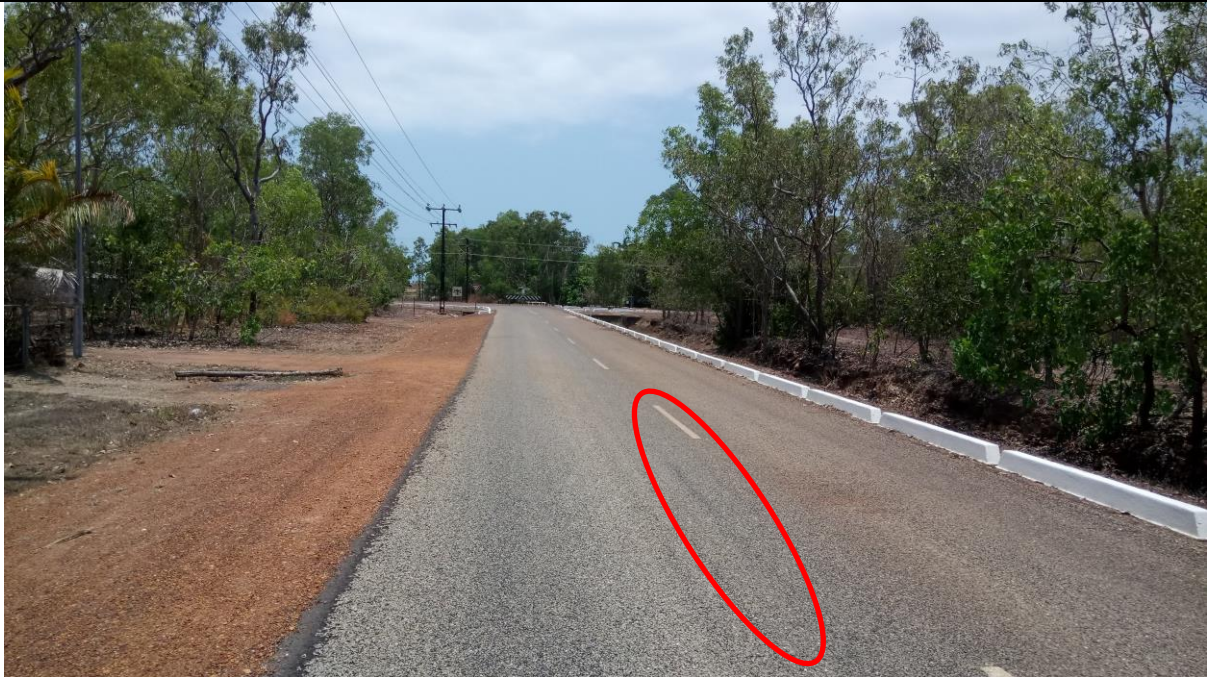
Cracking approximate chainage 1.1

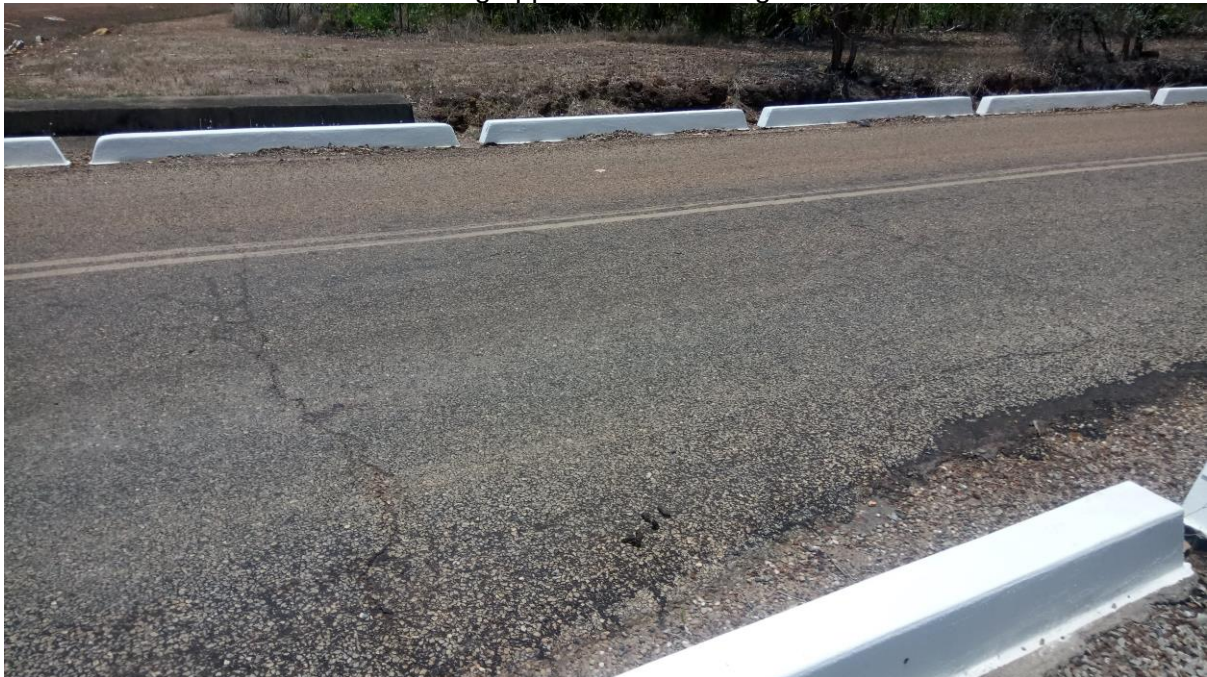
Cracking at Cox Drive intersection

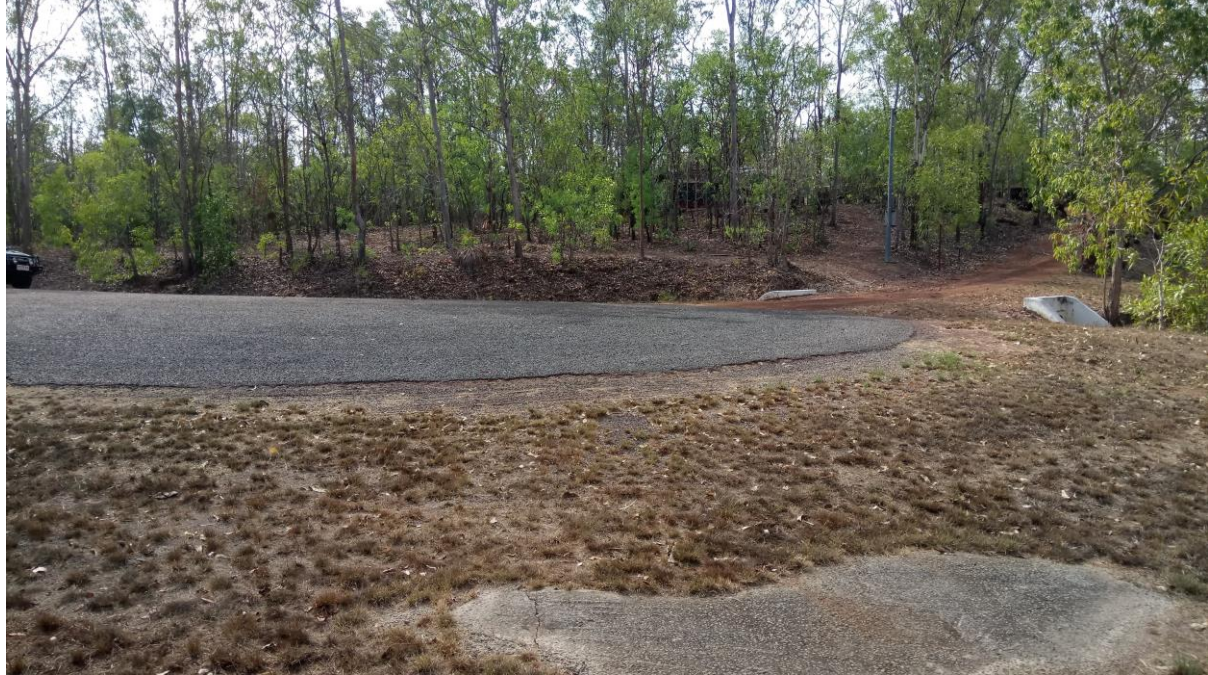
Edge drop at cul-de-sac

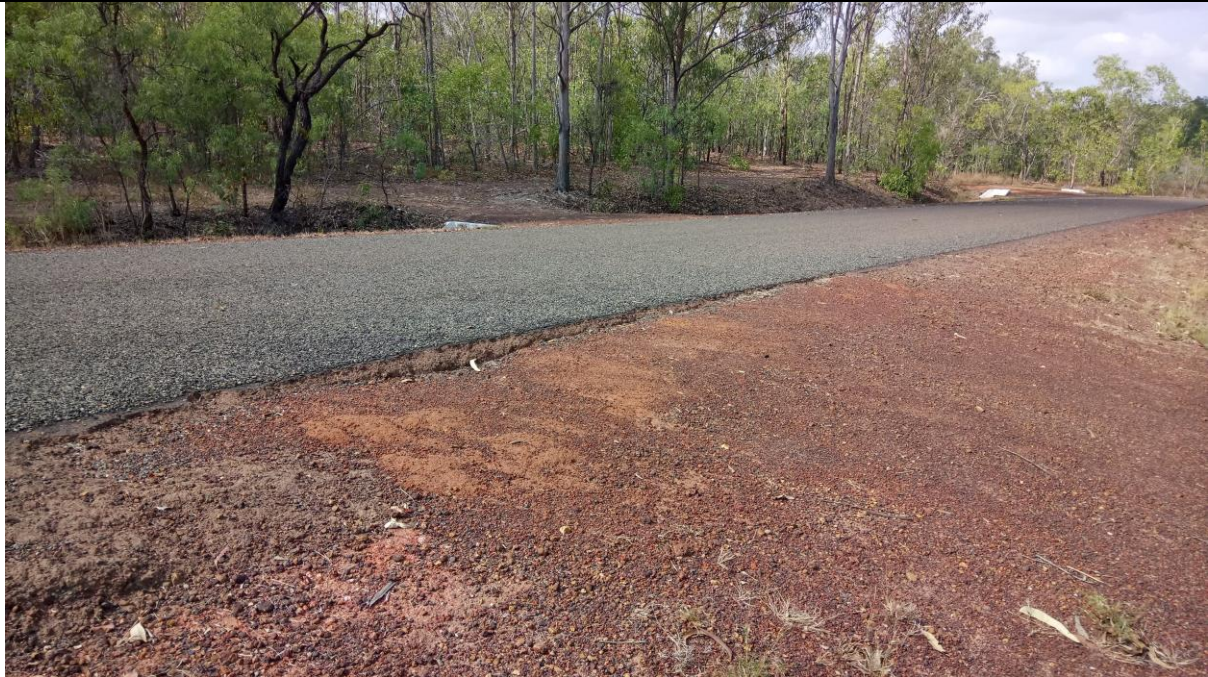
Edge drop at driveway

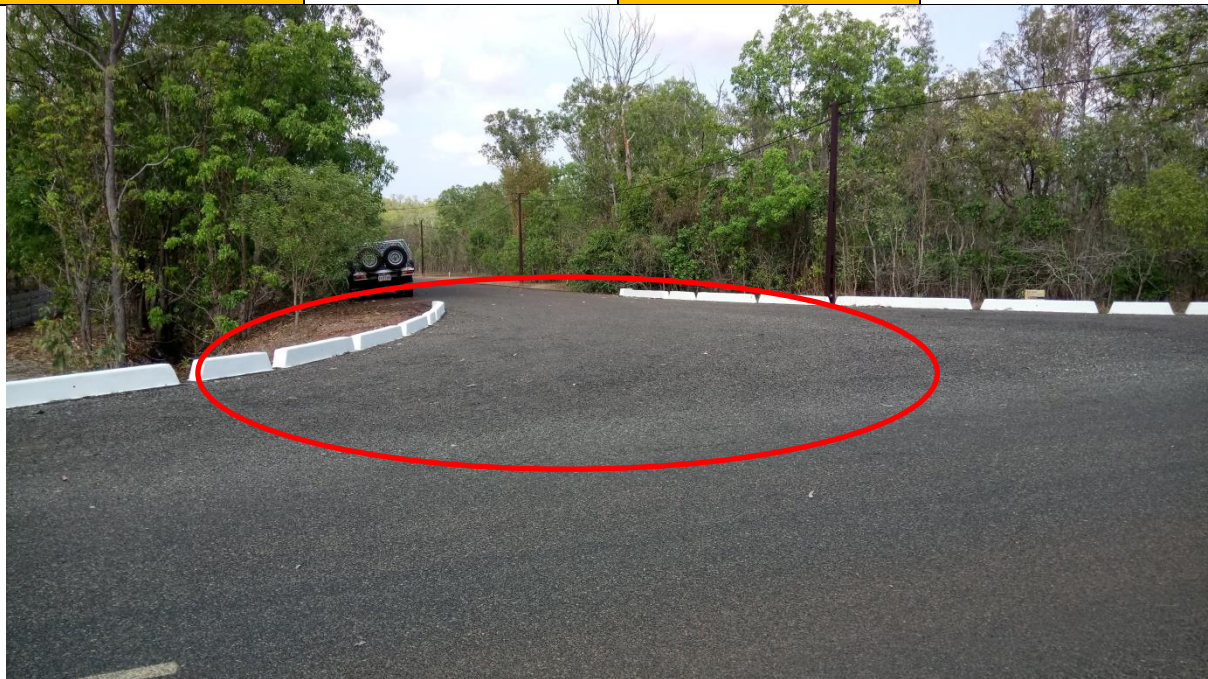
Raveling at Erickson Crescent Intersection
