Road Network Investigation Report
For
Wagait Shire Council

Date: November 2018

Road Network Investigation Report for Wagait Shire Council

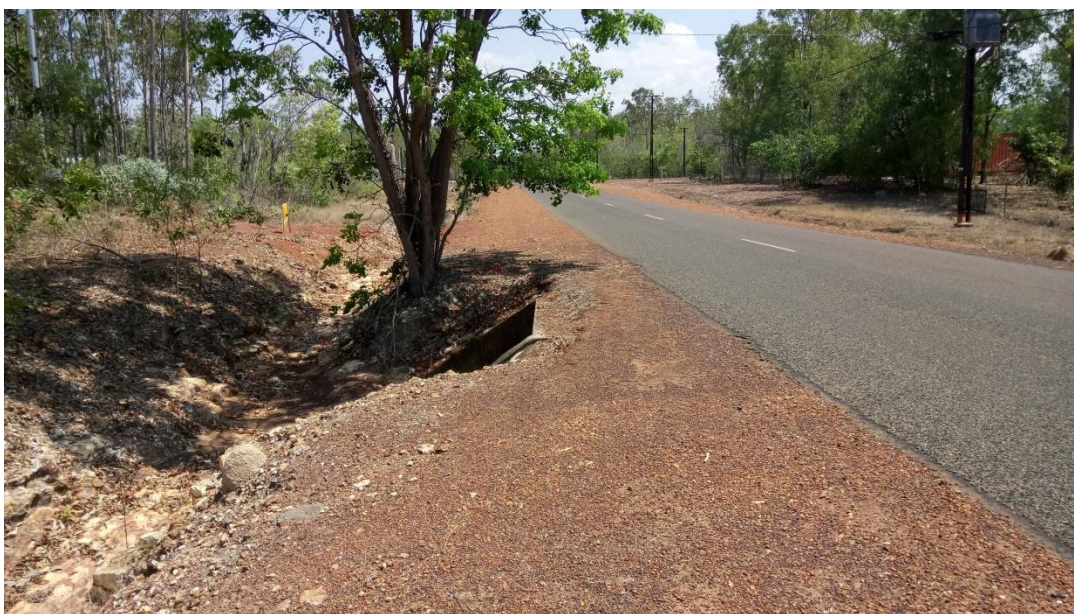
Photo: Unprotected Culvert Erickson Crescent

LGANT recommends that these issues should be further investigated from a road and pedestrian safety perspective to provide an adequate indication of the current risk profile and potential funding avenues.

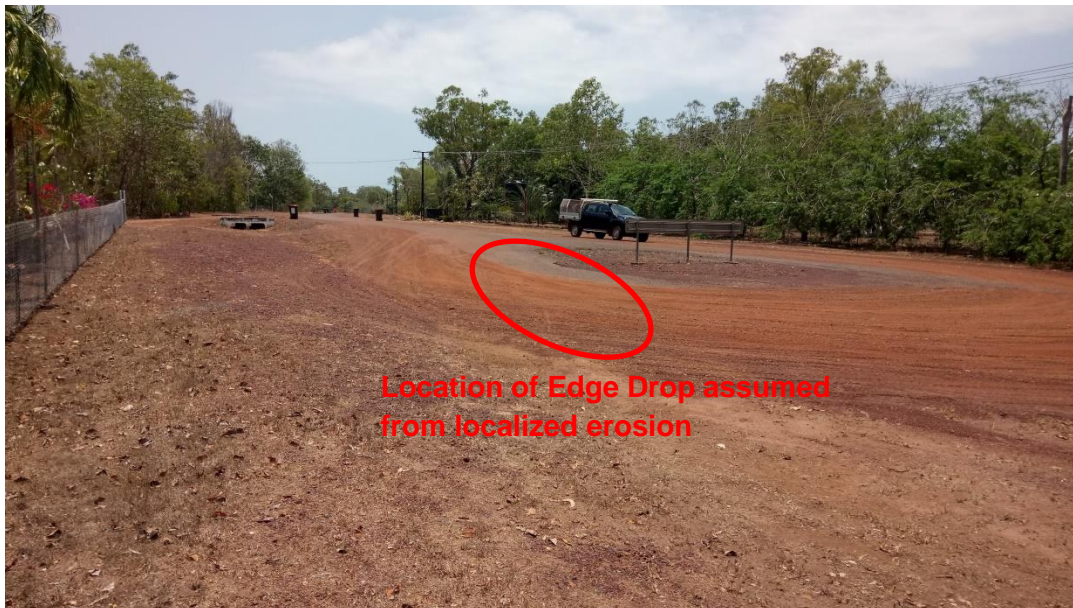
Figure 5 – Road section of maintenance concern, 105 De Lissa Drive

A road section adjacent to 105 De Lissa Drive has been identified as a maintenance concern due to consistent edge drop forming that has been associated with the current topography. Please refer to **Figure 5** for a photo of the identified area of maintenance concern.

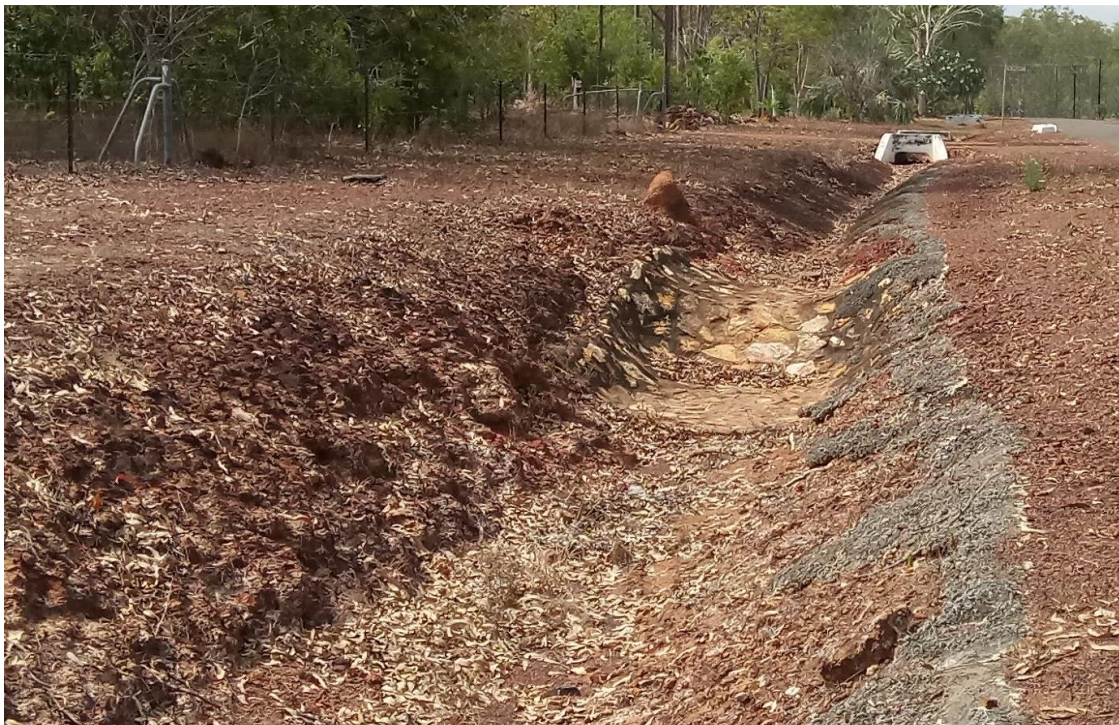
Photo: Example erosion protection Massey Street

- Introducing erosion protection structures within unlined drains (e.g. rock sheeting)
- Either increase clear width of drainage structures or providing safety barriers around the assets

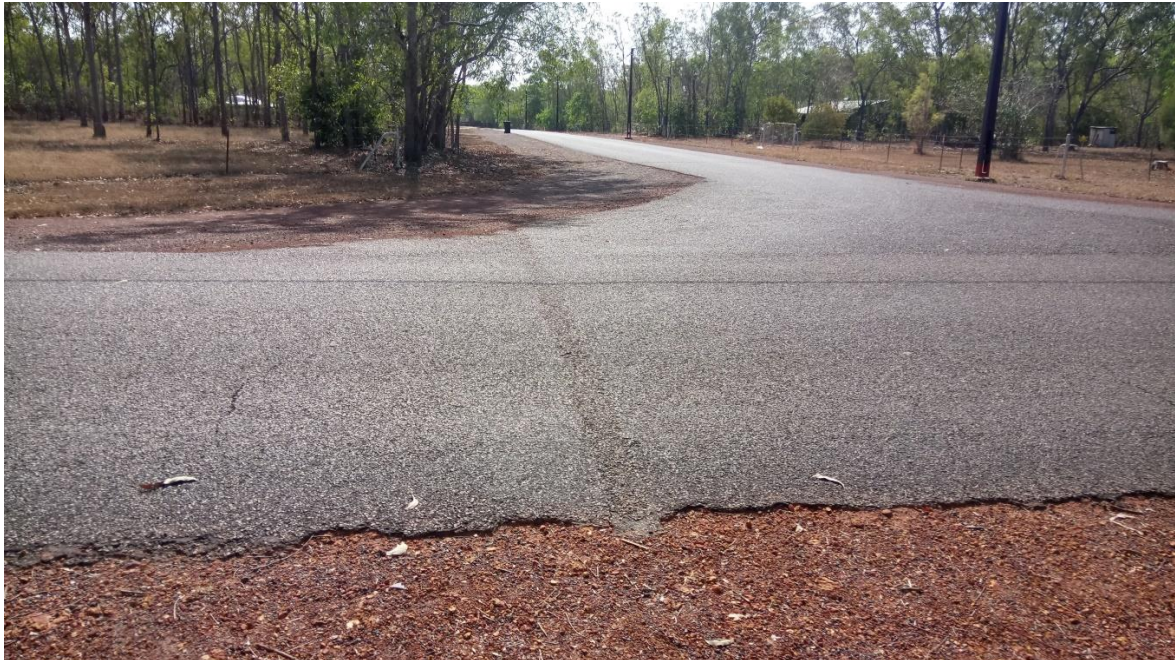
Service crossing adjacent to Sachse Street

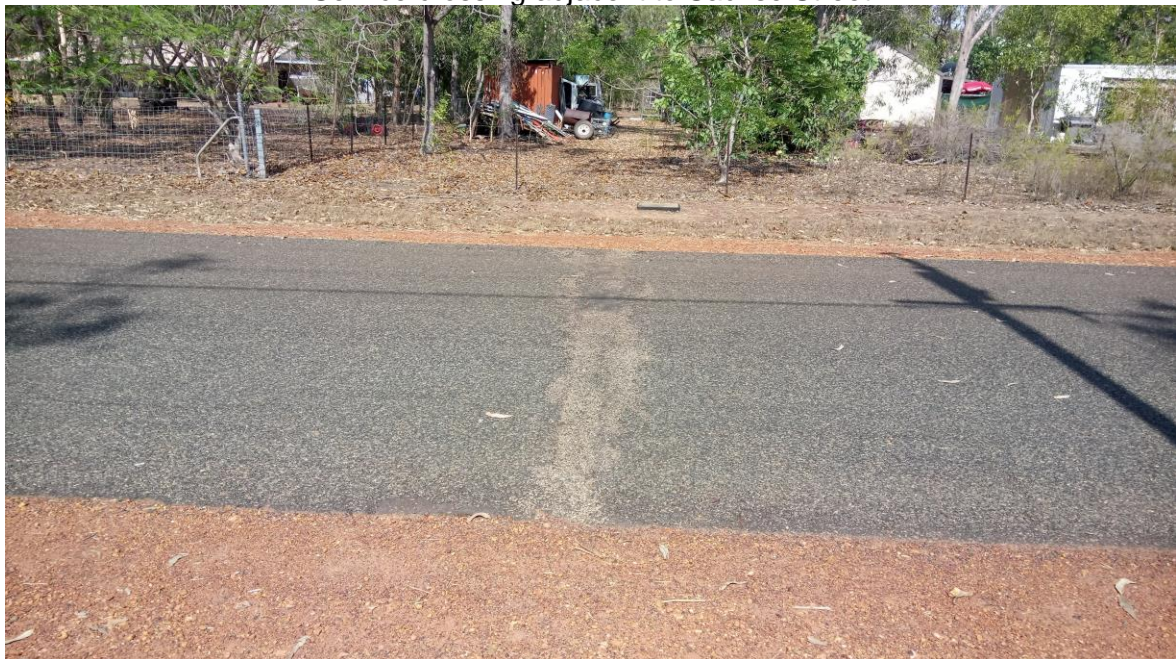
Service Crossing approximate Chainage 0.9

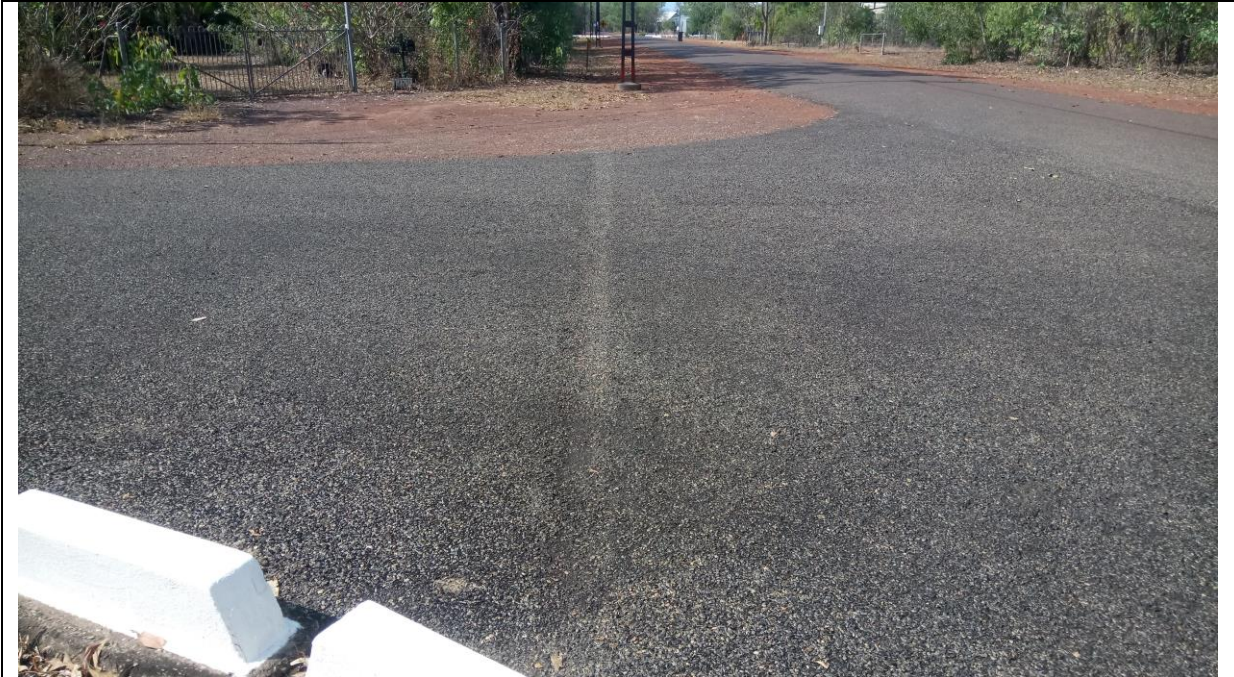
Service Crossing adjacent to Baluria Road

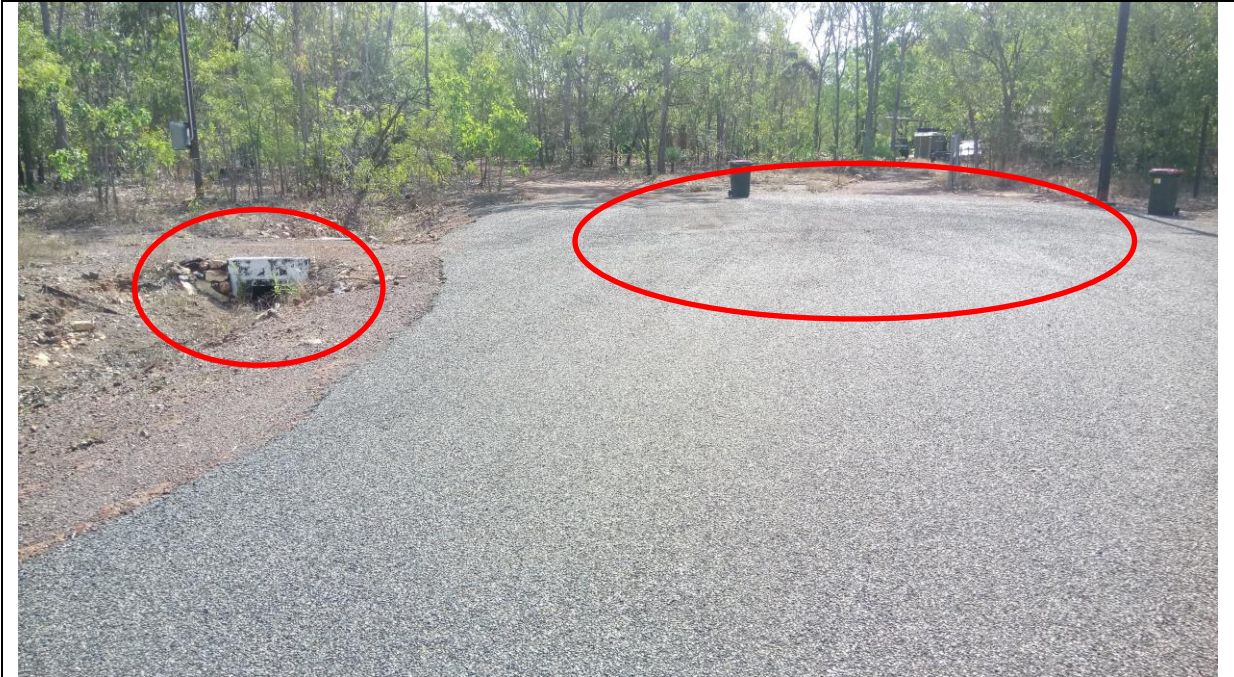
Ravelling and unprotected drainage structure at Boom Place cul-de-sac

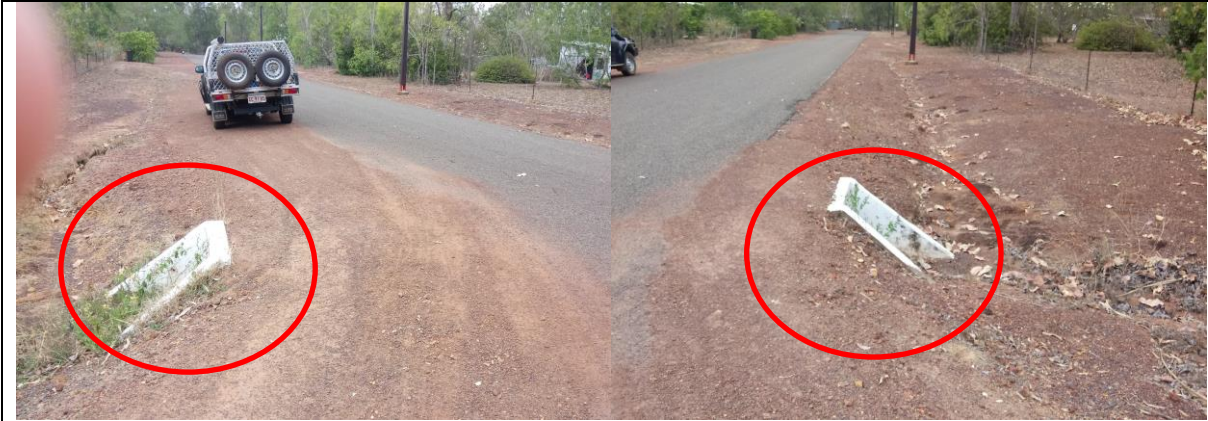
Unprotected culvert at Uhr Road intersection

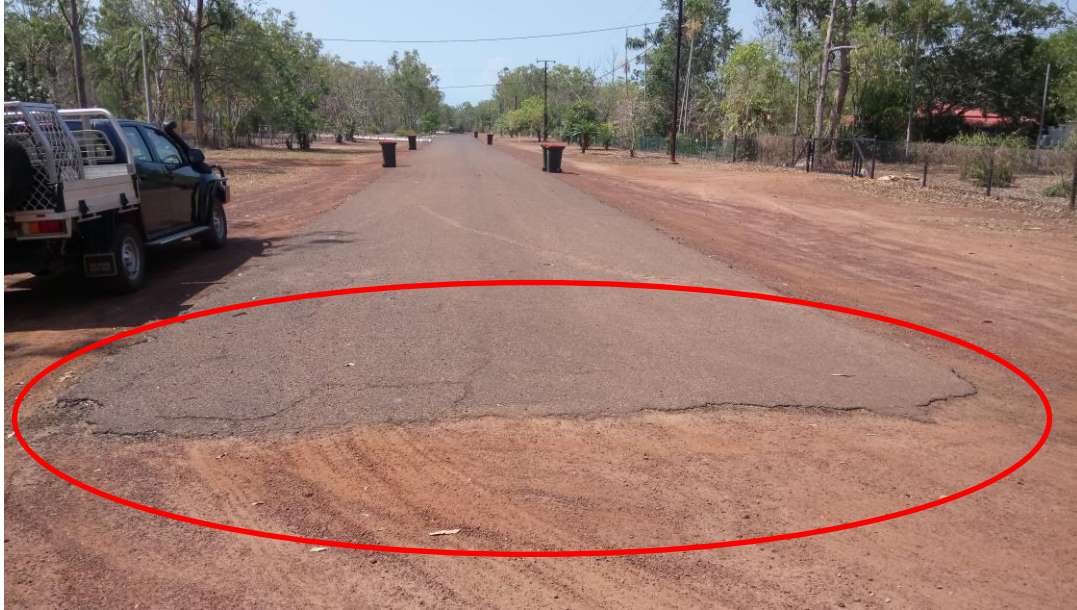
Edge break at CH0.0

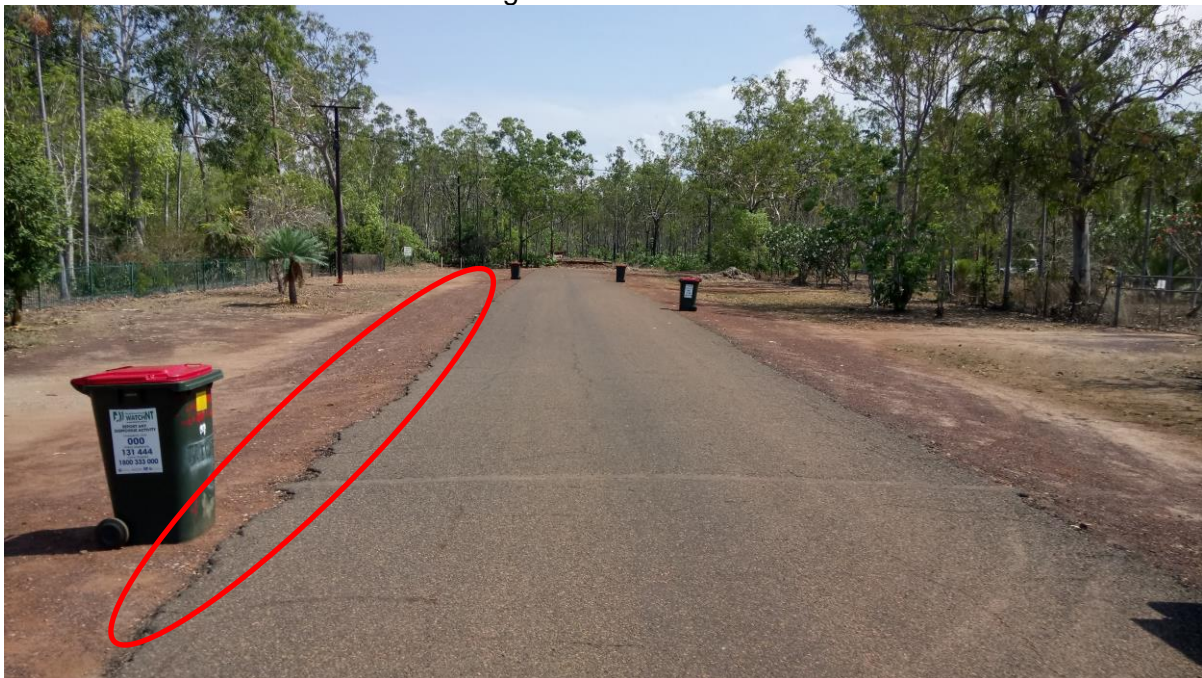
Edge break between CH0.0-CH0.1

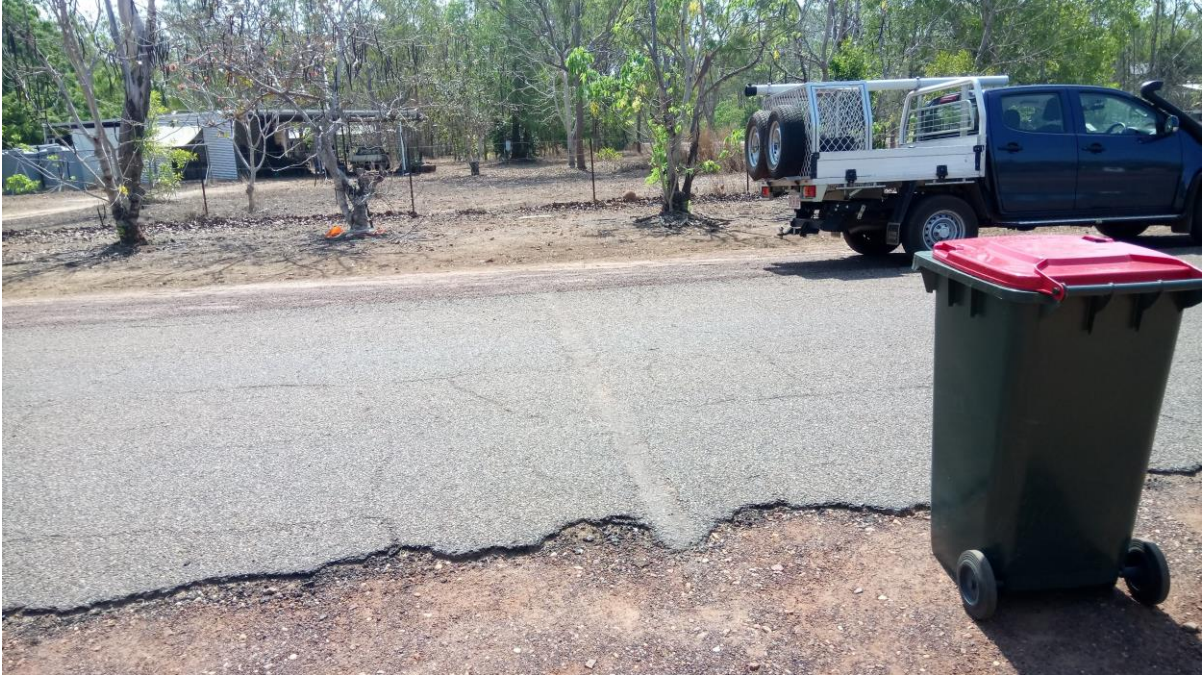
Service crossing at approximately CH0.75

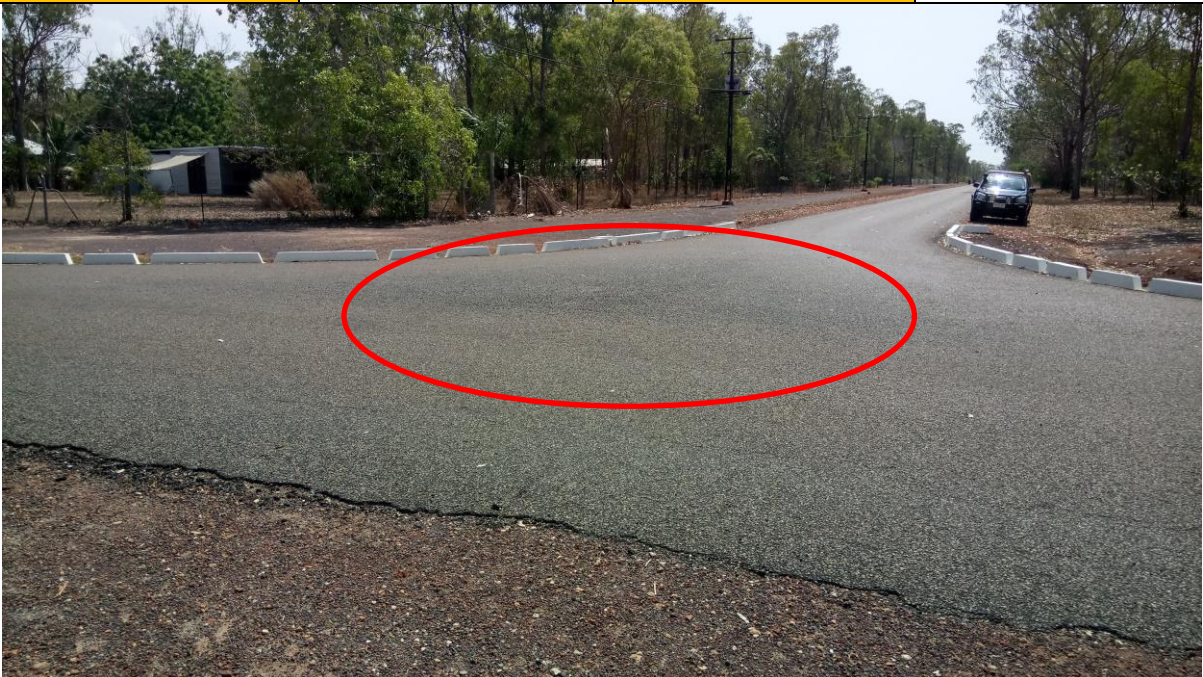
Ravelling at Erickson Crescent Intersection

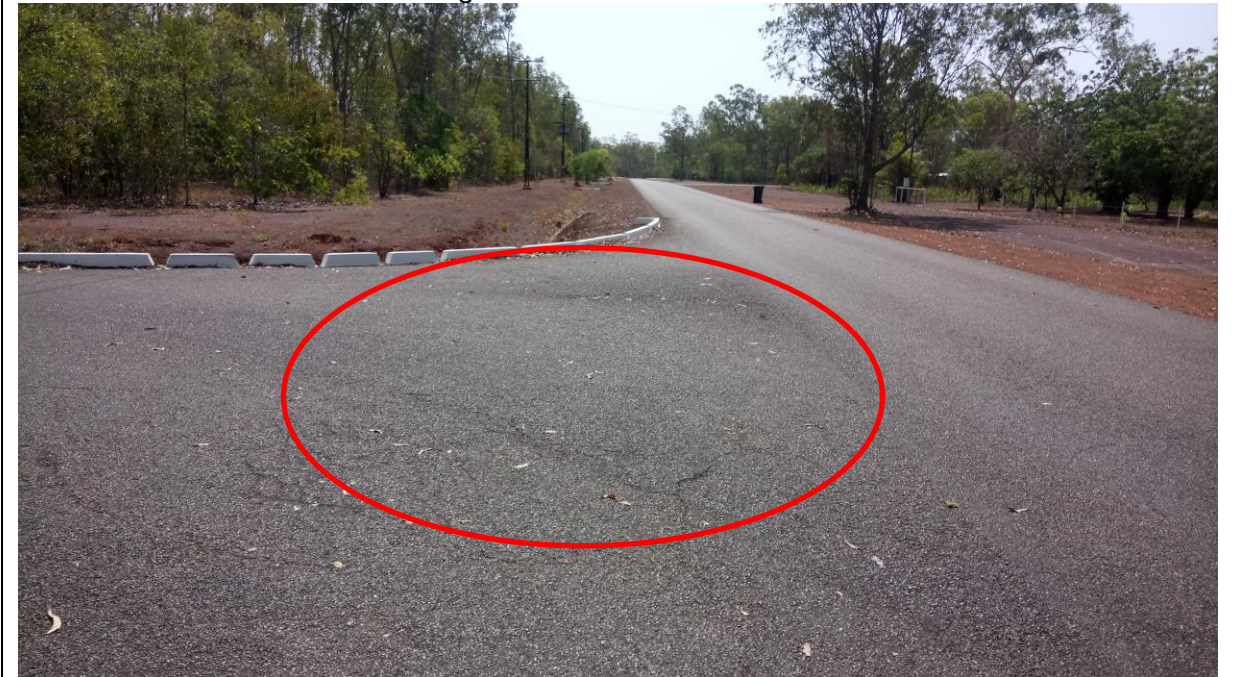
Ravelling at Dalmeny Street Intersection

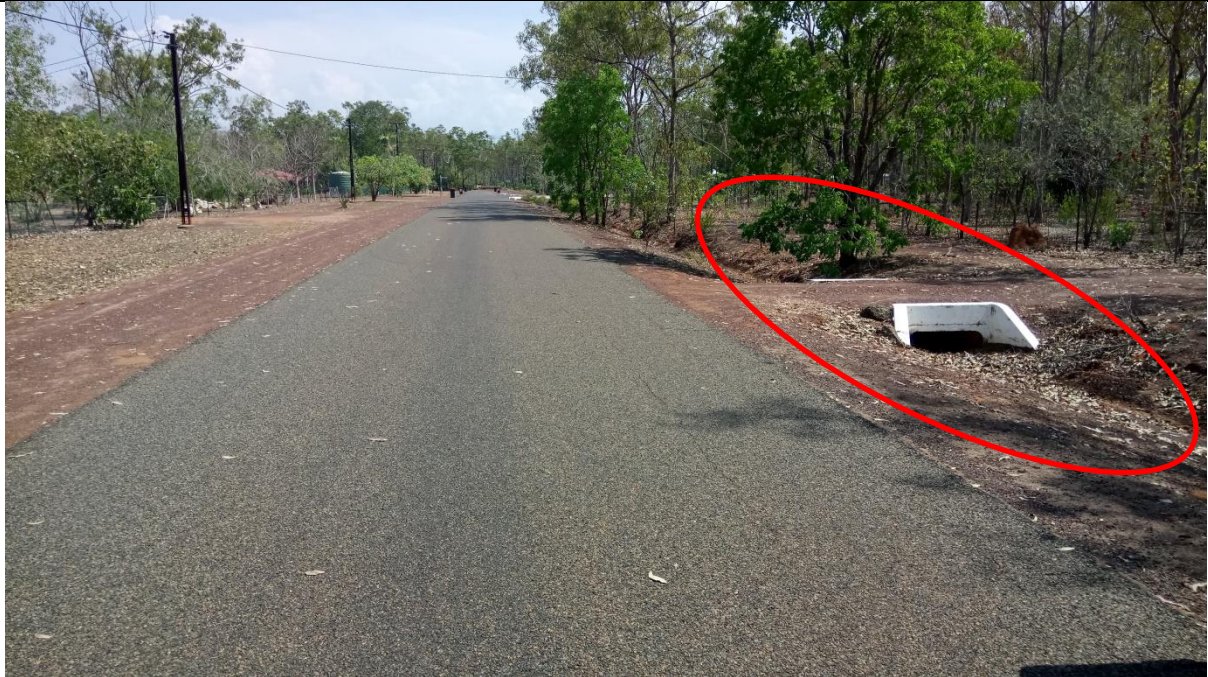
Drainage structure CH.02

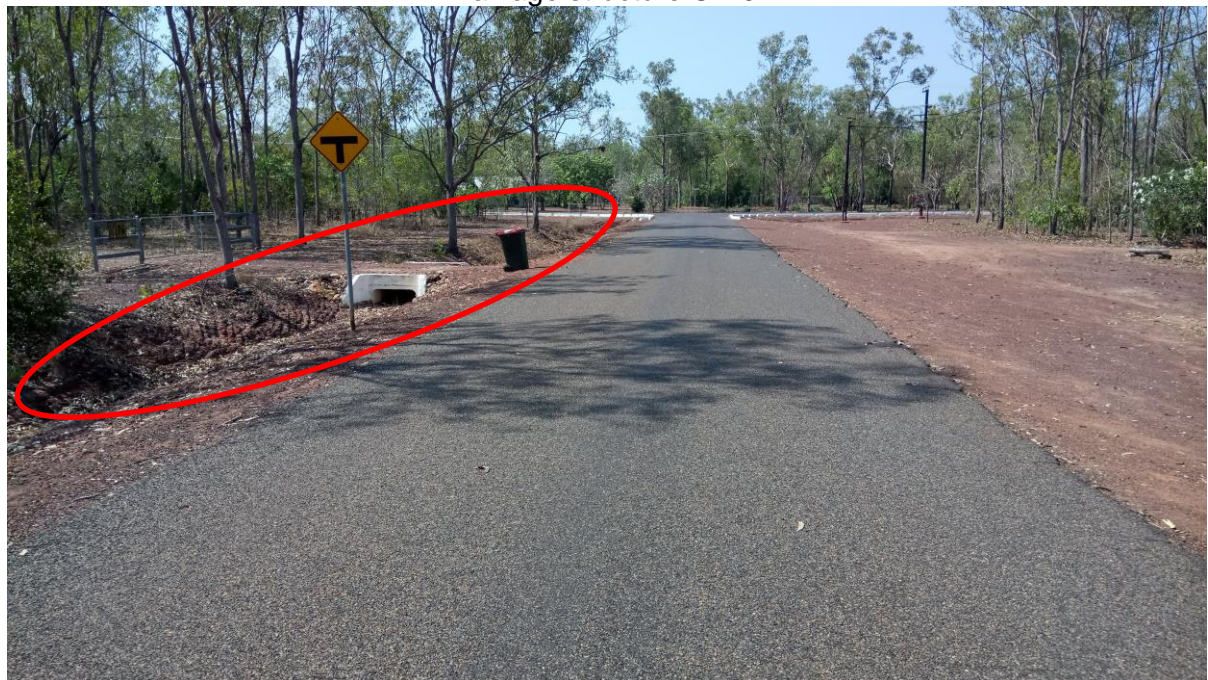
Drainage structure CH0.4

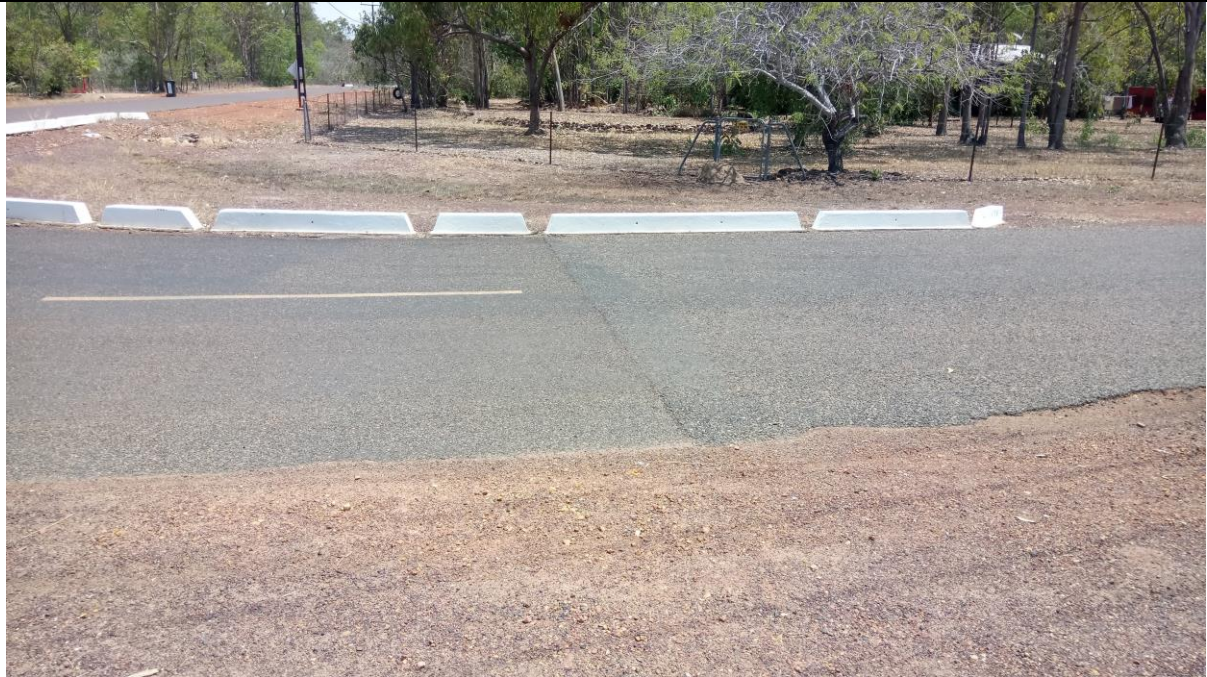
Service crossing adjacent to Baluria Road Intersection

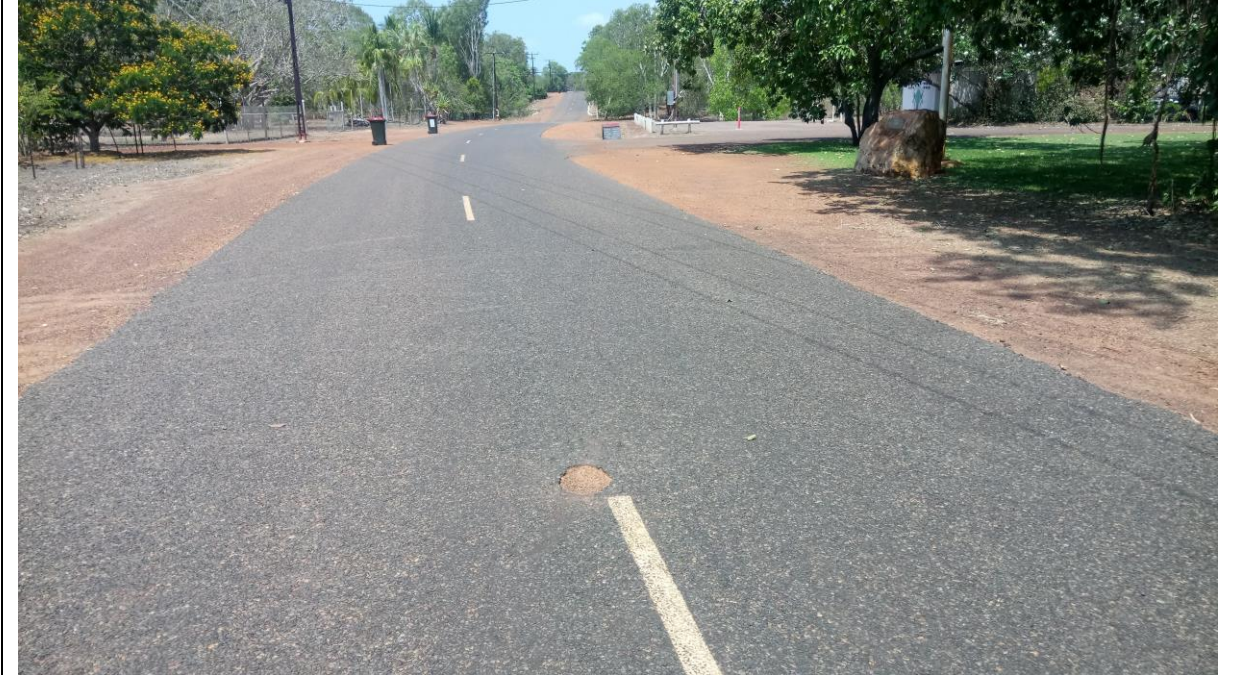
Pot hole forming at Chainage 1.05

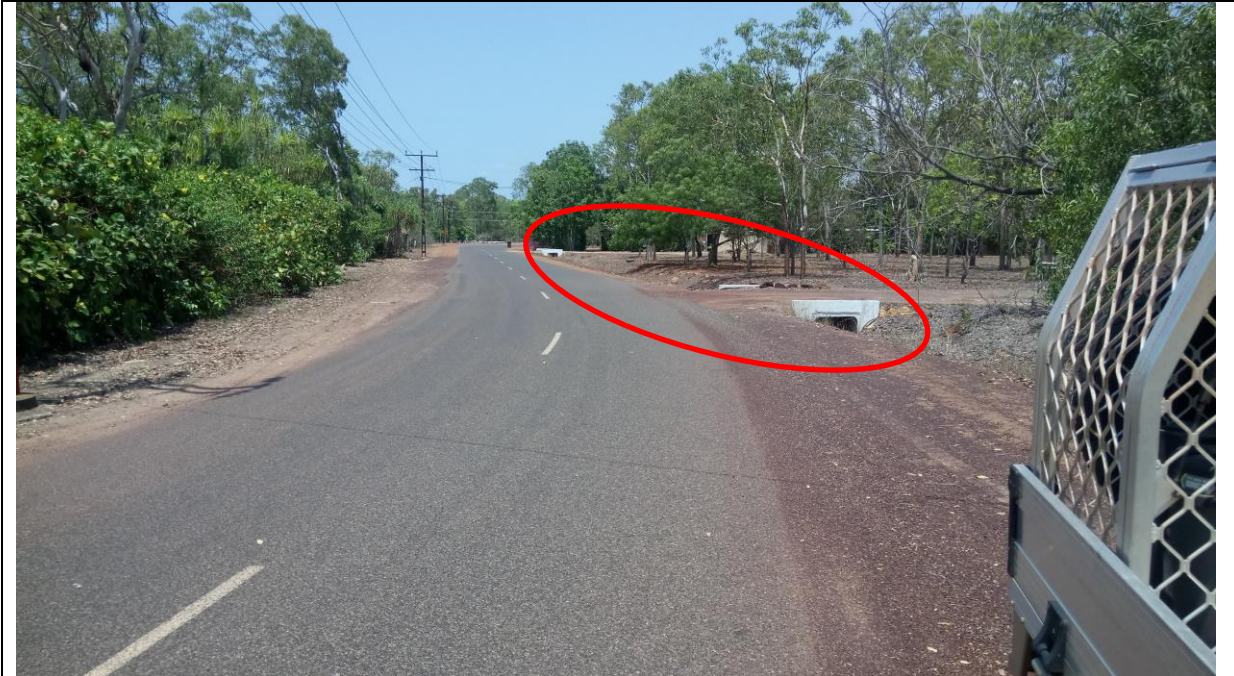
Unprotected driveway culverts approximate chainage 0.3

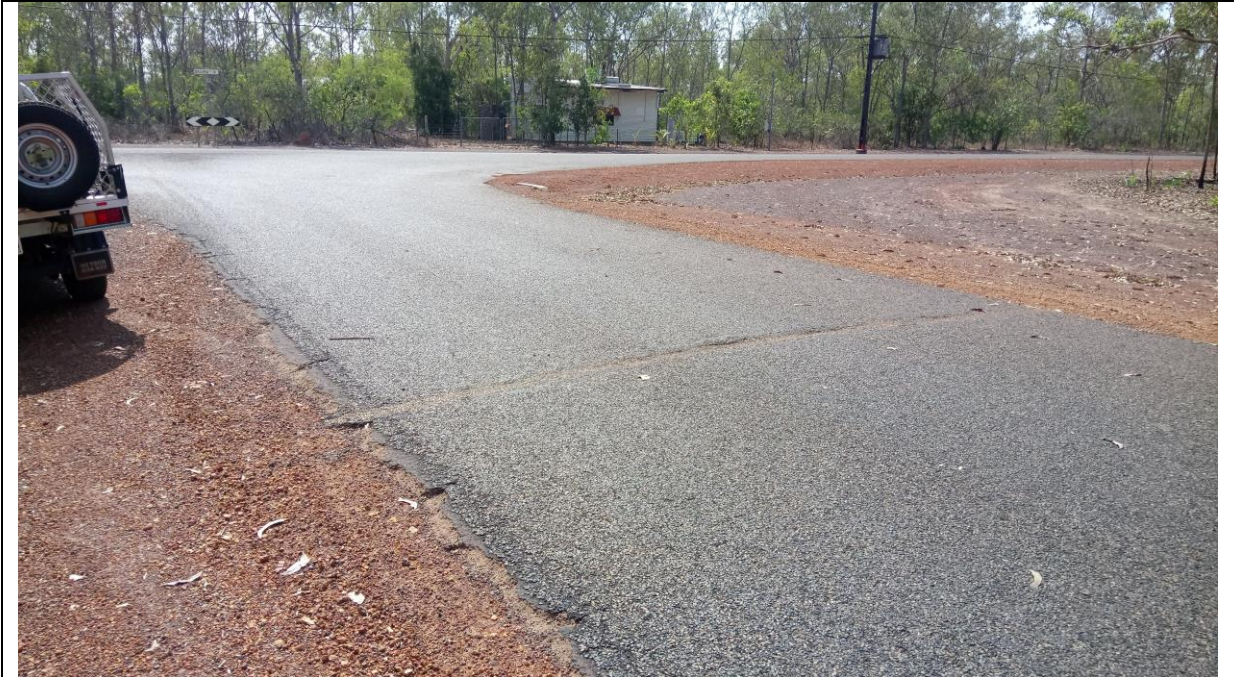
Service crossing approximate chainage 0.55

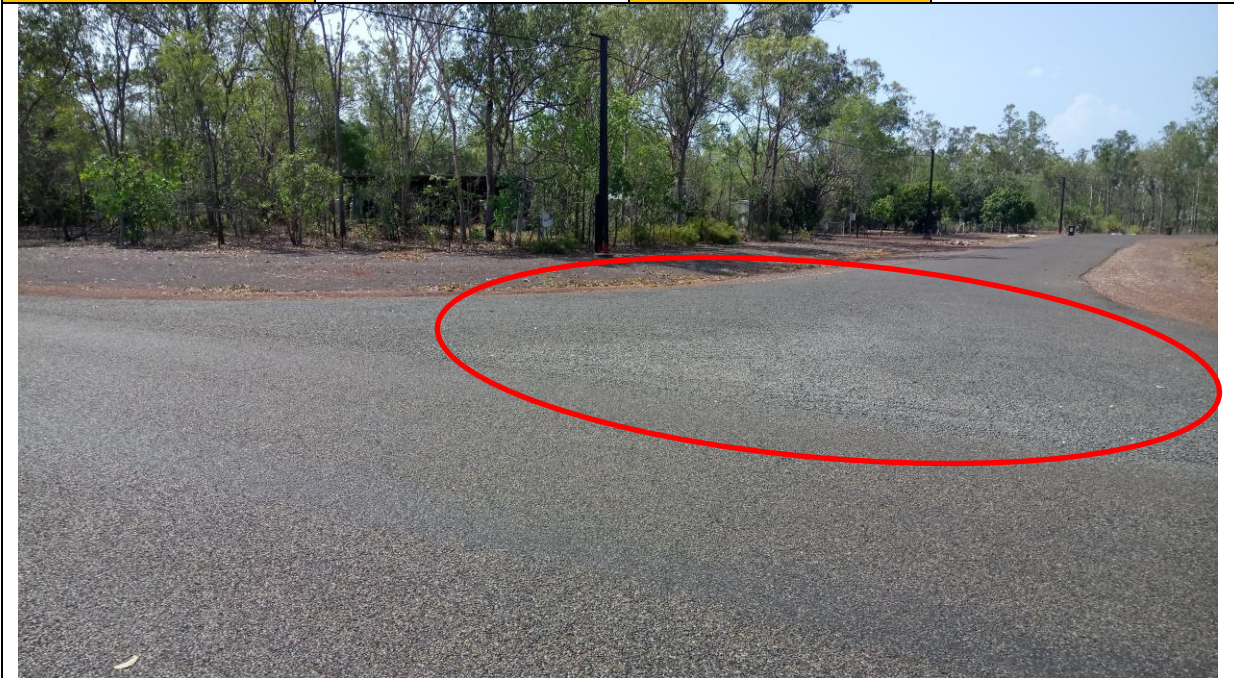
Ravelling at Head Crescent

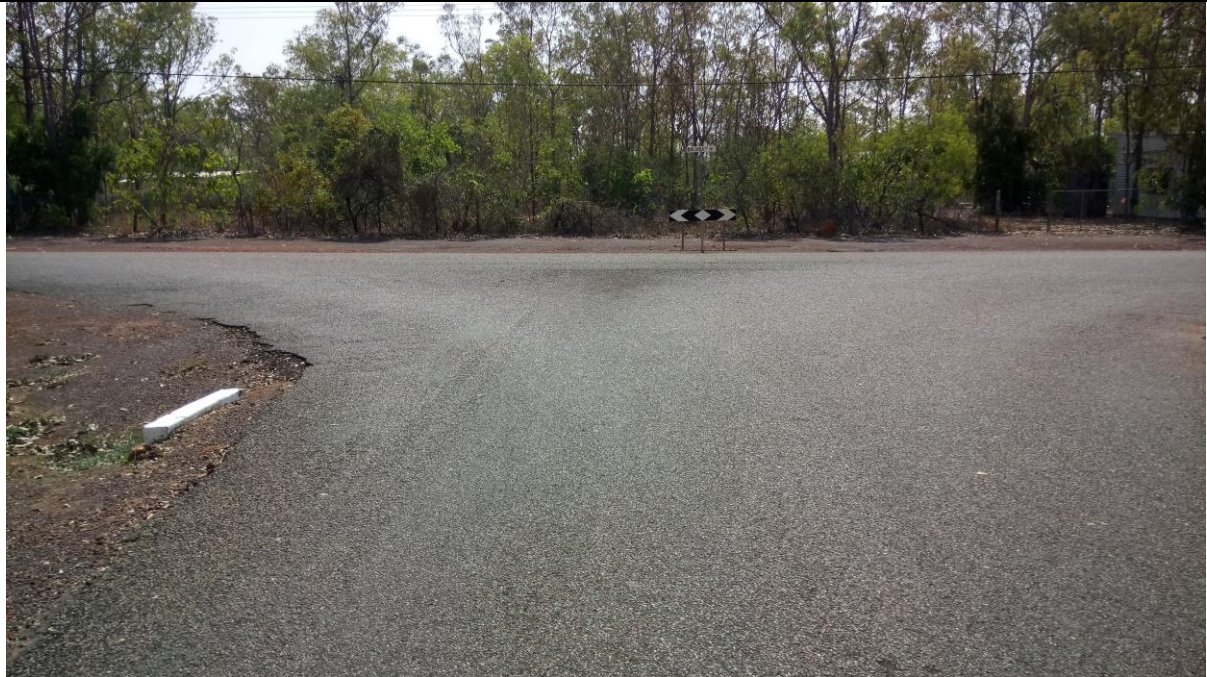
Ravelling at Baluria Road

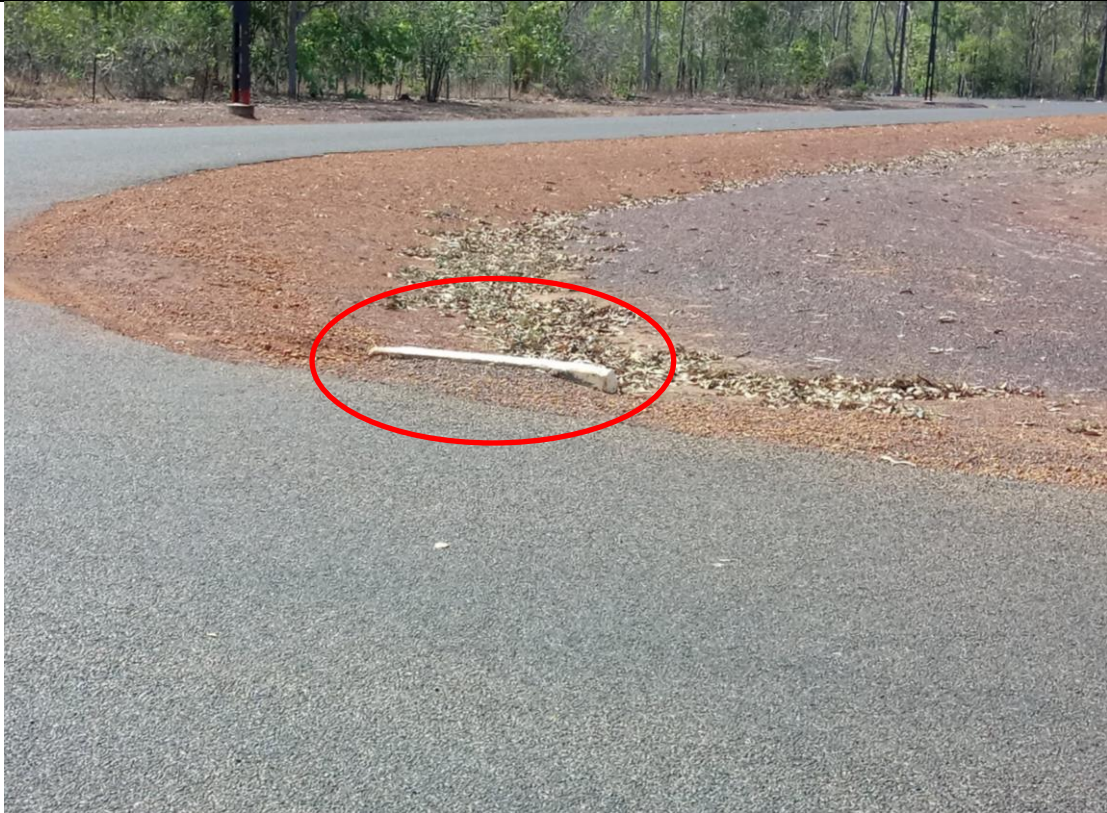
Unprotected Drainage Structure Dalmeny Street Intersection

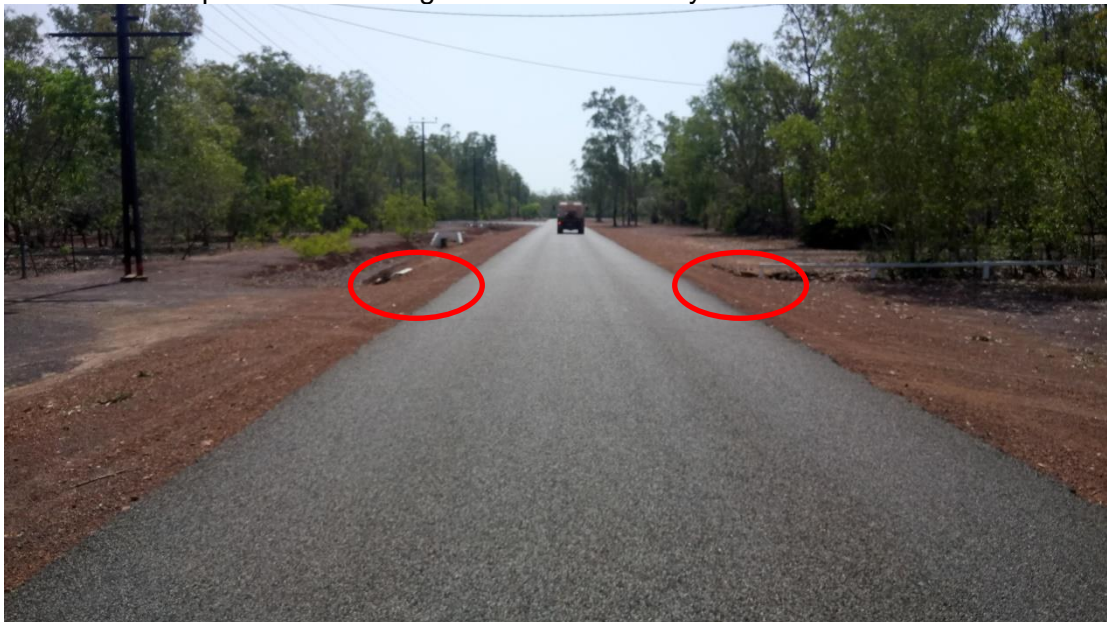
Unprotected Drainage Structure approximate chainage 0.15

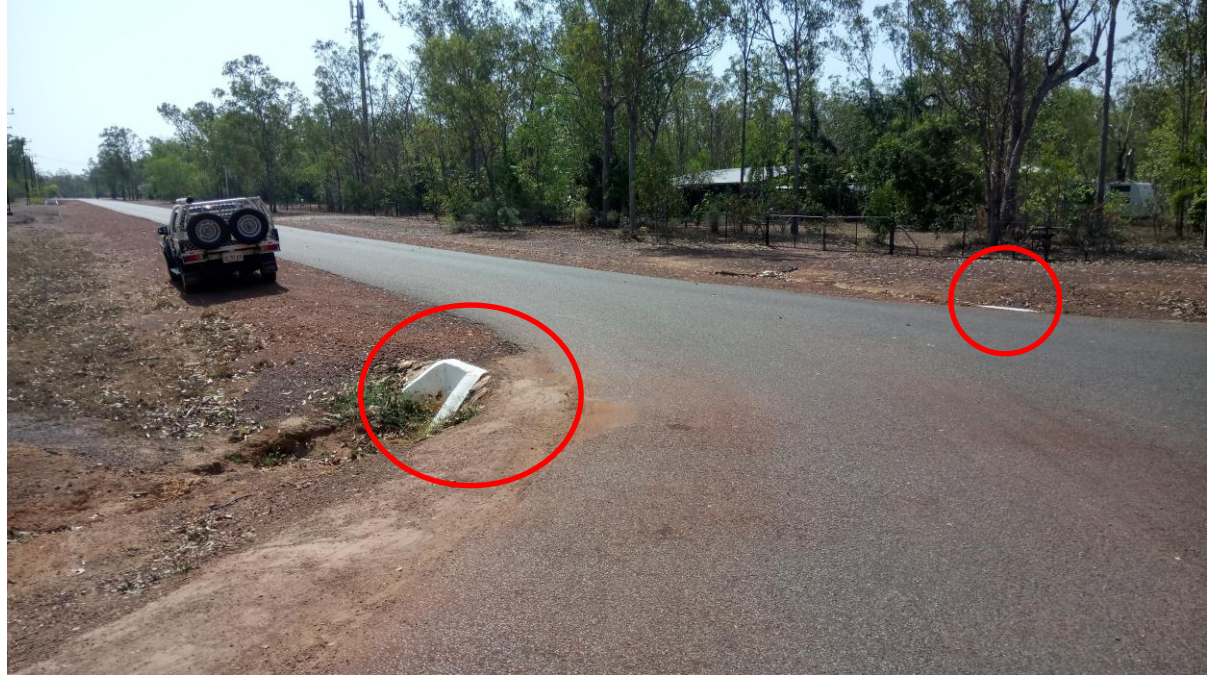
Unprotected drainage structure Wagait Tower Road

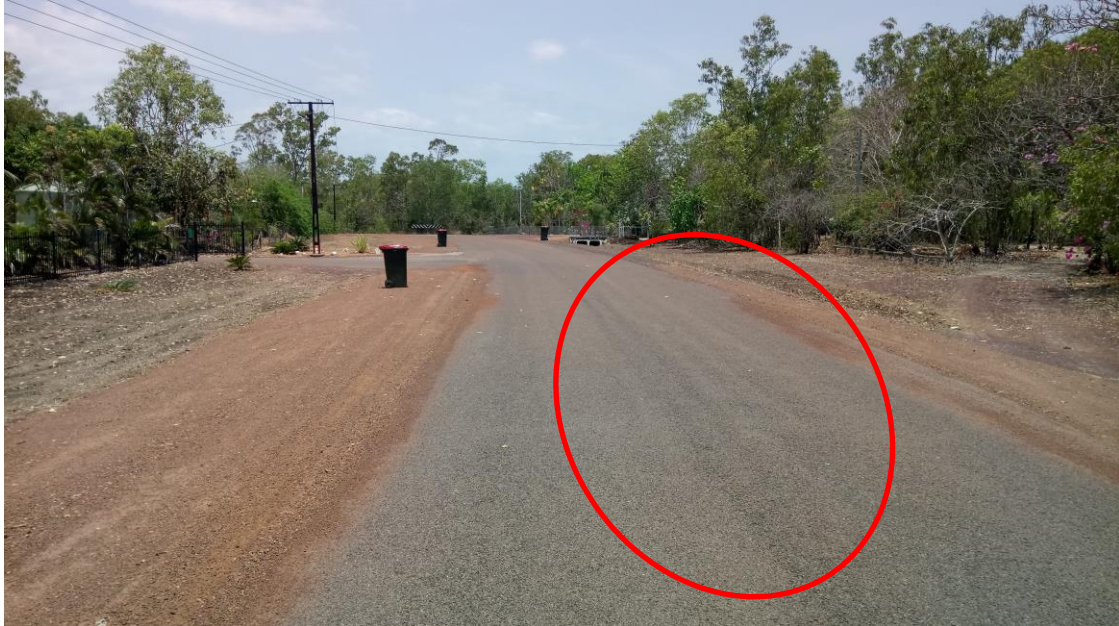
Appearance of potential raveling at approximate chainage 0.8

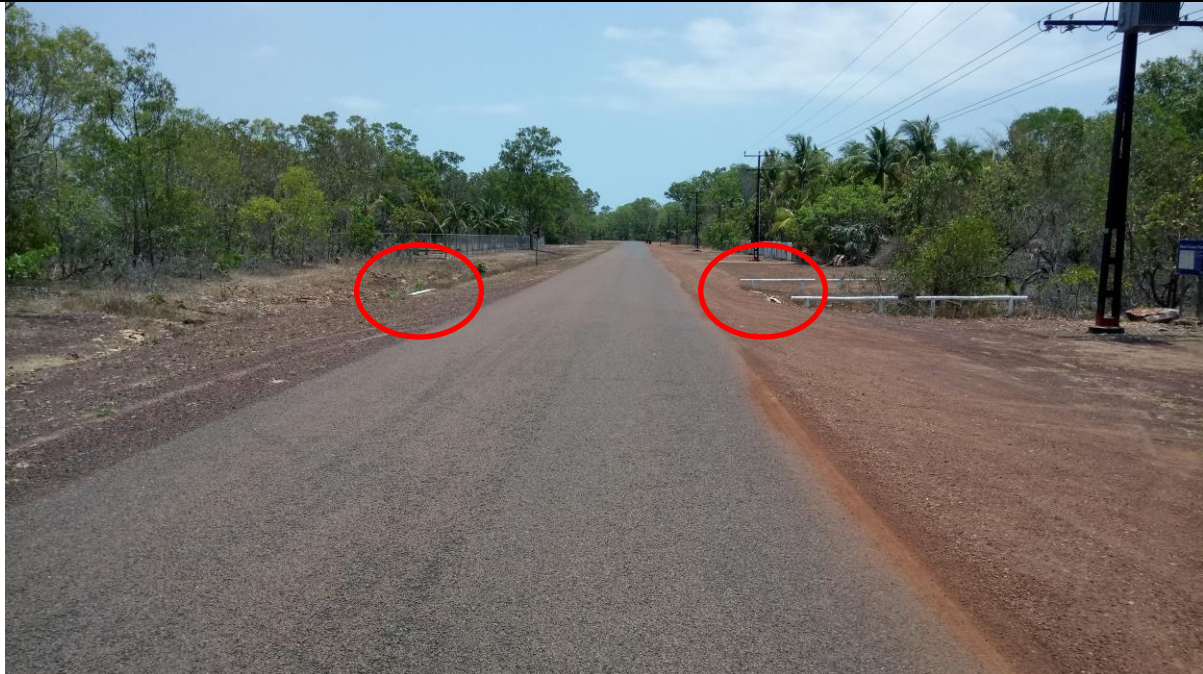
Potholes	No	Affected Area	NA
Unprotected Drainage Structures	Yes	Affected Area	CH0.45 and CH0.95

Unprotected drainage structure approximate chainage 0.45

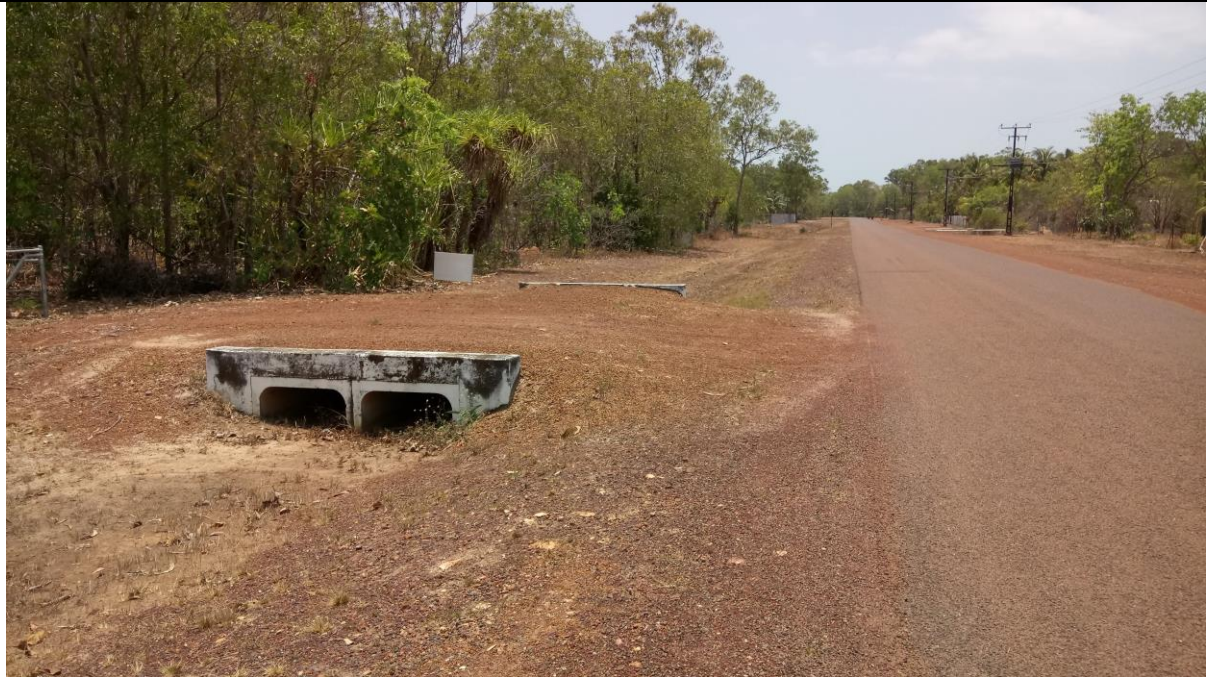
Unprotected driveway culvert approximate chainage 0.95

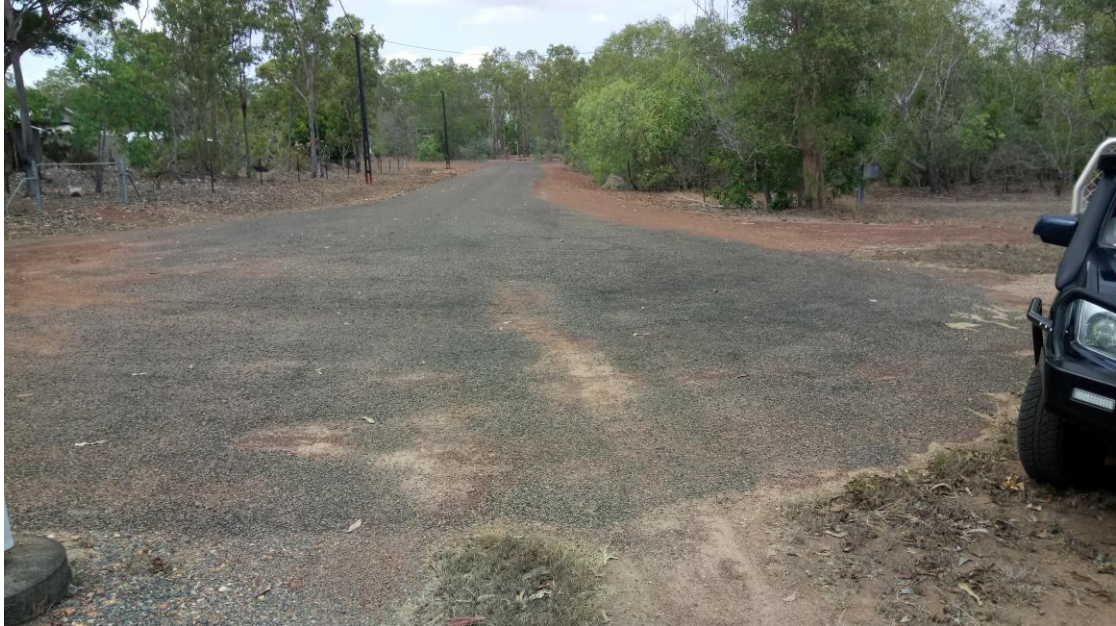
Raveling at Cul-de-sac

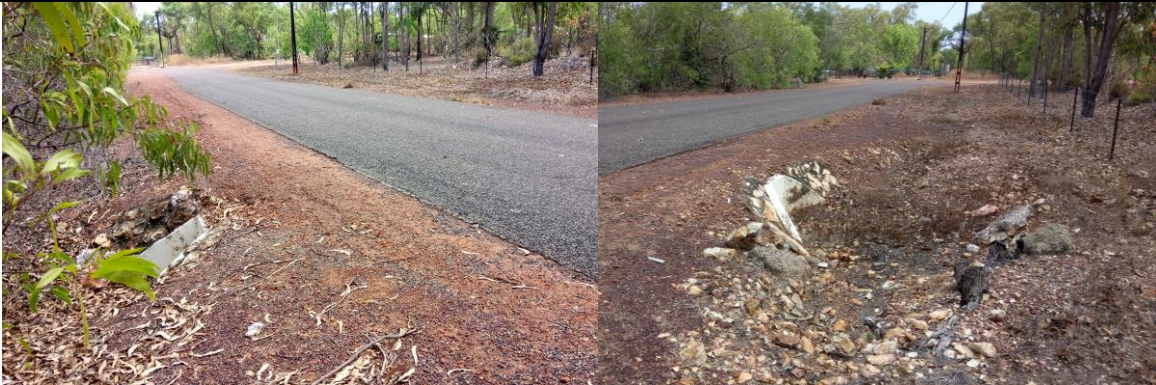
Potholes	No	Affected Area	NA
Unprotected Drainage Structures	Yes	Affected Area	CH0.05

Unprotected culvert at approximate chainage 0.05
