Road Network Investigation Report
For
Wagait Shire Council

Date: November 2018

Road Network Investigation Report for Wagait Shire Council

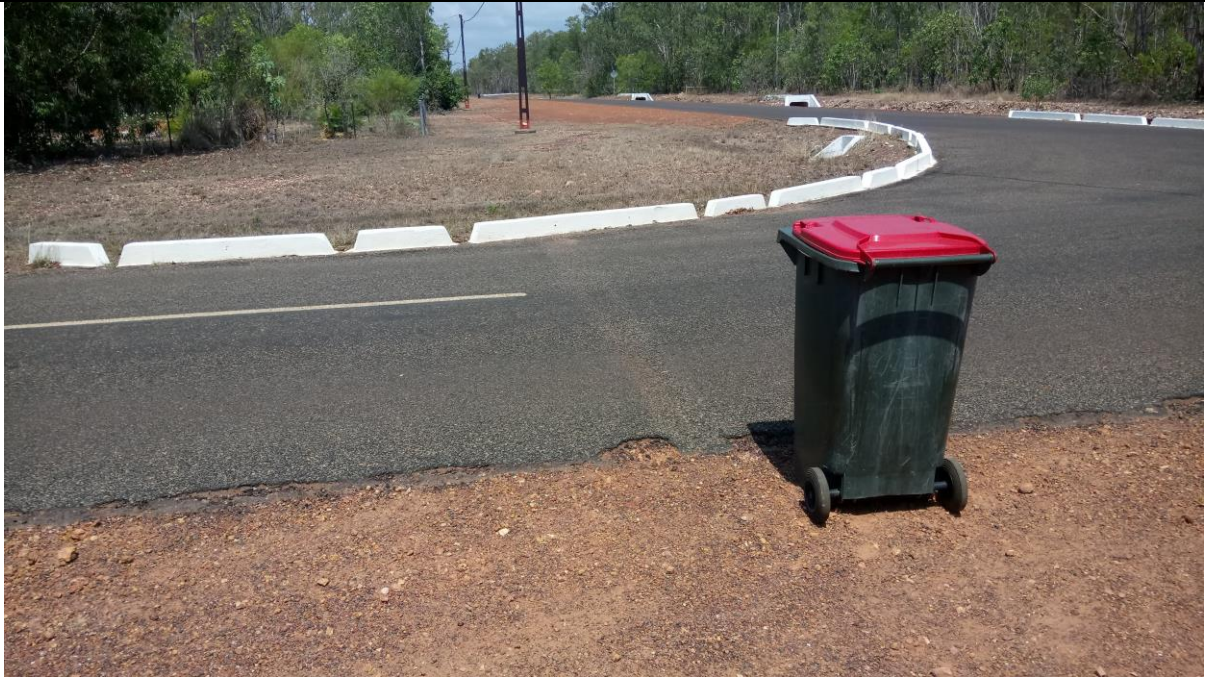
Service crossing Sachse Street Intersection

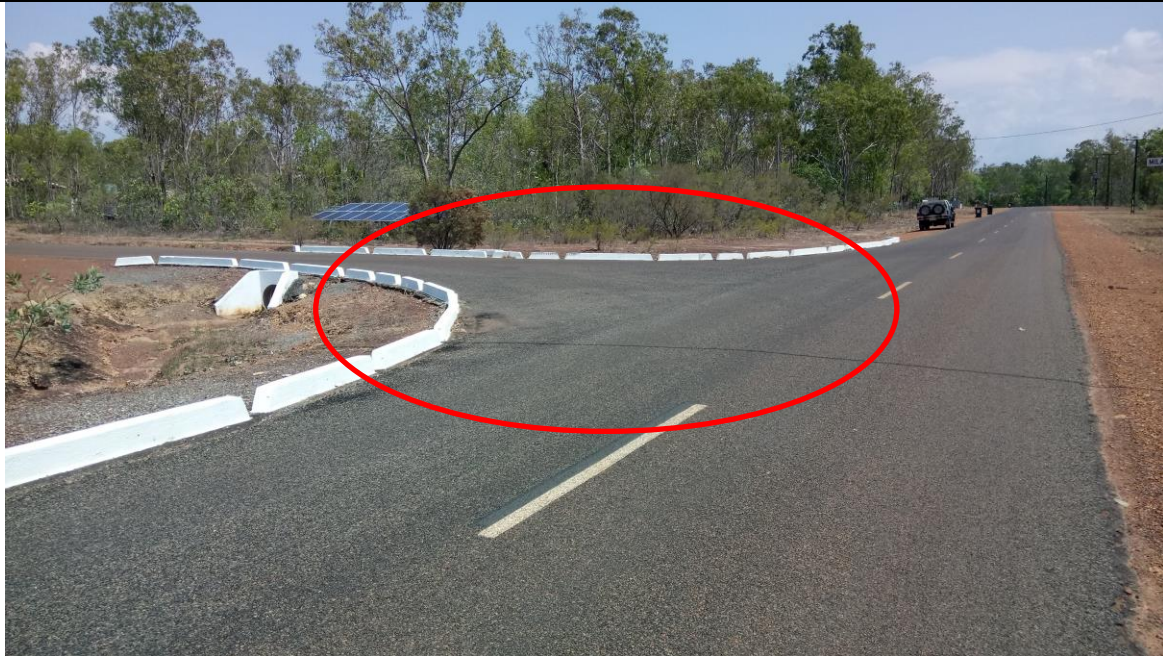
Raveling	Yes	Affected Area	Milady Street, Vangemann Street, Winnal Court, Massey Street and Brisbane Street
-----------------	-----	----------------------	--

Raveling Milady Street Intersection

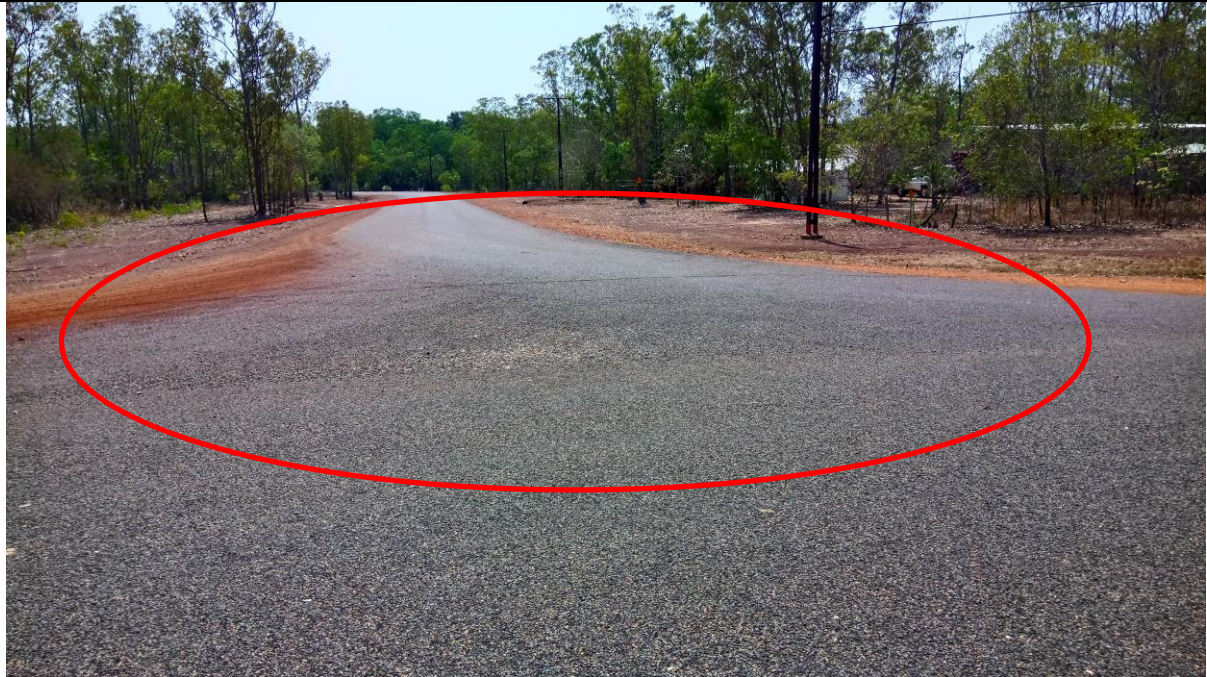
Raveling Vangemann Street Intersection

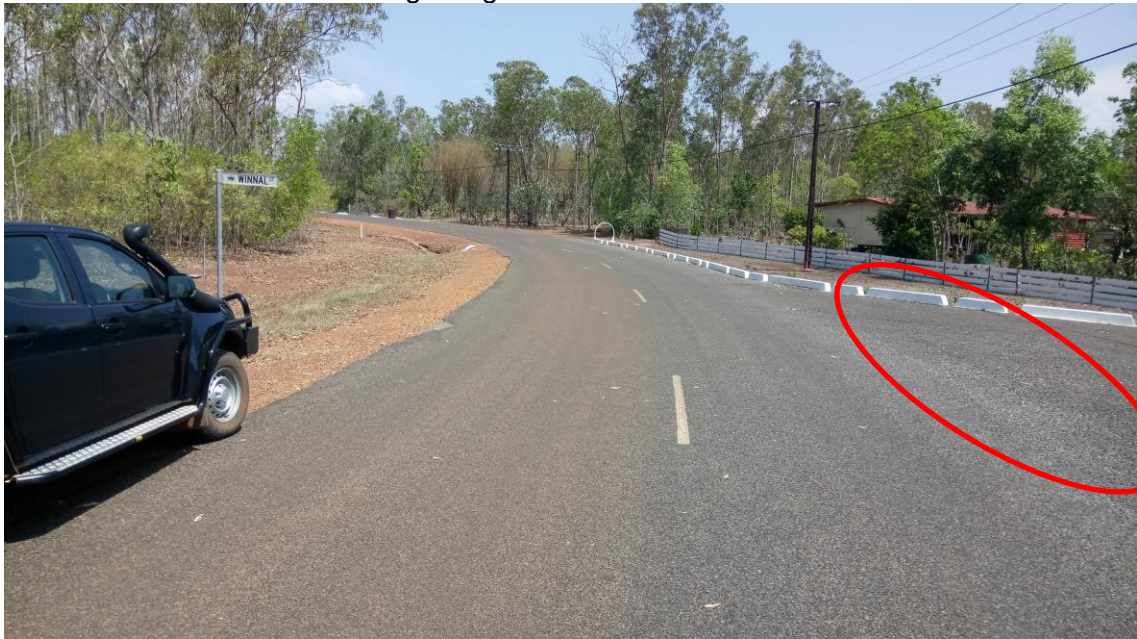
Raveling Winnal Court Intersection

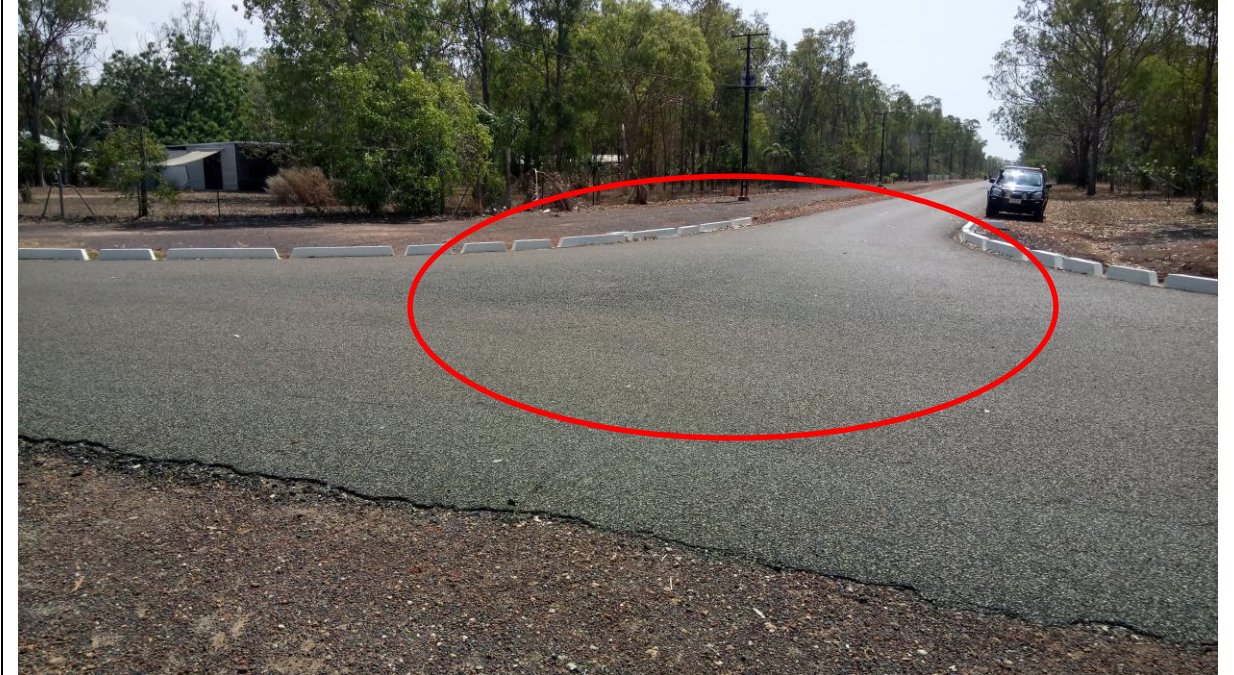
Ravelling Brisbane Street Intersection

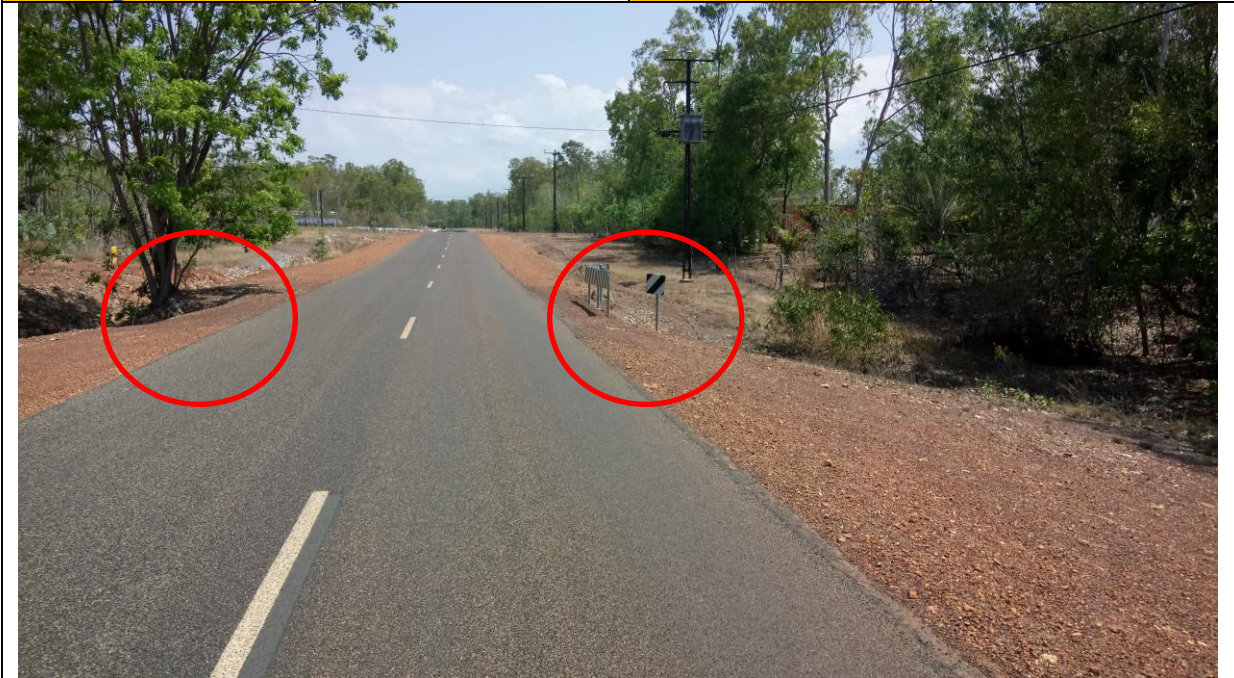
Potholes	No	Affected Area	NA
Unprotected Drainage Structures	Yes	Affected Area	CH0.45, CH0.95 and CH1.1

Culvert approximate chainage 0.45

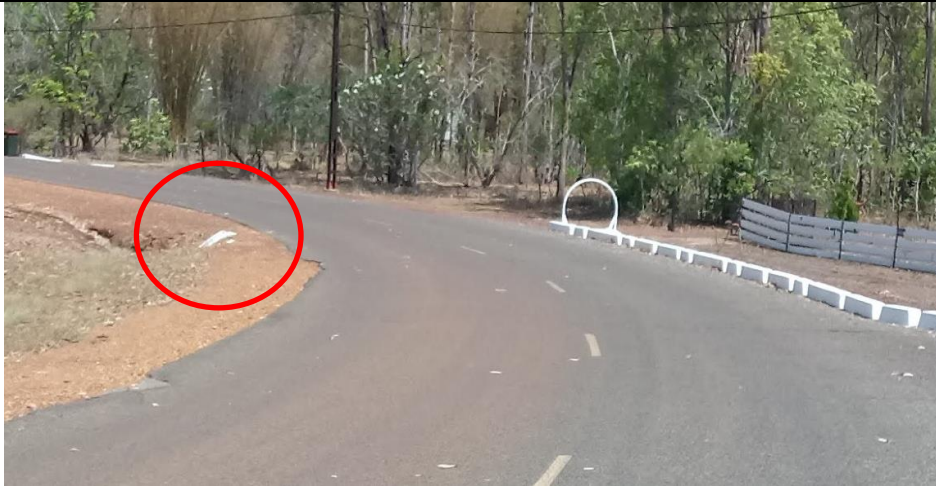
Culvert approximate chainage 0.95

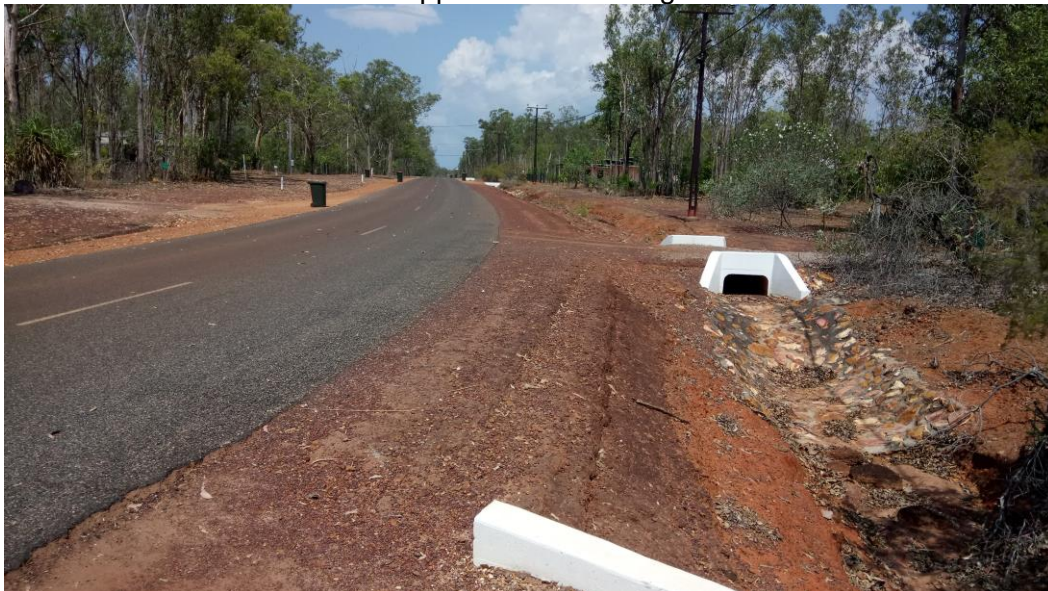
Unprotected drains and driveway culverts approximate chainage 1.1

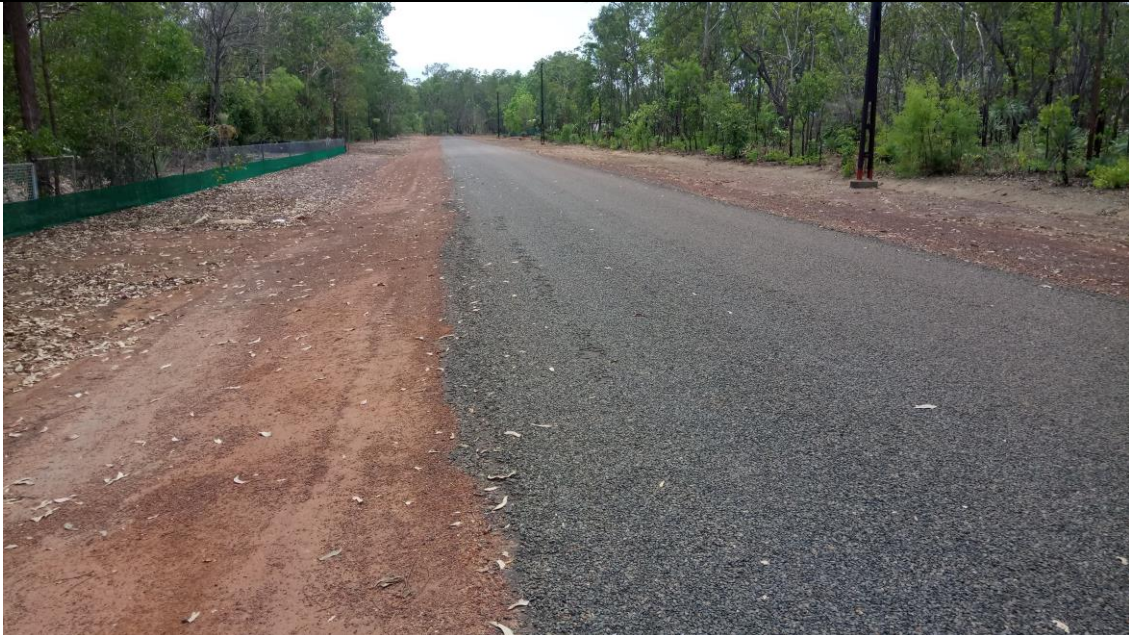
Raveling at approximate chainage 0.15

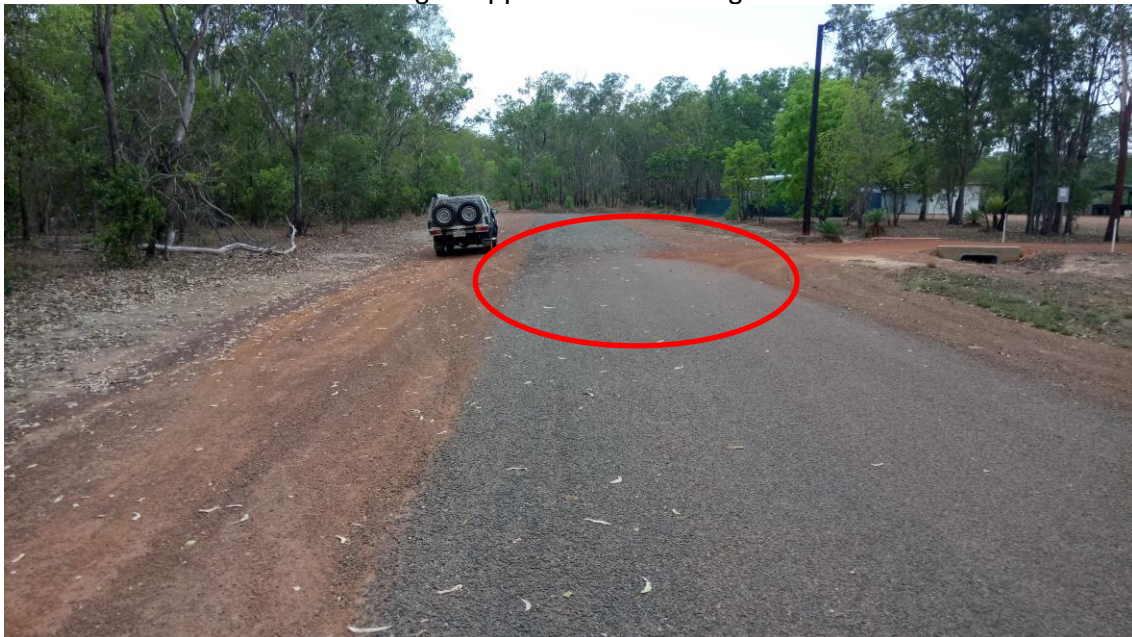
Raveling at recreational centre entrance

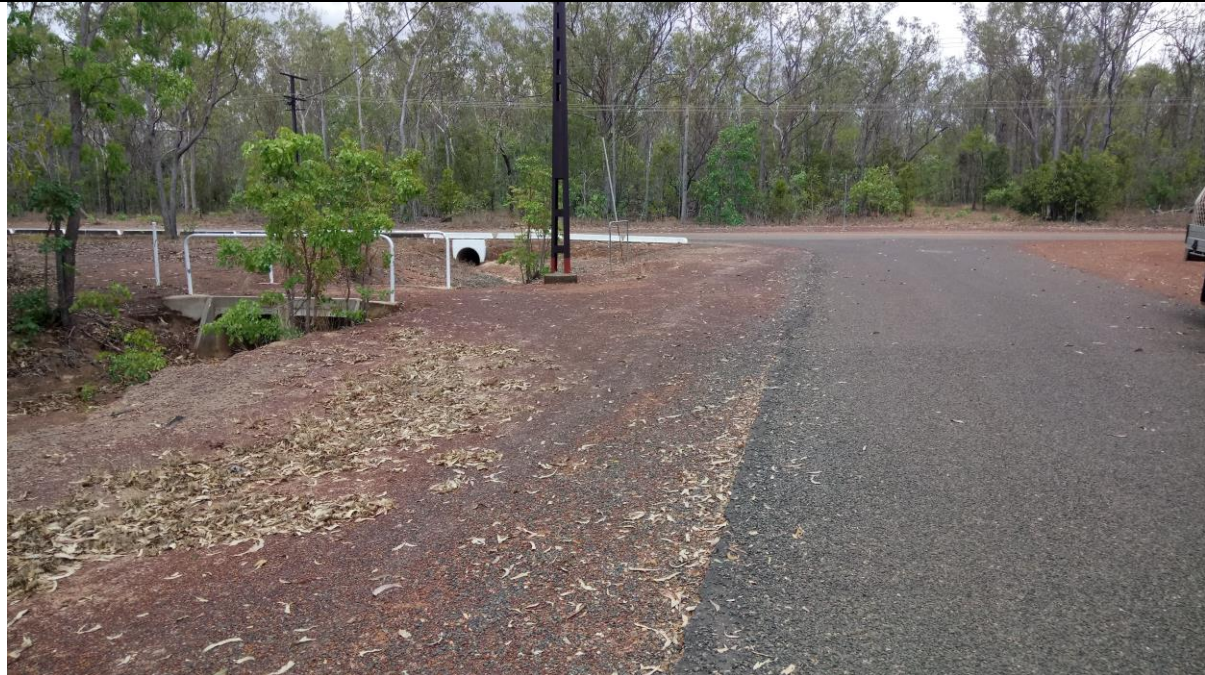
Potholes	No	Affected Area	NA
Unprotected Drainage Structures	Yes	Affected Area	Pedestrian culvert adjacent to Wagait Tower Road

Unprotected drainage structure adjacent to Wagait Tower Road

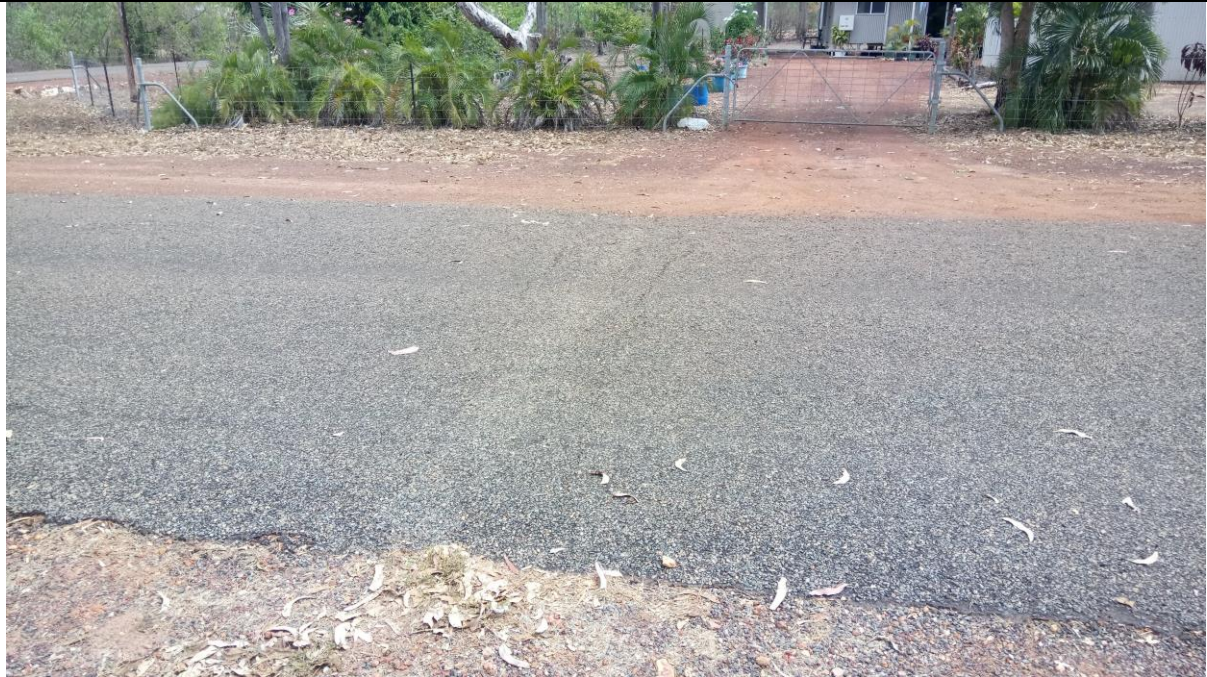
Service crossing approximate chainage 0.15

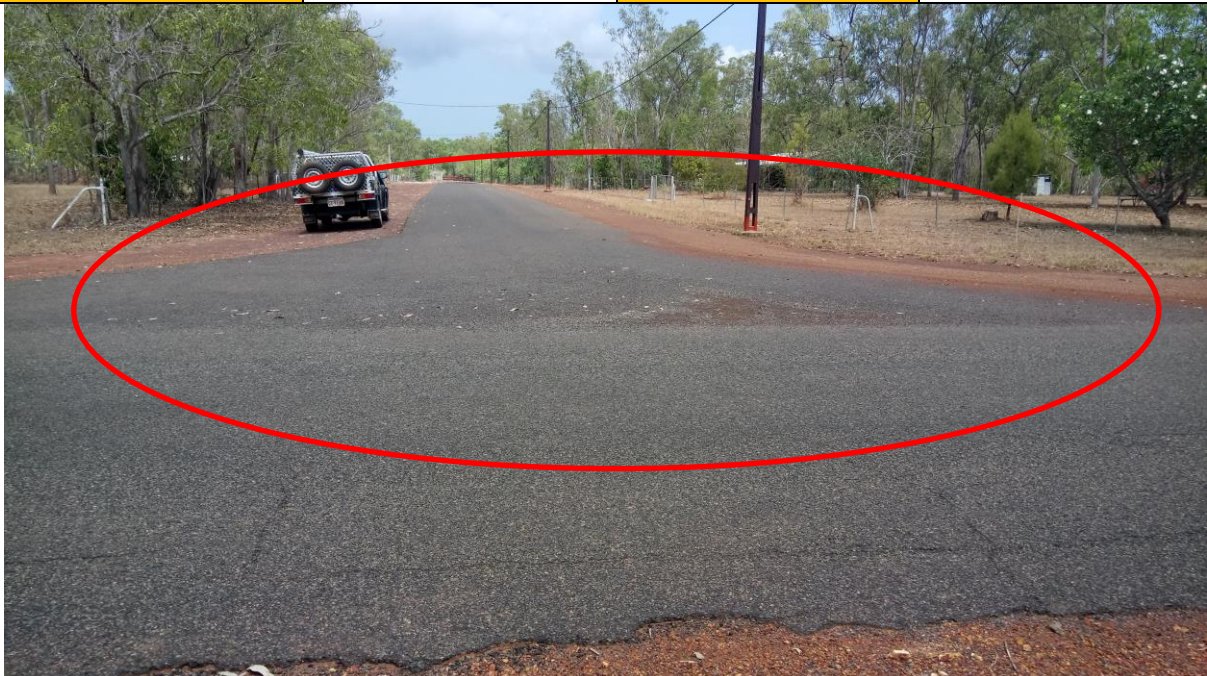
Raveling at Baluria Road Intersection

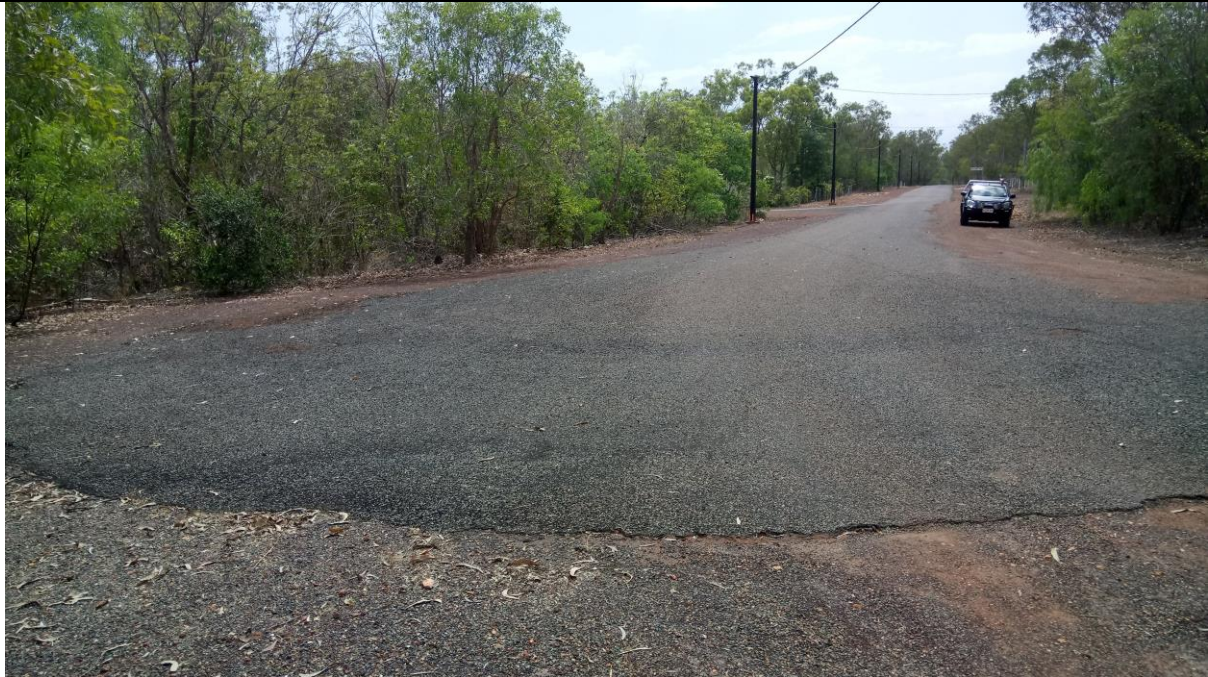
Raveling at cul-de-sac

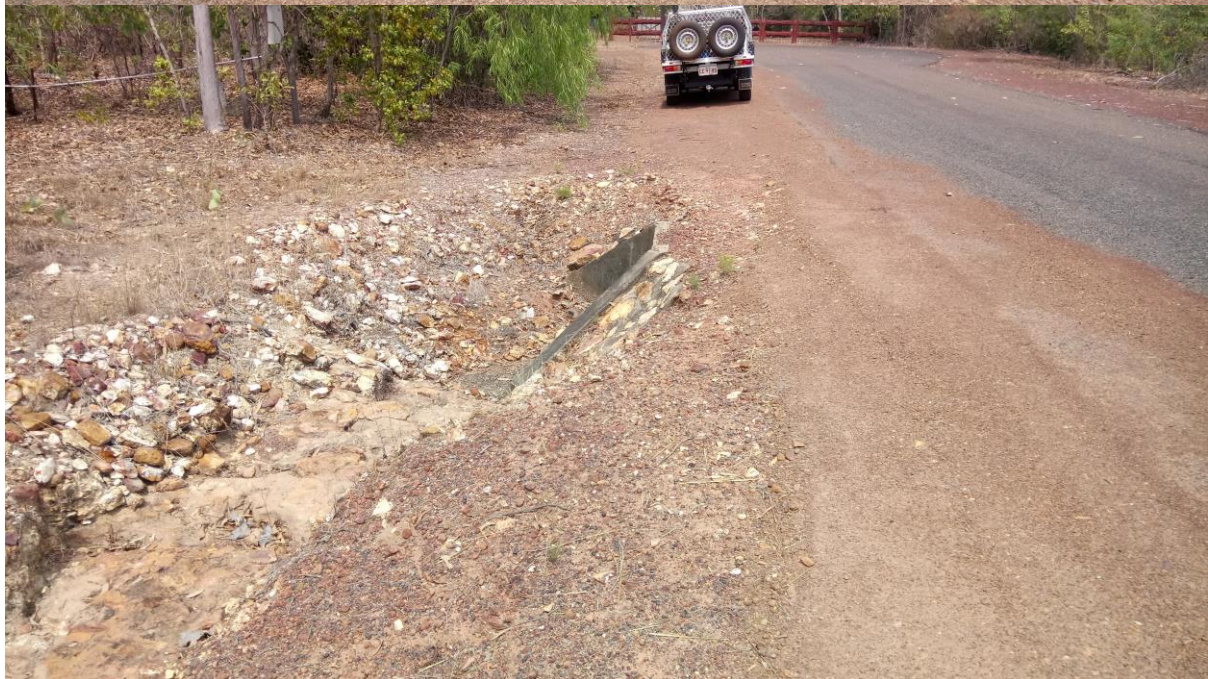
Unprotected Drainage Structures	Yes	Affected Area	Intersection at Dillon Place
--	-----	----------------------	------------------------------

Unprotected culvert crossing at Dillon Place Intersection

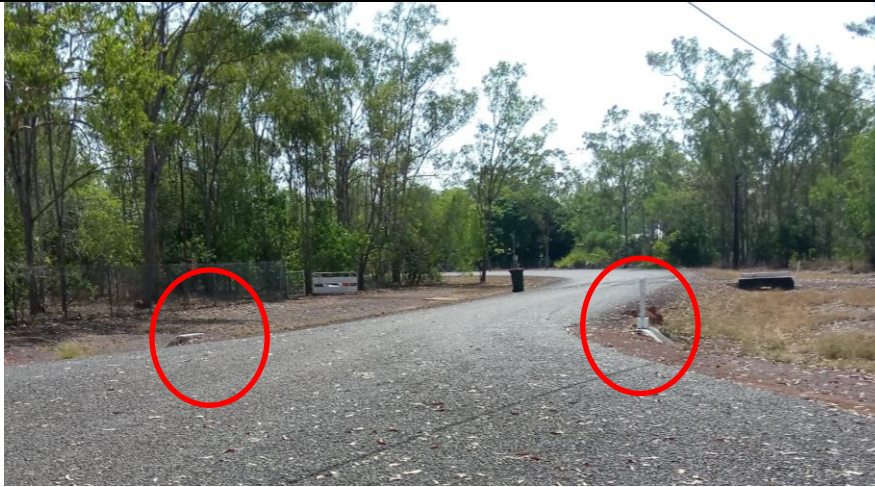
Unprotected Culvert approximate chainage 0.2

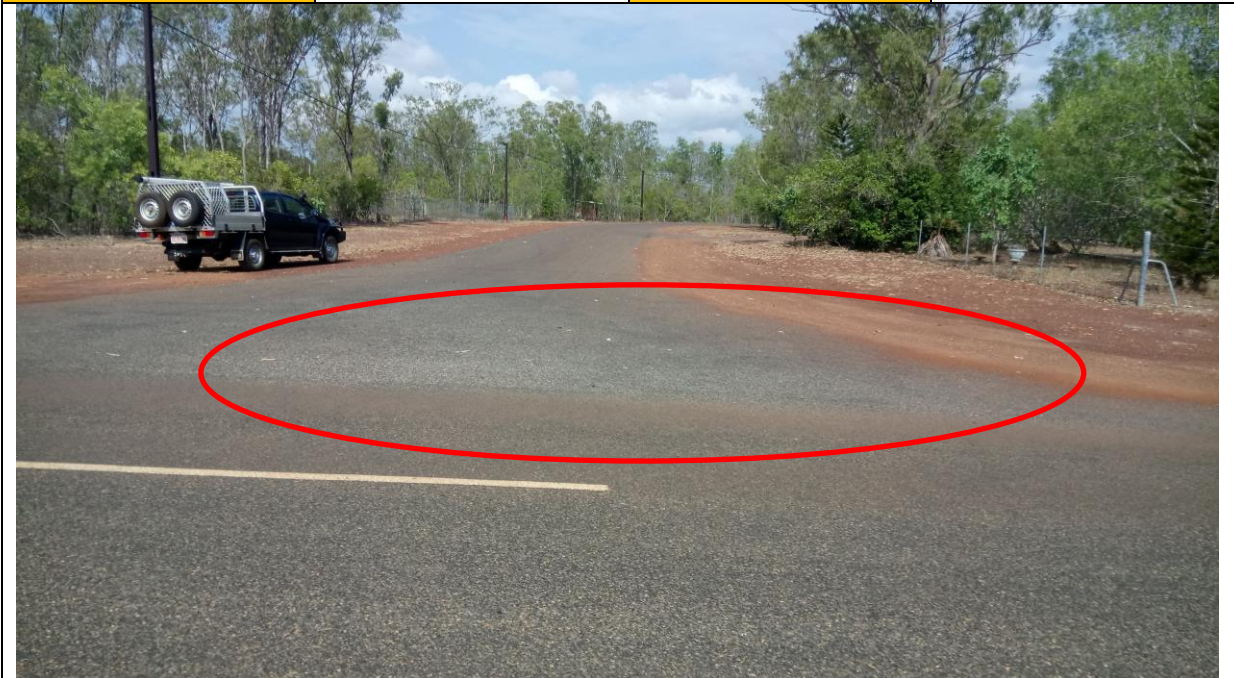
Raveling	Yes	Affected Area	Erickson Crescent Intersection and cul-de-sac
-----------------	-----	----------------------	---

Raveling Erickson Crescent Intersection

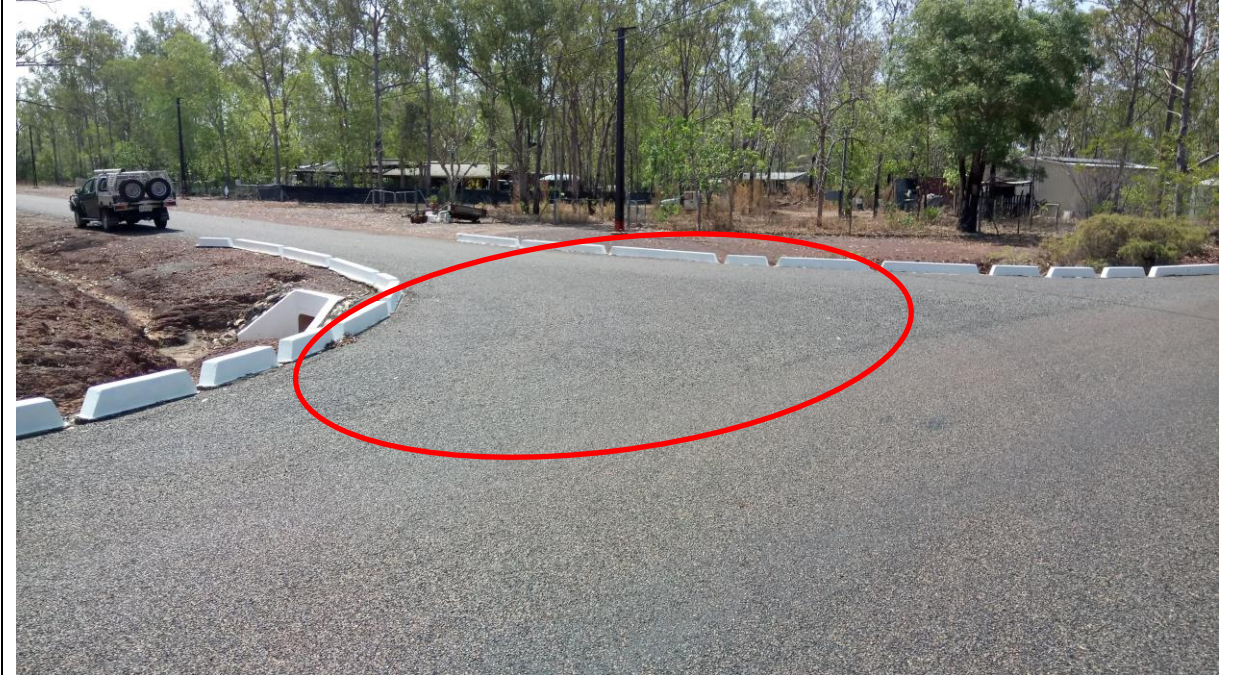
Raveling at Brisbane Street Intersection

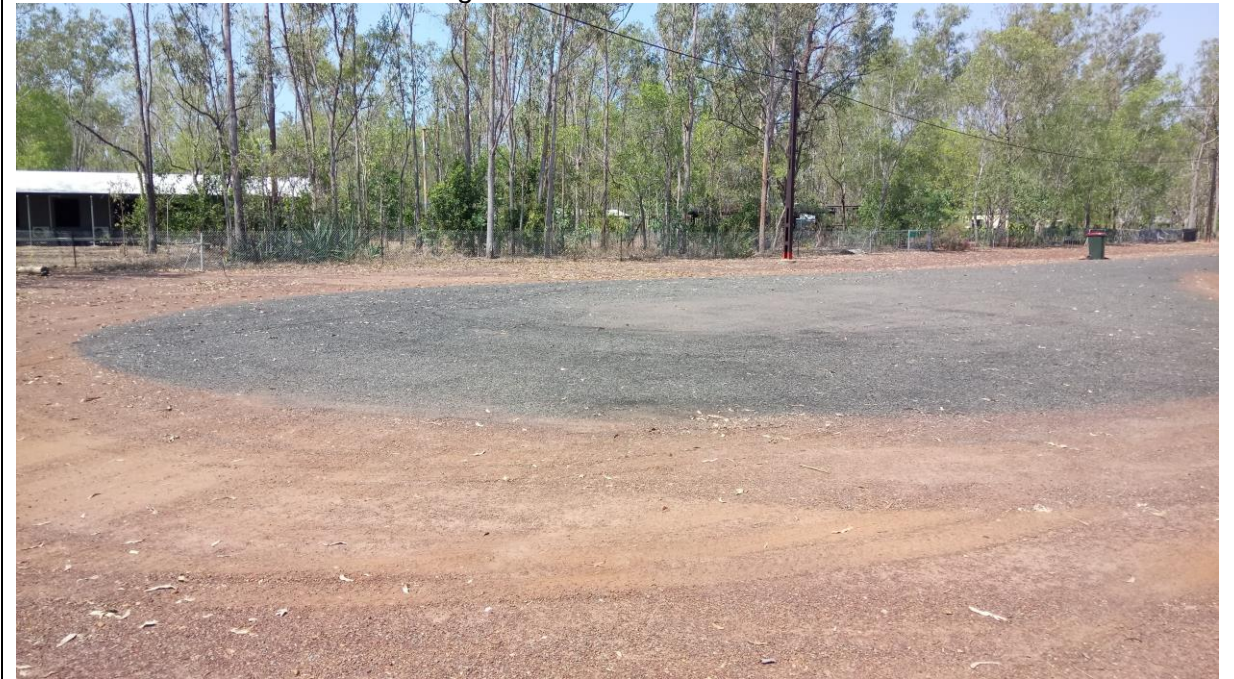
Raveling at Cul-de-sac

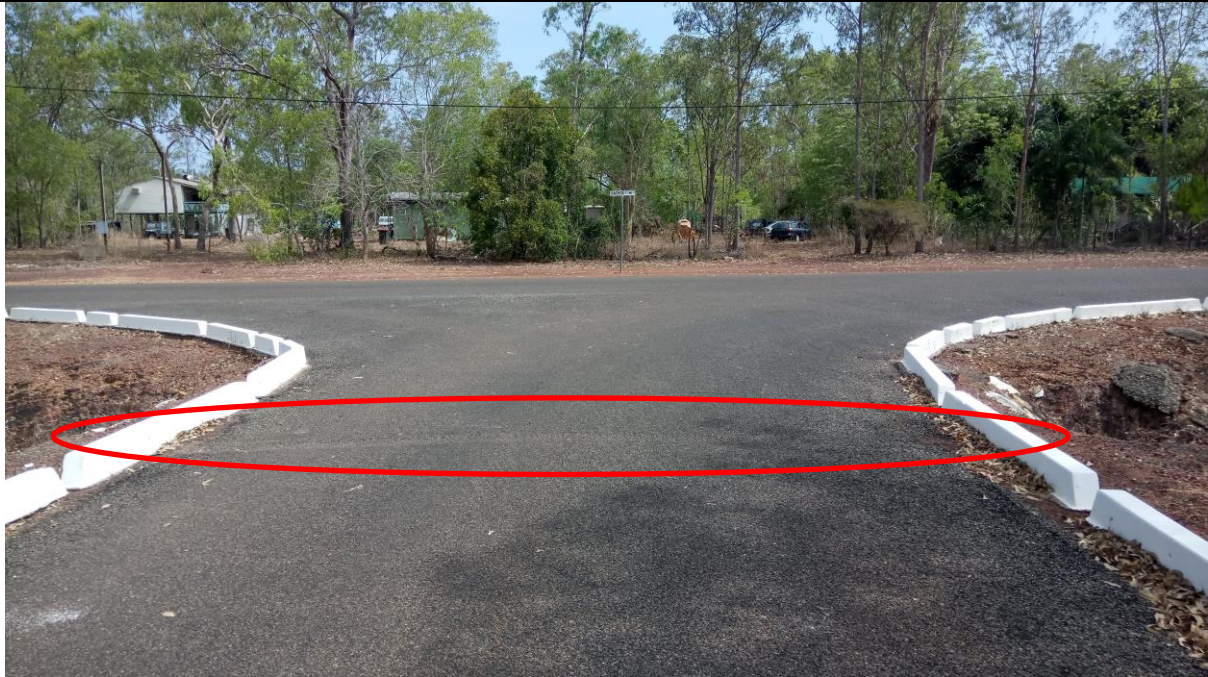
Service crossing at Sachse Street Intersection

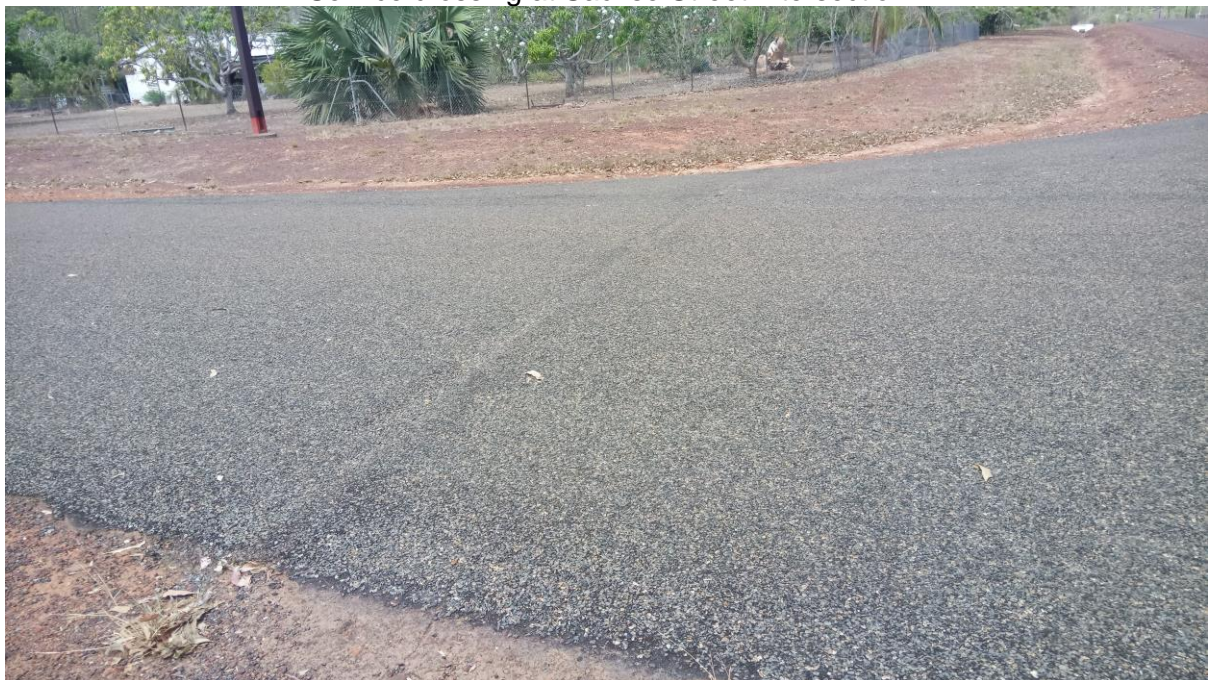
Service crossing at Milady Street Intersection

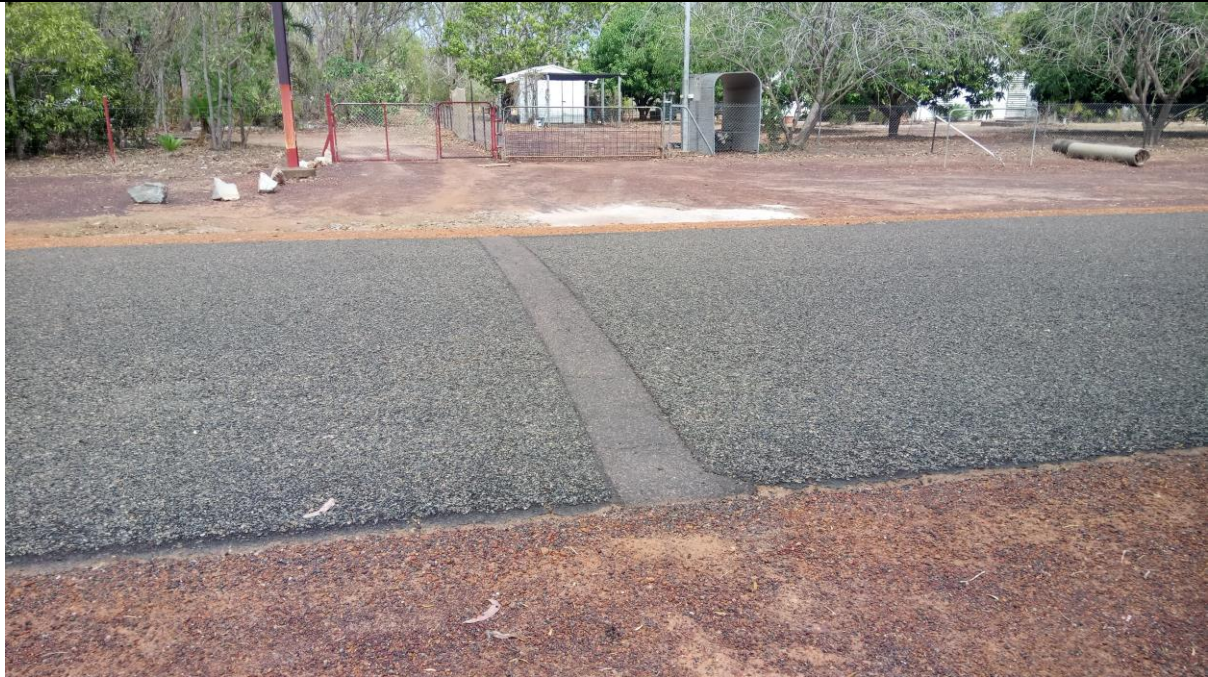
Service crossing at CH0.3

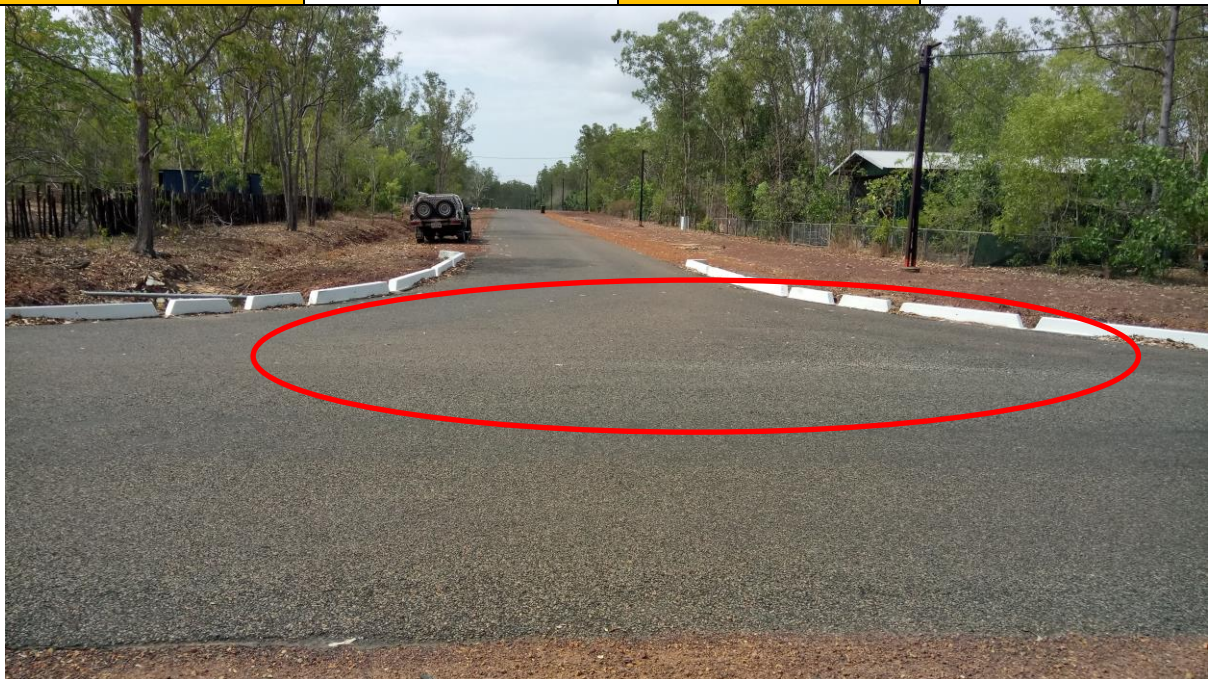
Raveling at Sachse Street Intersection

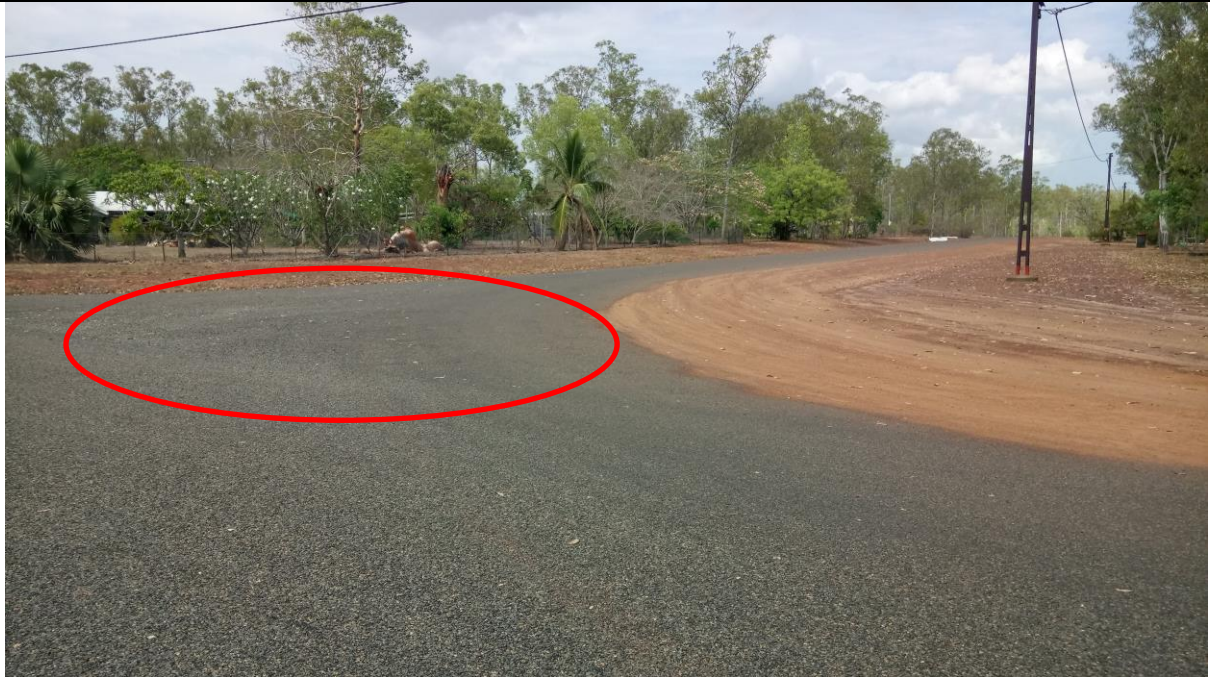
Raveling at Milady Street Intersection

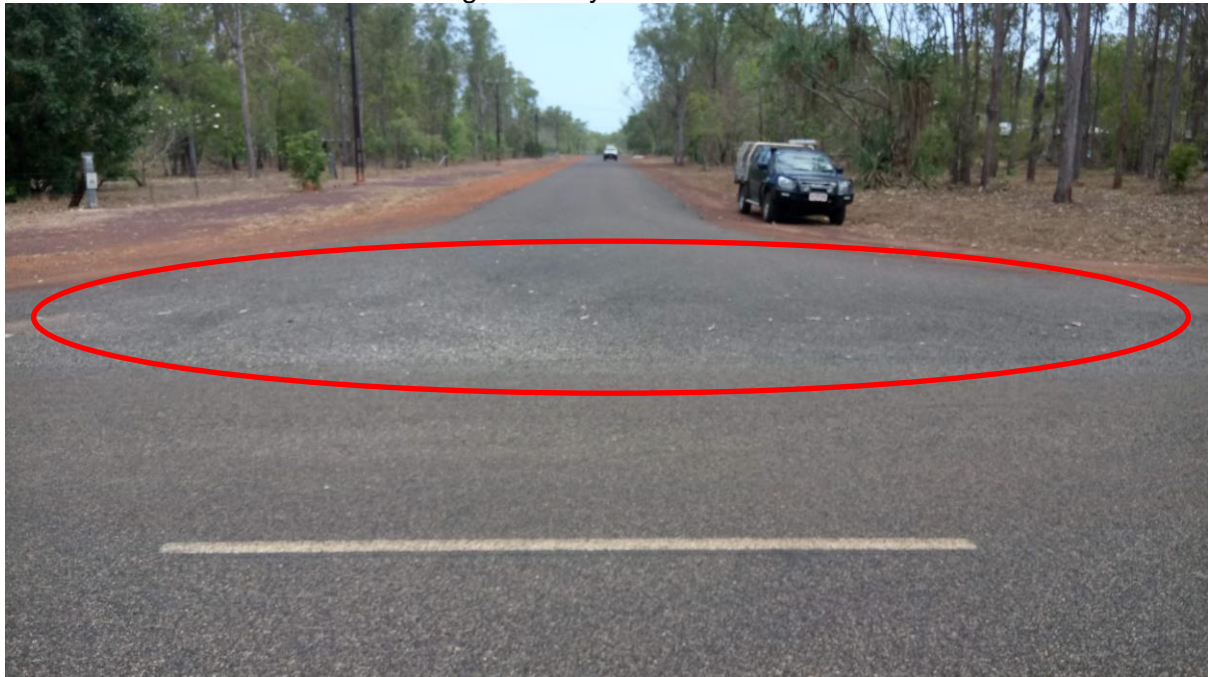
Raveling at Erickson Crescent Intersection

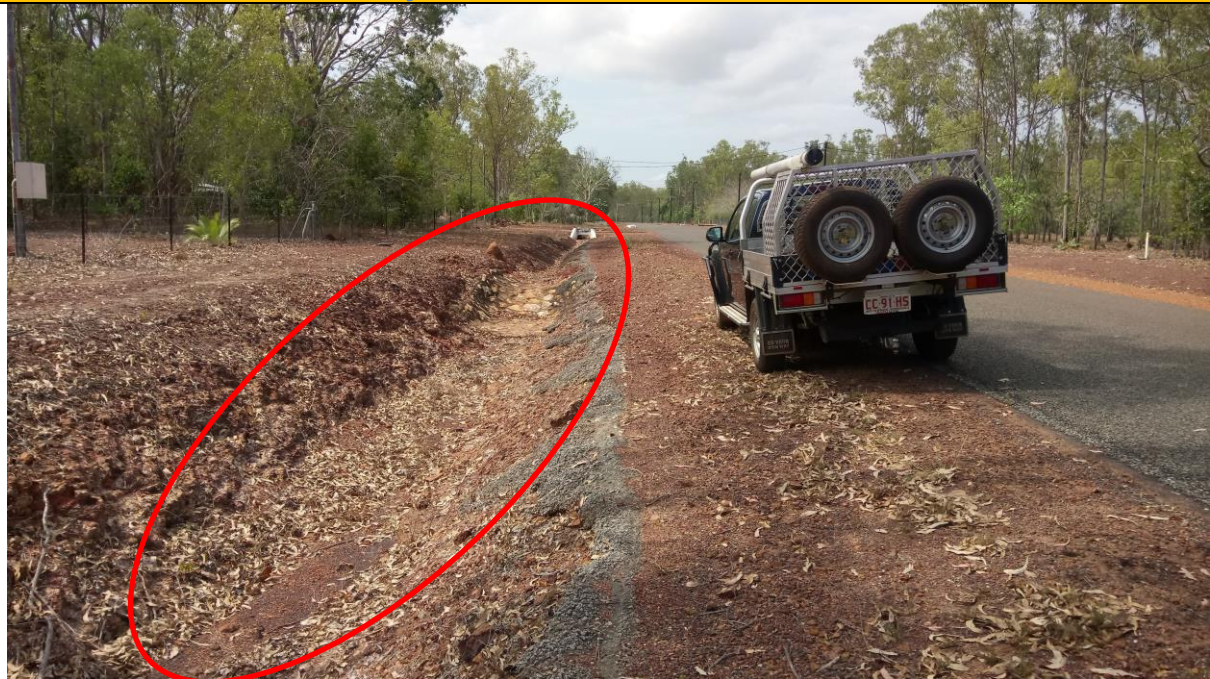
Unprotected open drain and culvert structures approximate chainage 0.1

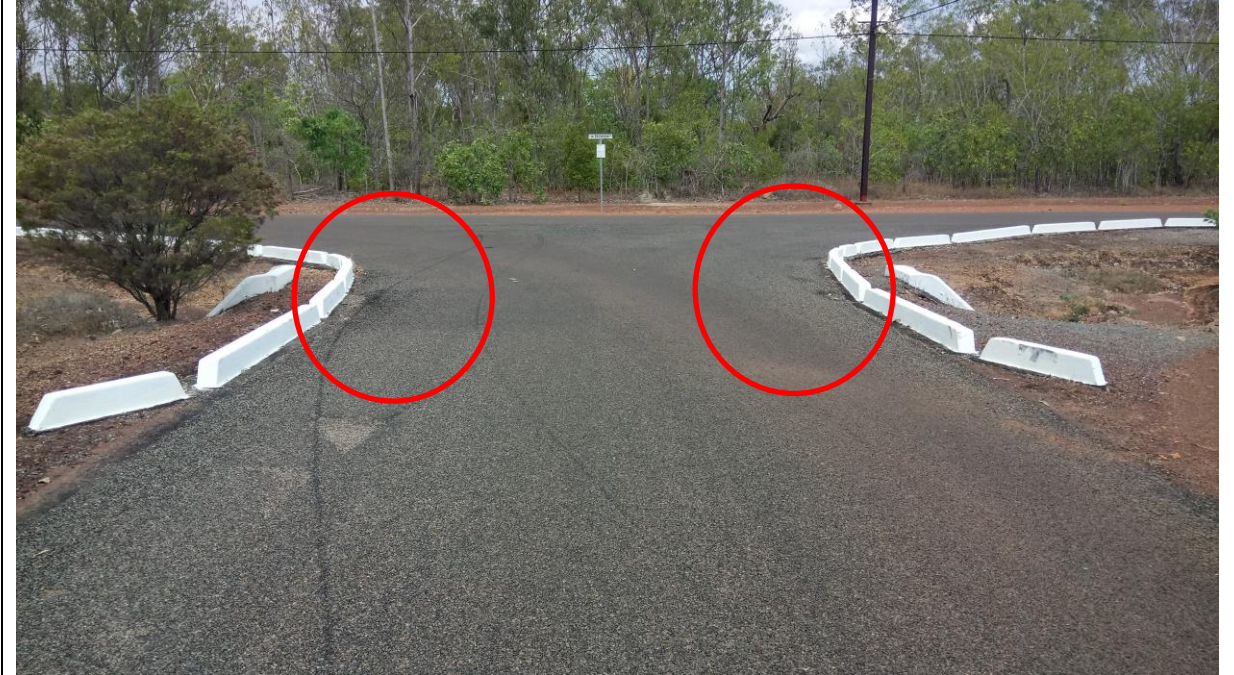
Raveling at Erickson Crescent

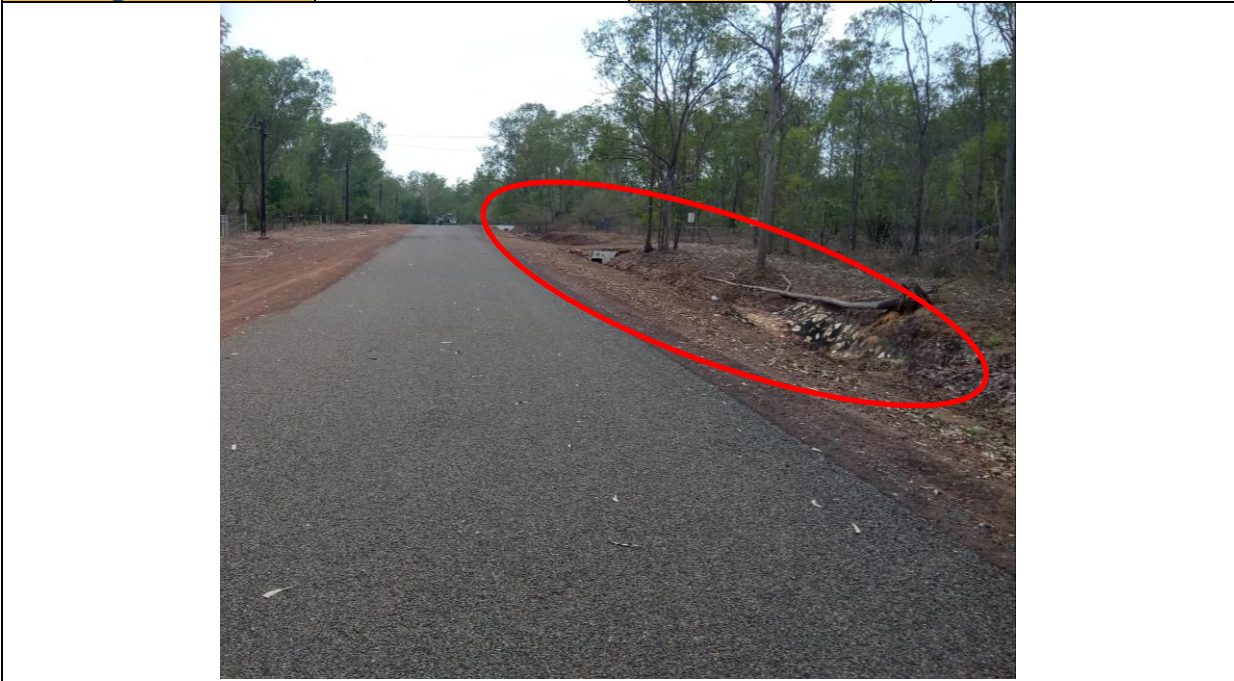
Unprotected drainage structures along southern edge of roadway

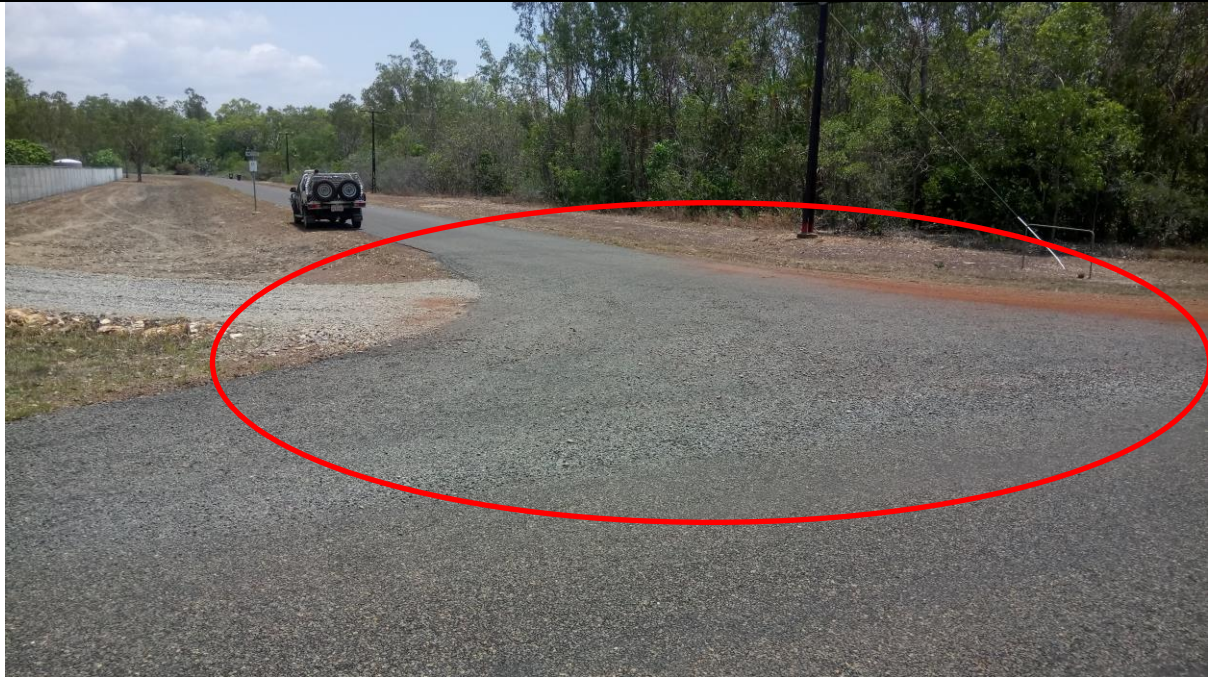
Raveling at De Lissa Road Intersection
