Road Network Investigation Report
For
Wagait Shire Council

Date: November 2018

Road Network Investigation Report for Wagait Shire Council

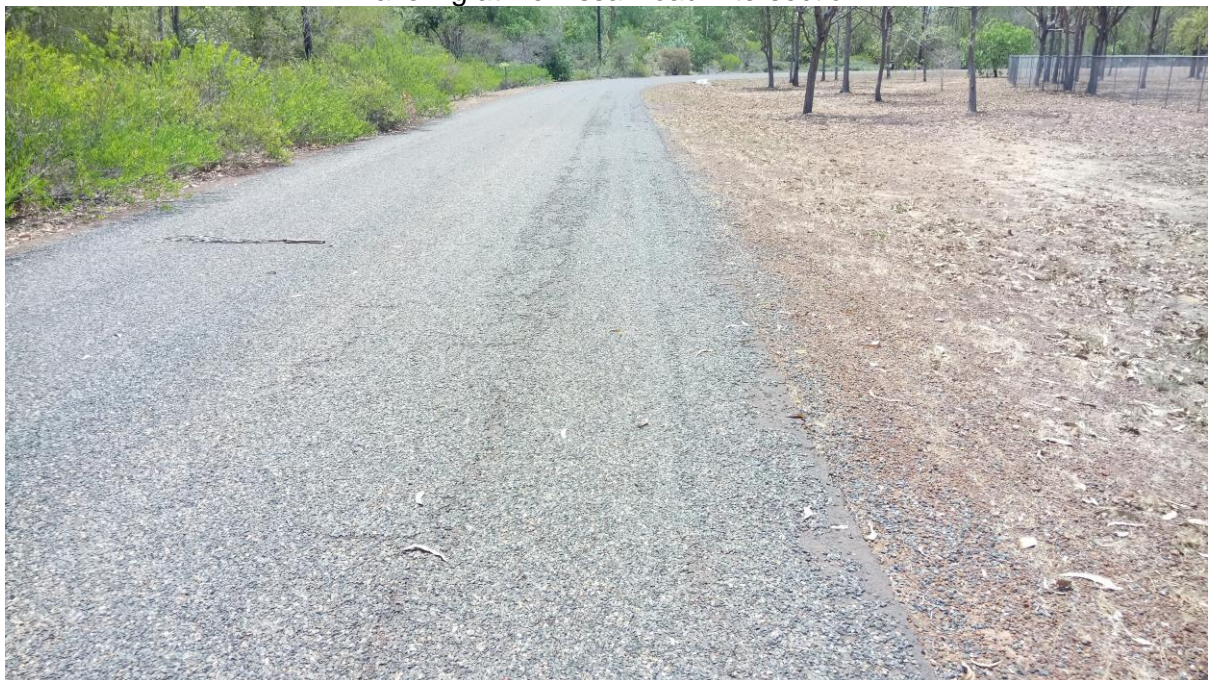
Raveling at approximate chainage 0.25

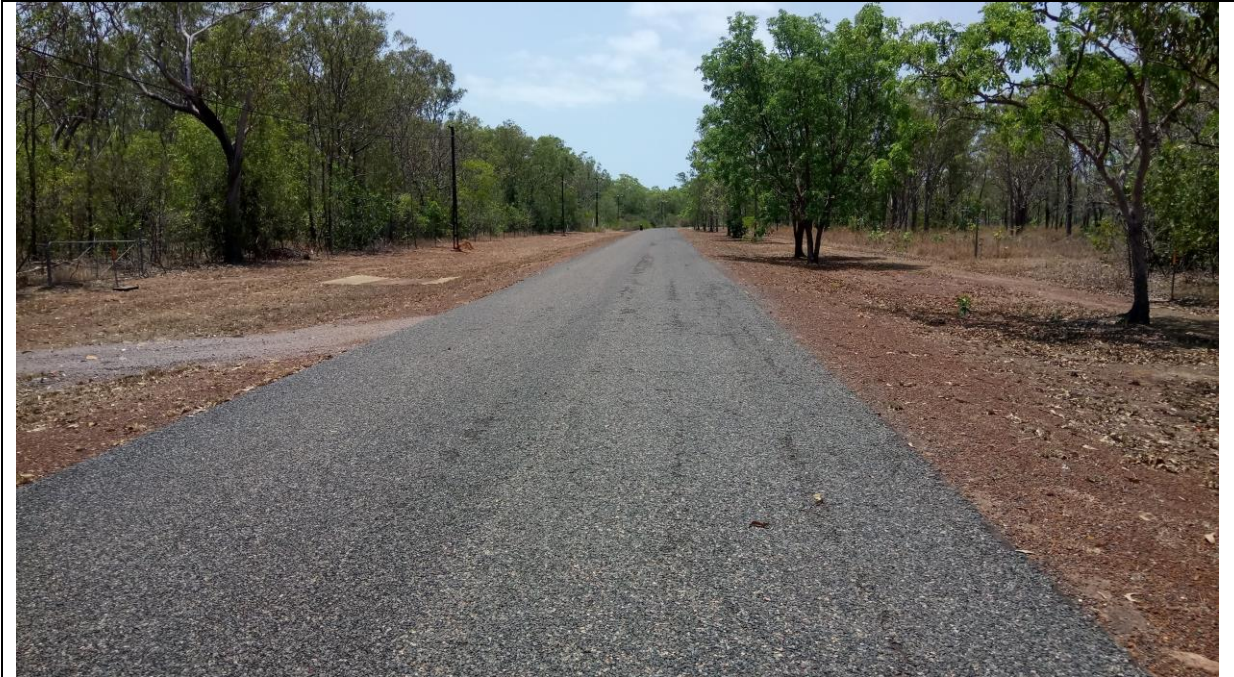
Raveling at approximate chainage 0.4

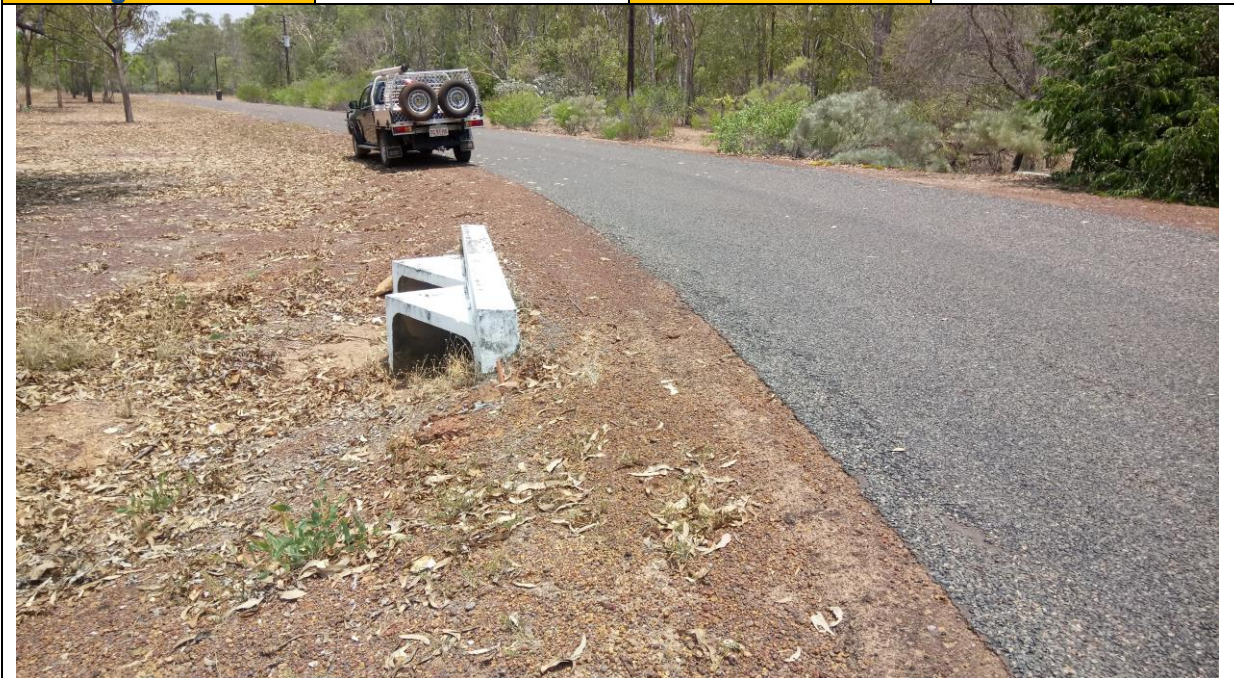
Unprotected culvert at approximate chainage 0.2

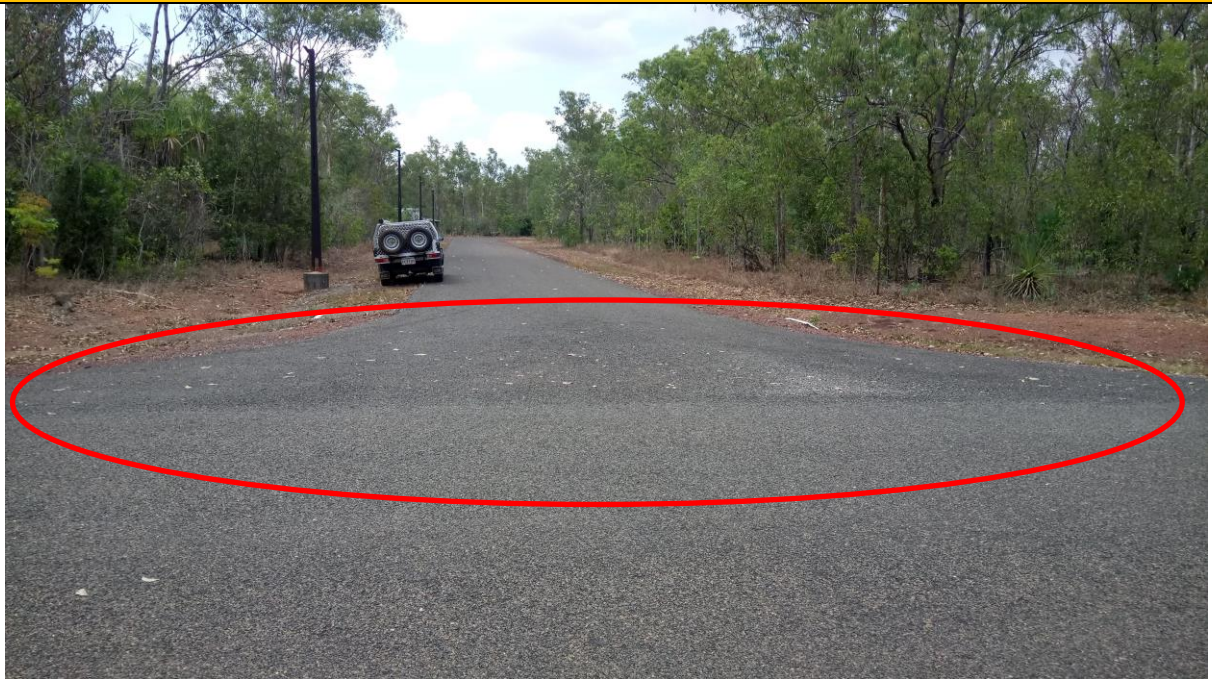
Raveling at Uhr Road Intersection

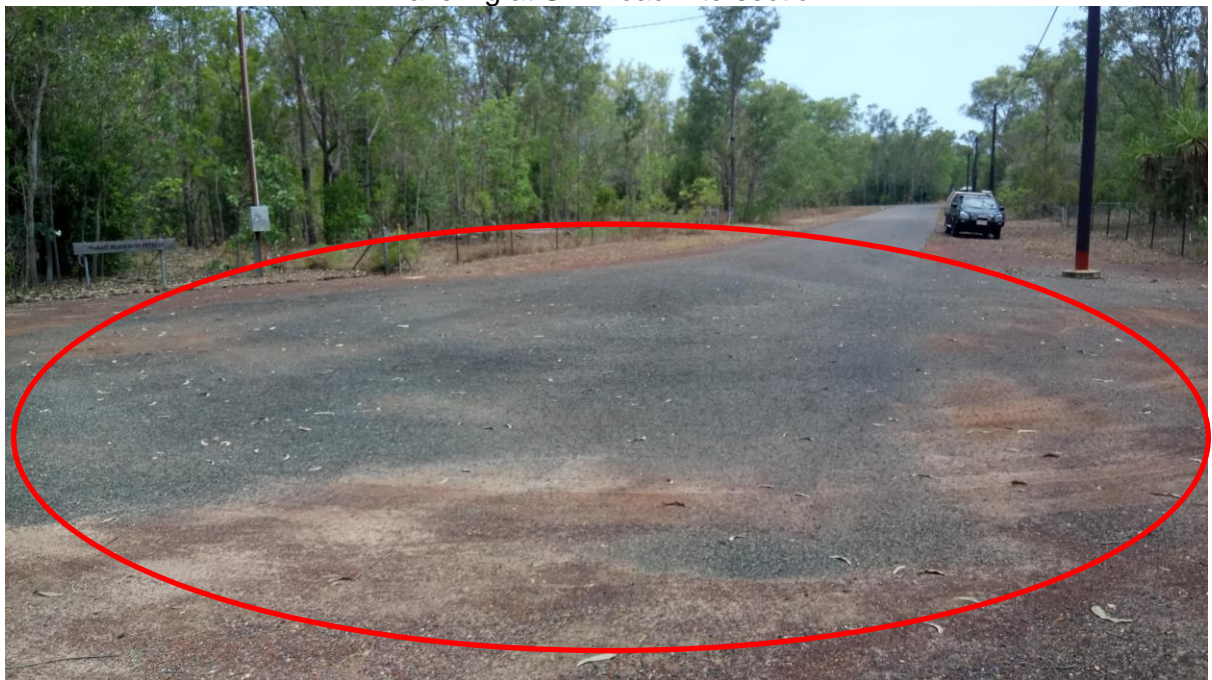
Raveling at Cul-de-sac

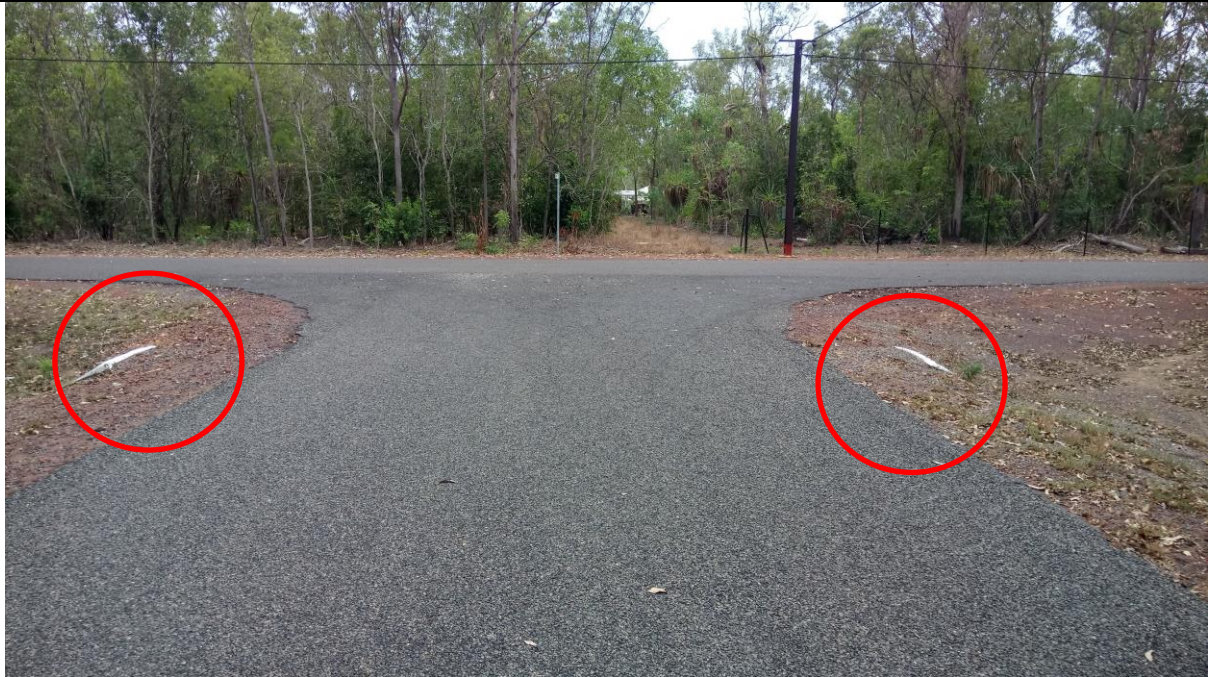
Unprotected drainage structure Uhr Road Intersection

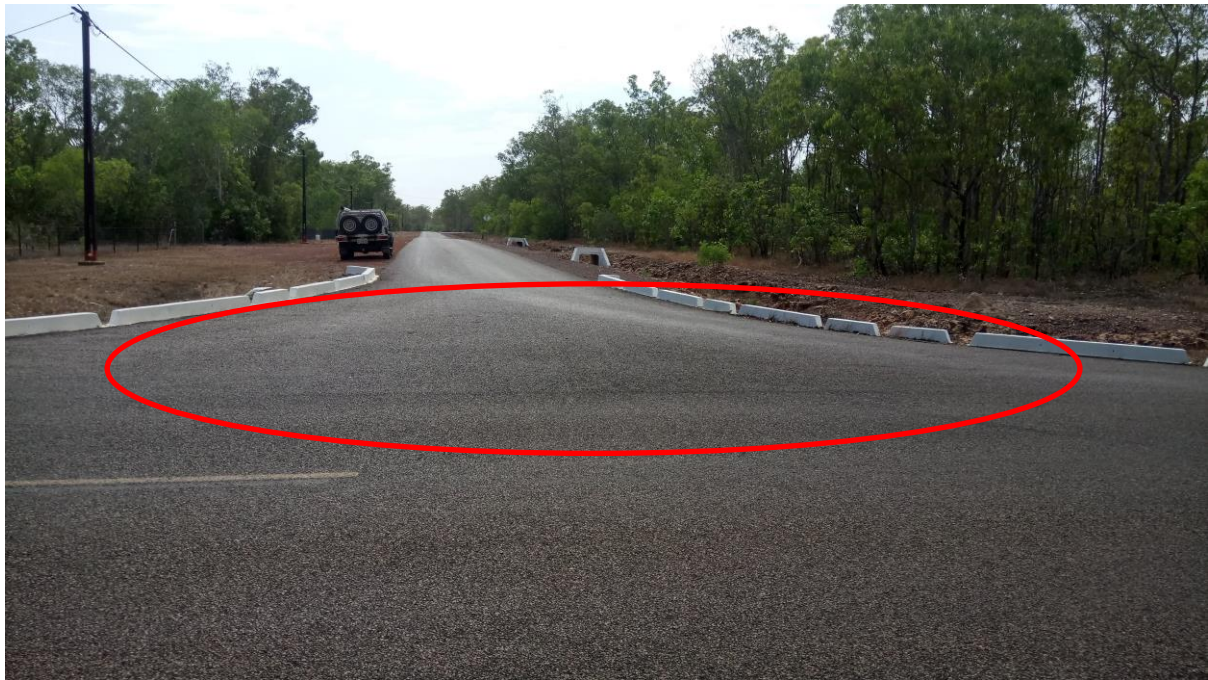
Raveling at Erickson Intersection

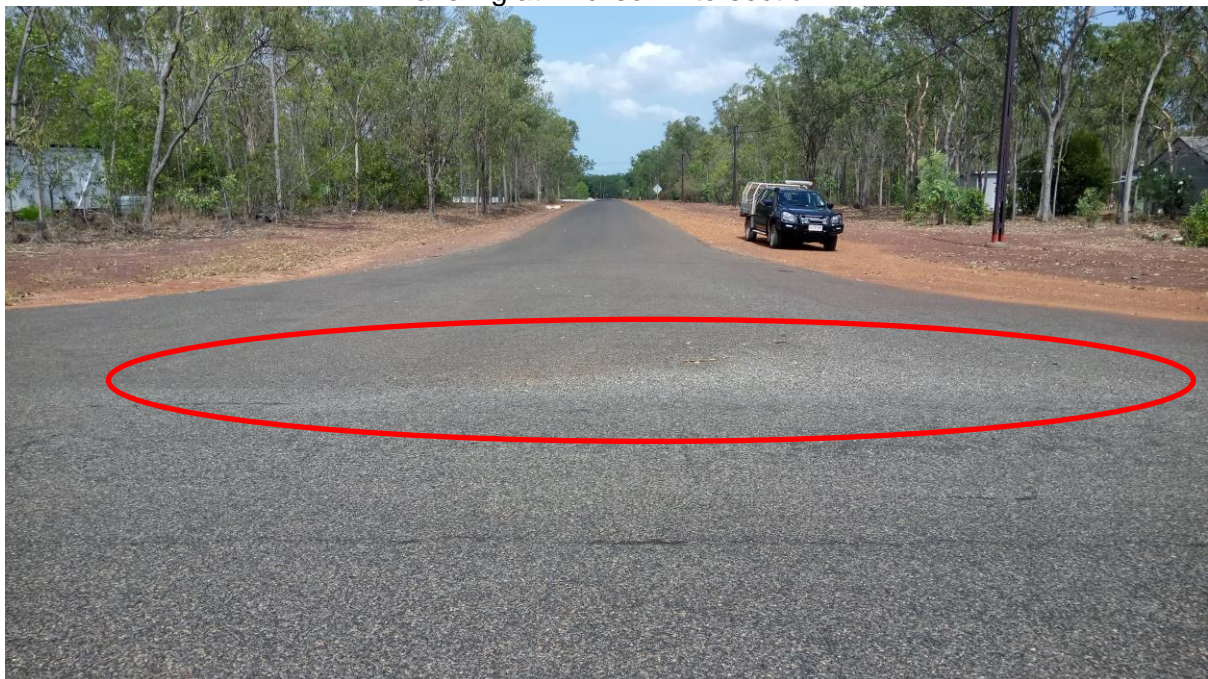
Raveling at Baluria Road Intersection

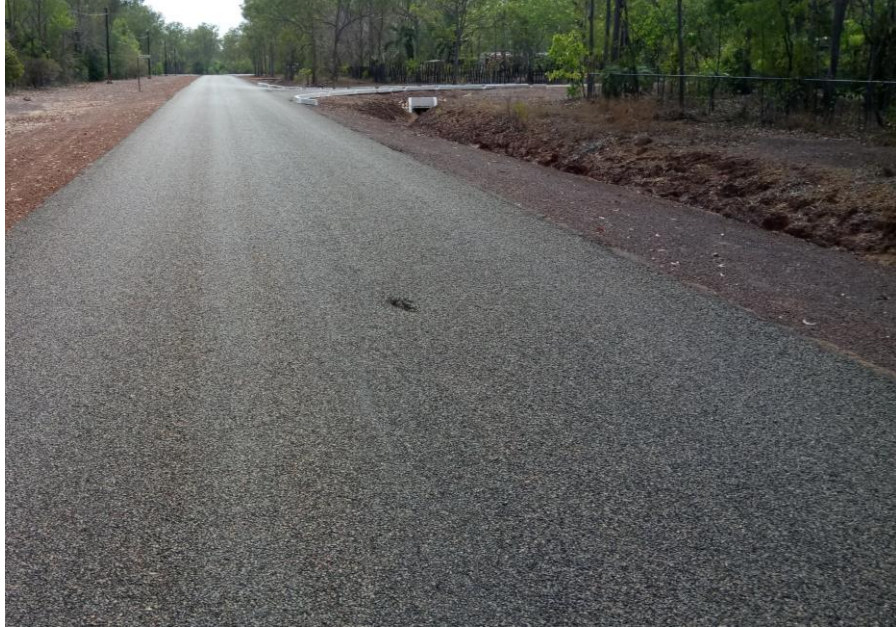
Pothole approximate chainage 0.2

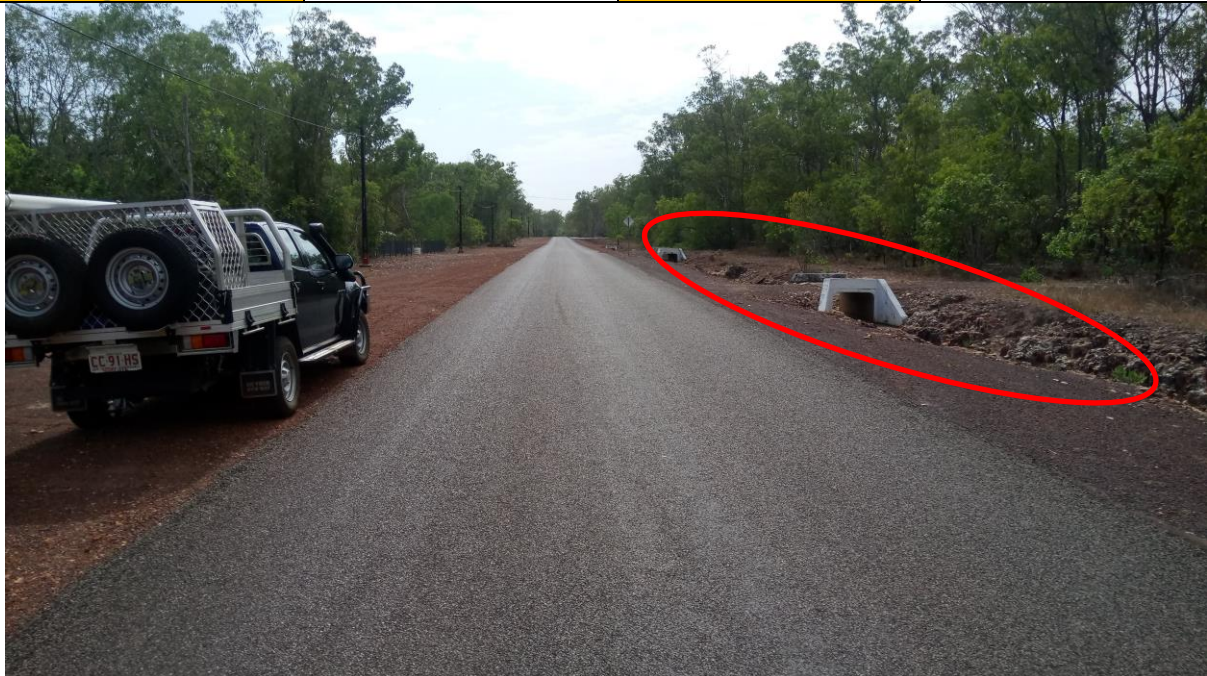
Unprotected culverts at approximate chainage 0.1

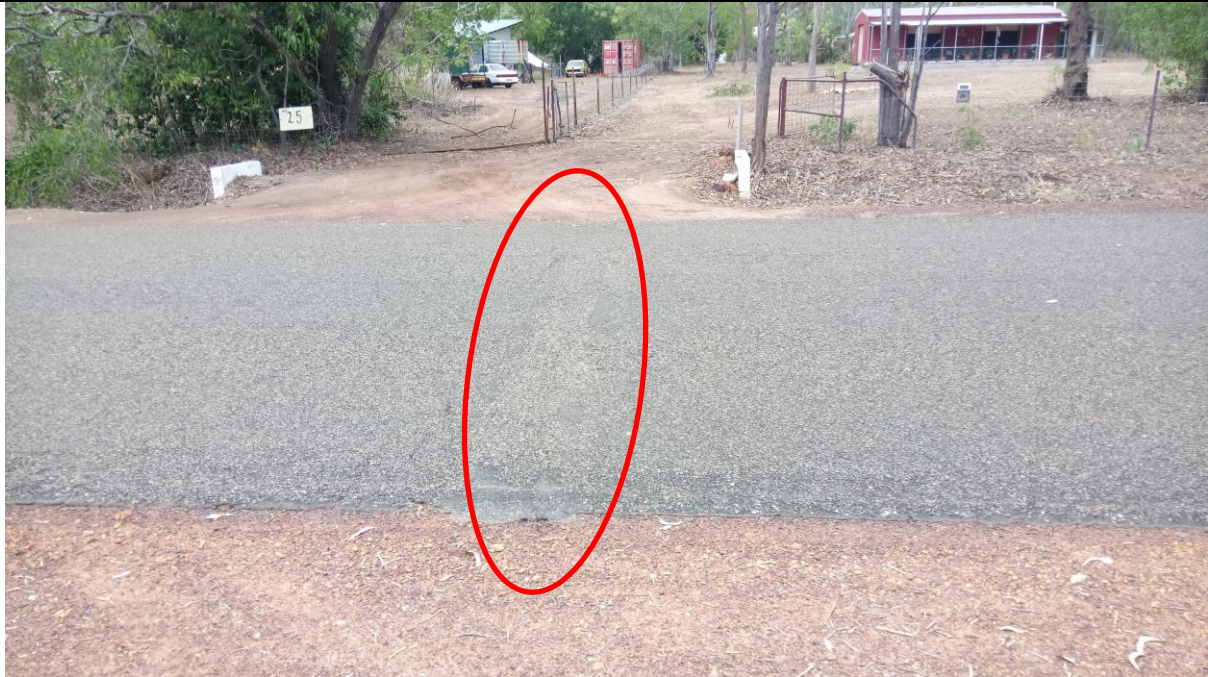
Service crossing approximate chainage 0.35

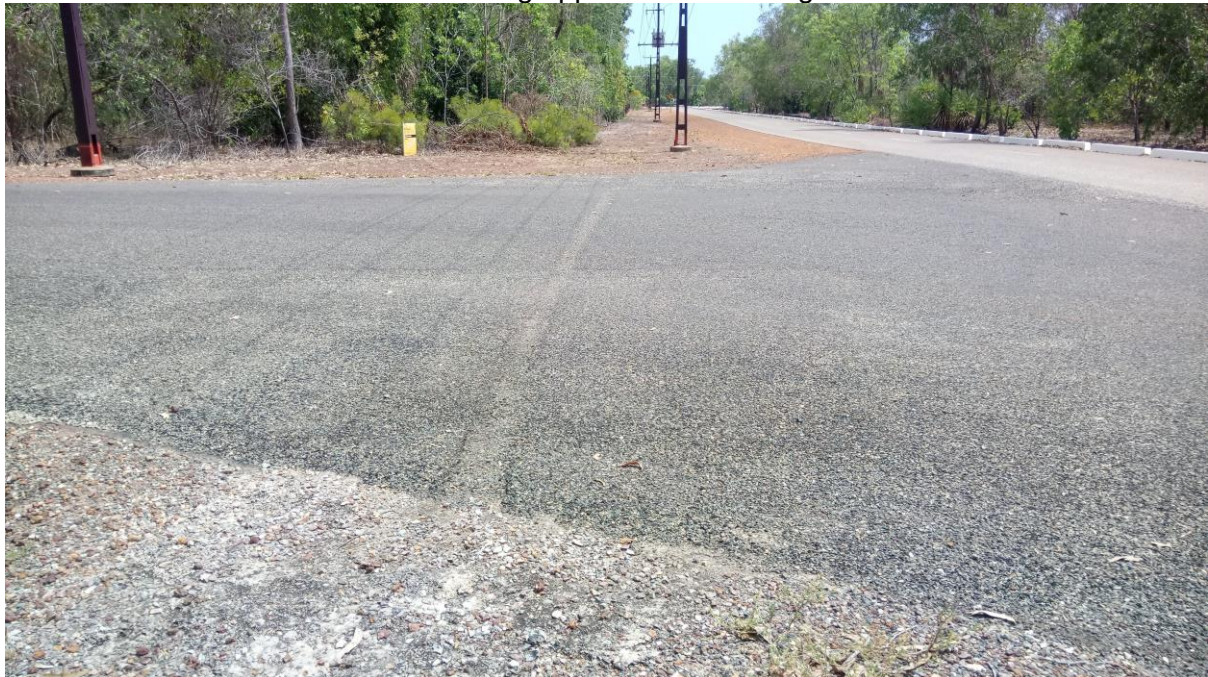
Service crossing Wagait Tower Road Intersection

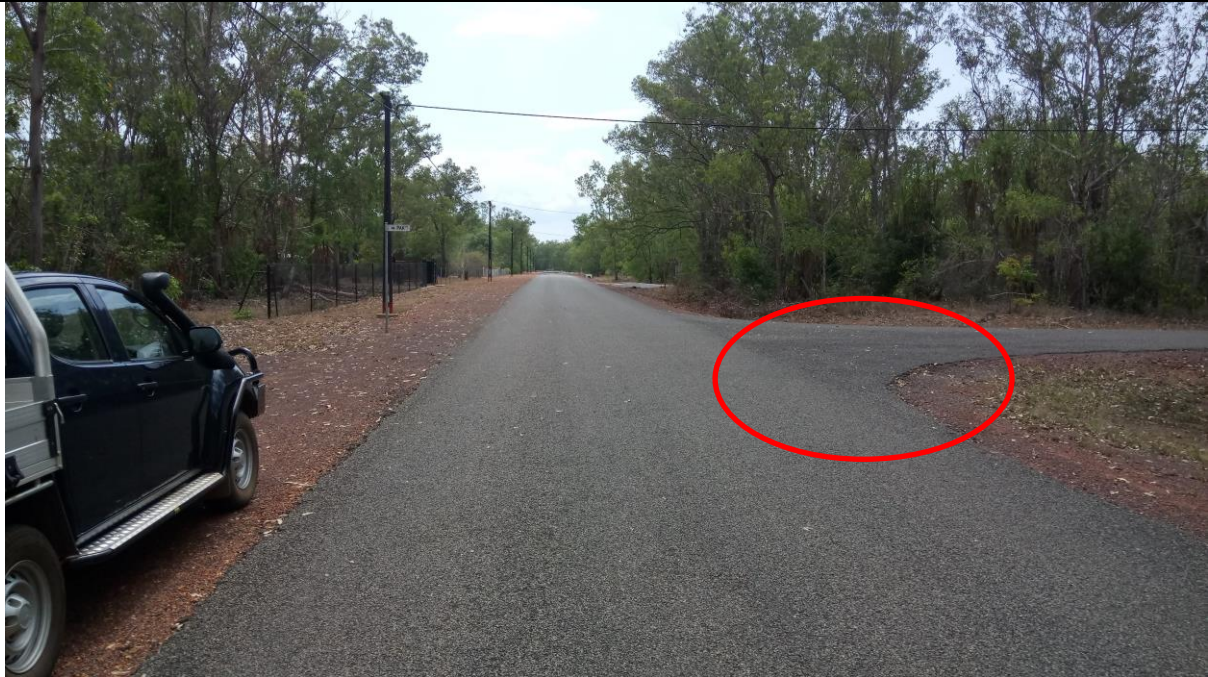
Raveling at Pak Place Intersection

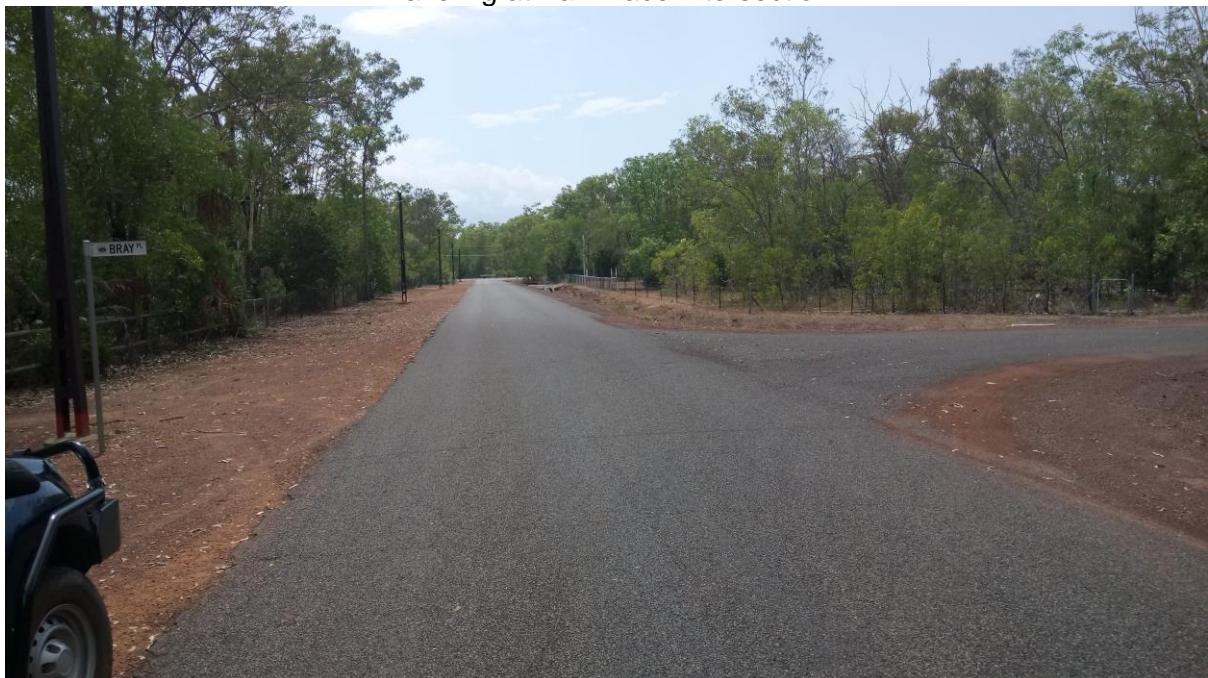
Raveling at Bray Place Intersection

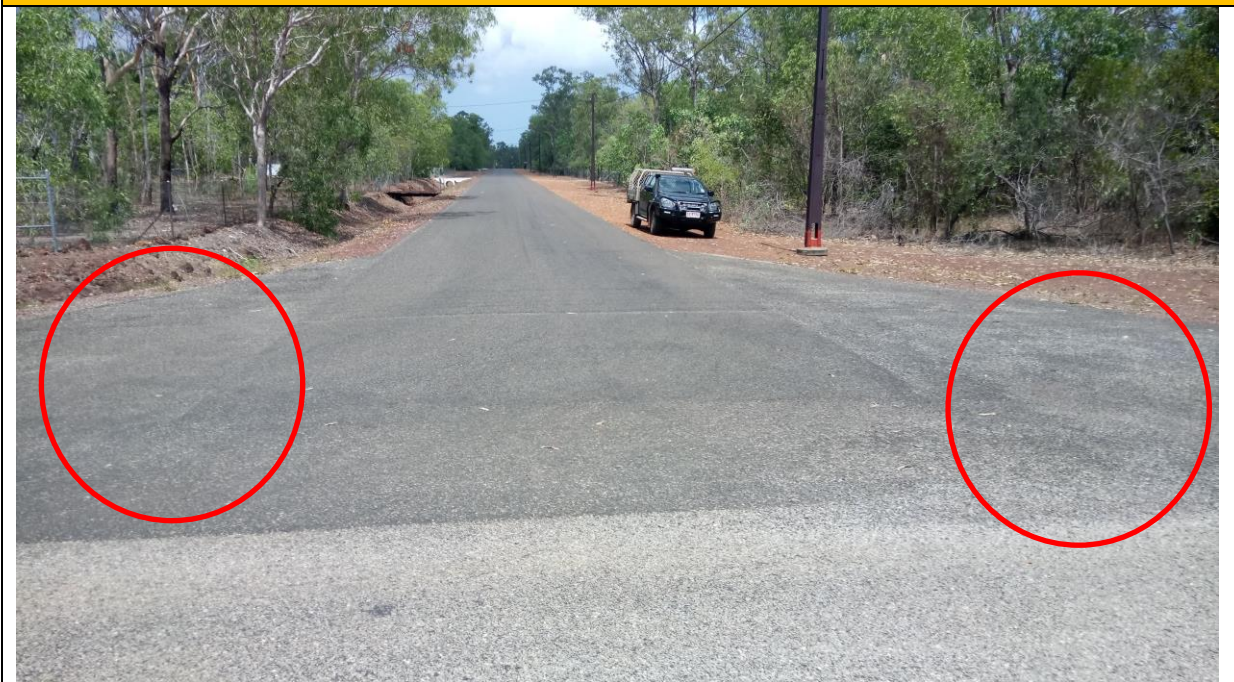
Raveling at Wagait Tower Road

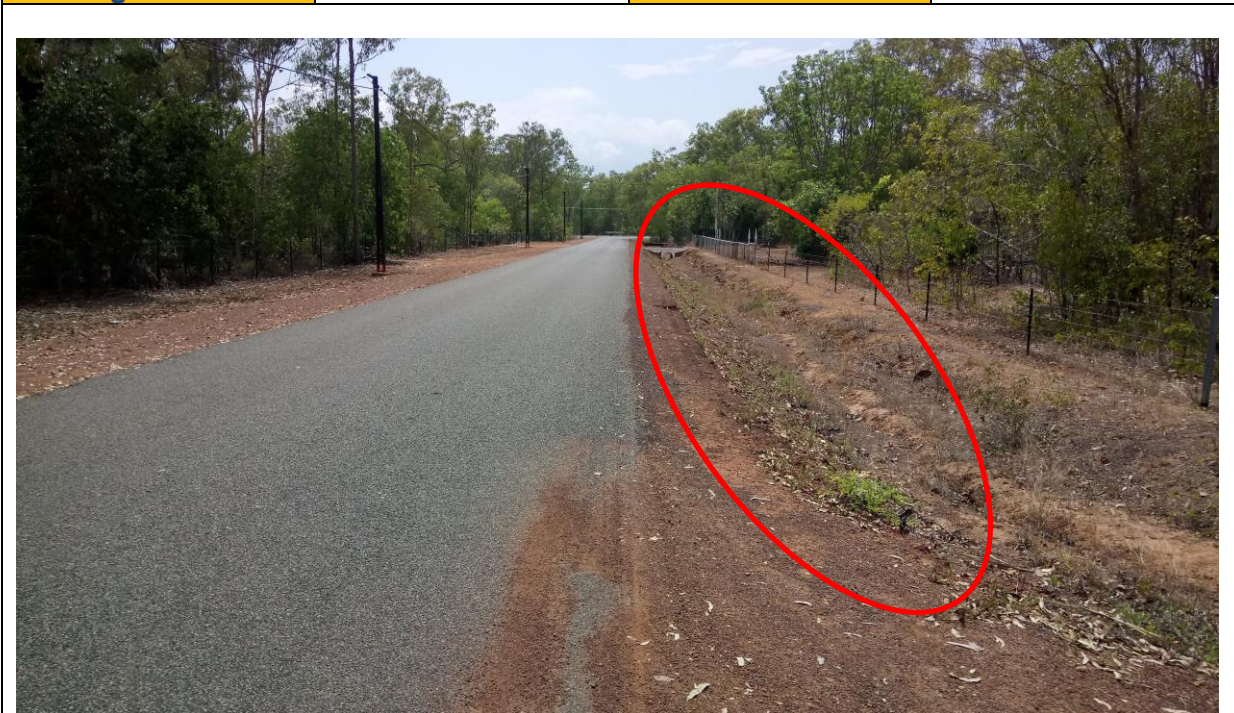
Unprotected drainage structure and driveway culverts approximate chainage 0.4

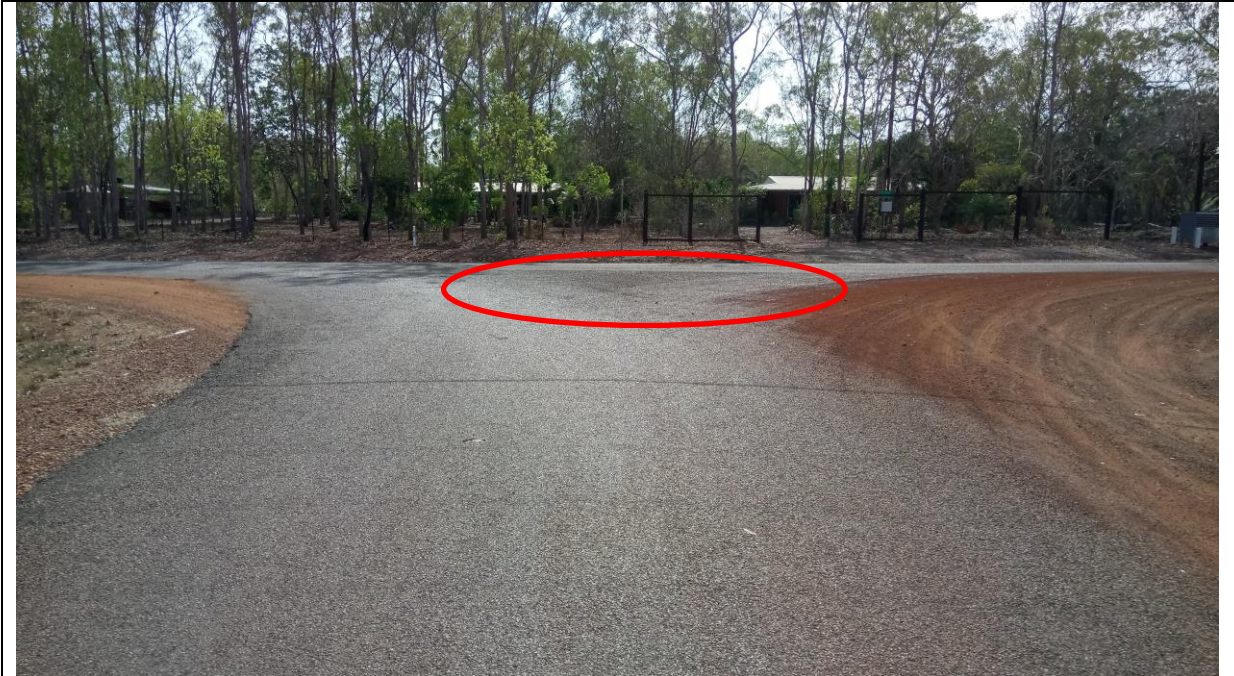
Raveling at Cul-de-sac

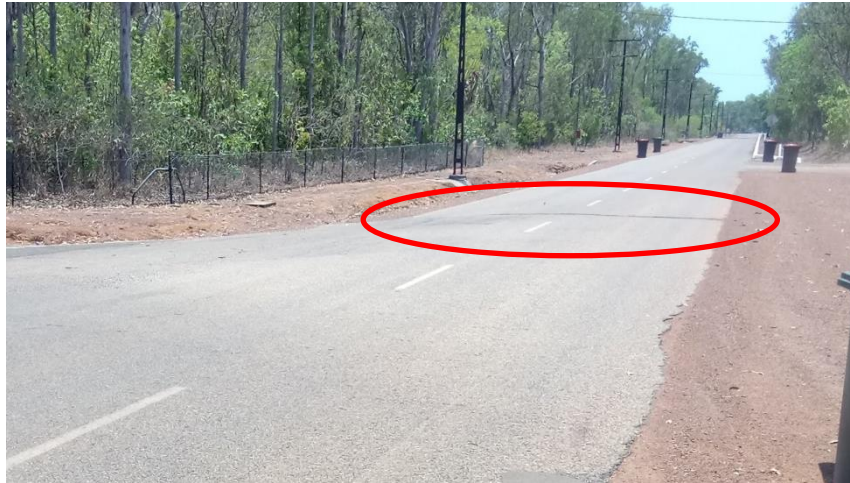
Service crossing Dalmeny Street

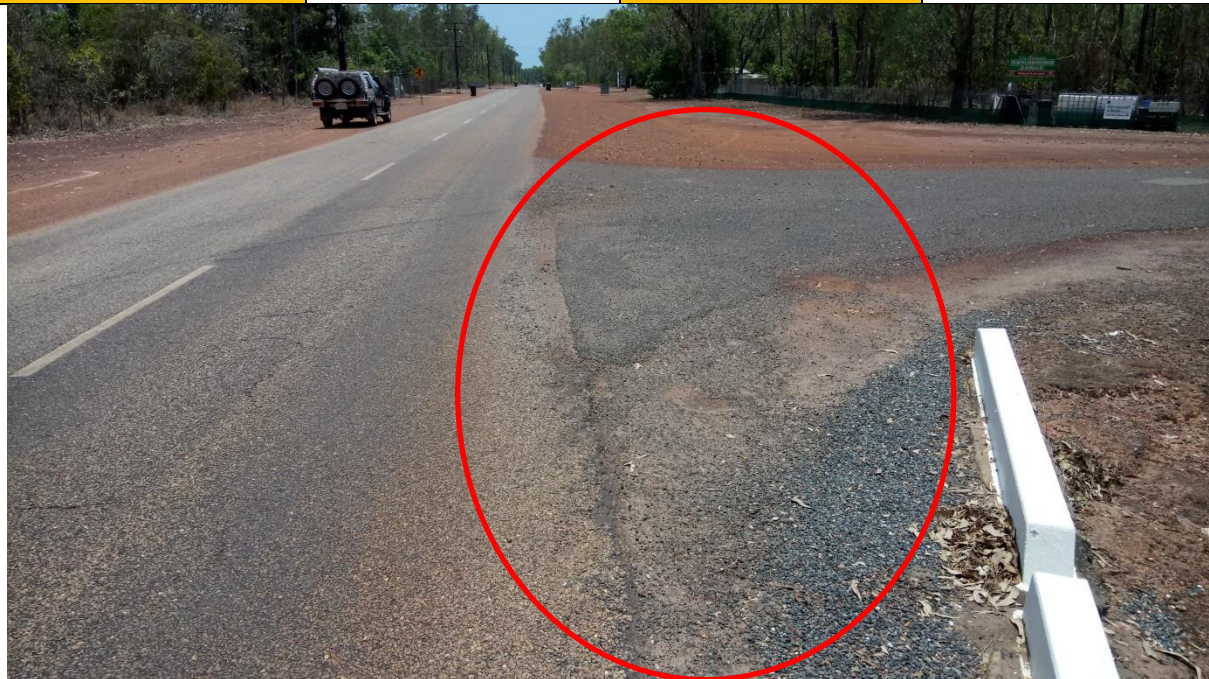
Raveling at Forsyth Road Intersection

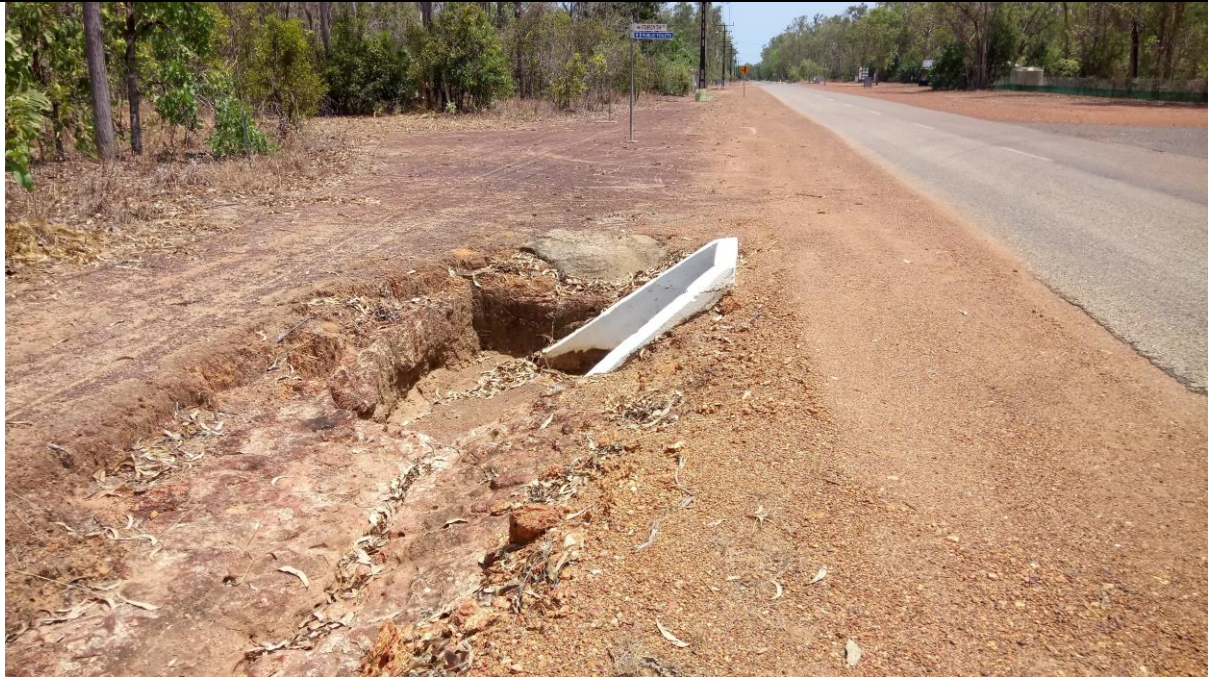
Unprotected culvert at approximate chainage 0.4

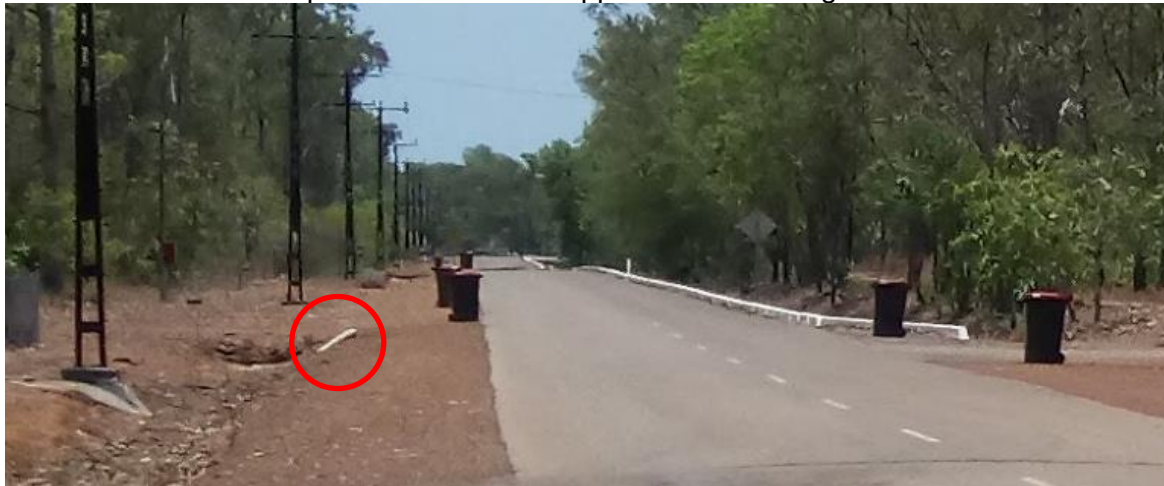
Unprotected culvert at approximate chainage 0.75

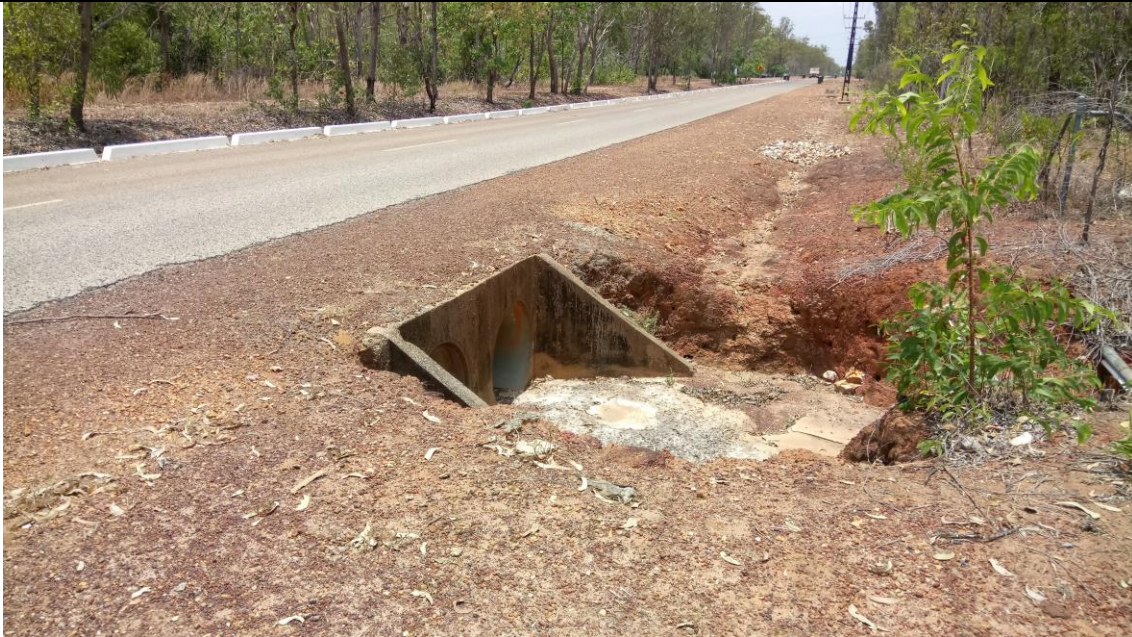
A22. Wagait Tower Road - Field Record October 2018

Unprotected culvert crossing at approximate chainage 1.05

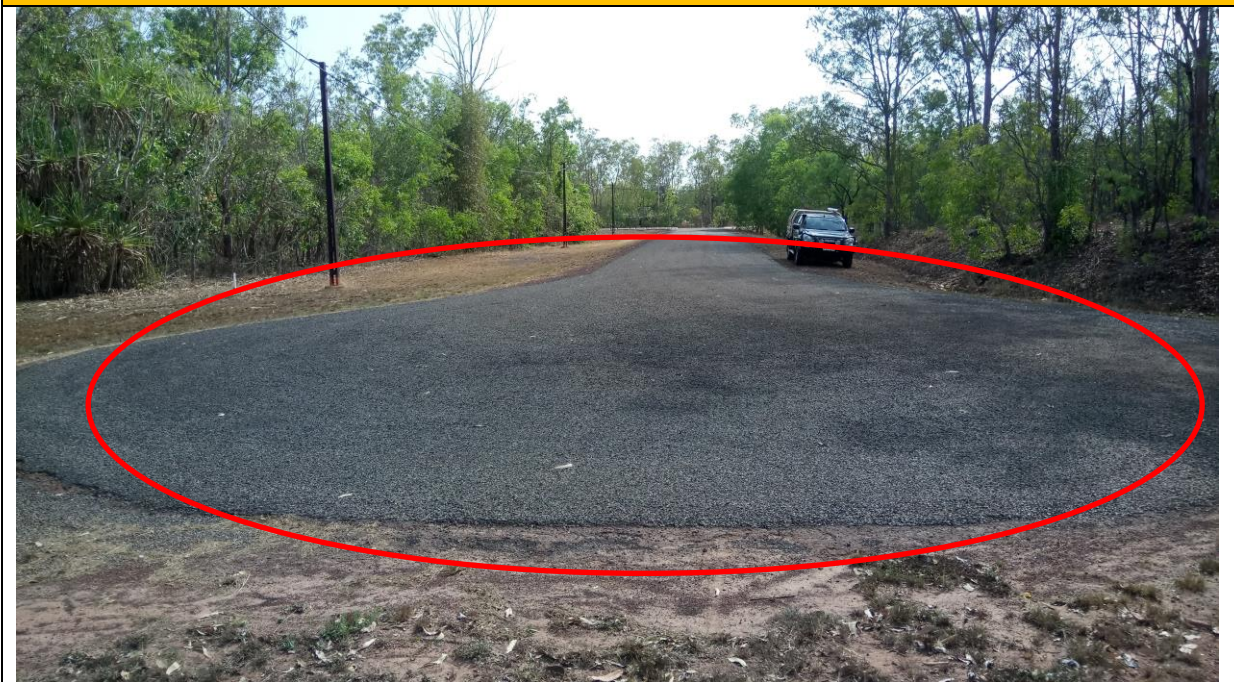
A23. Winnal Court - Field Record October 2018

Raveling at Cul-de-sac

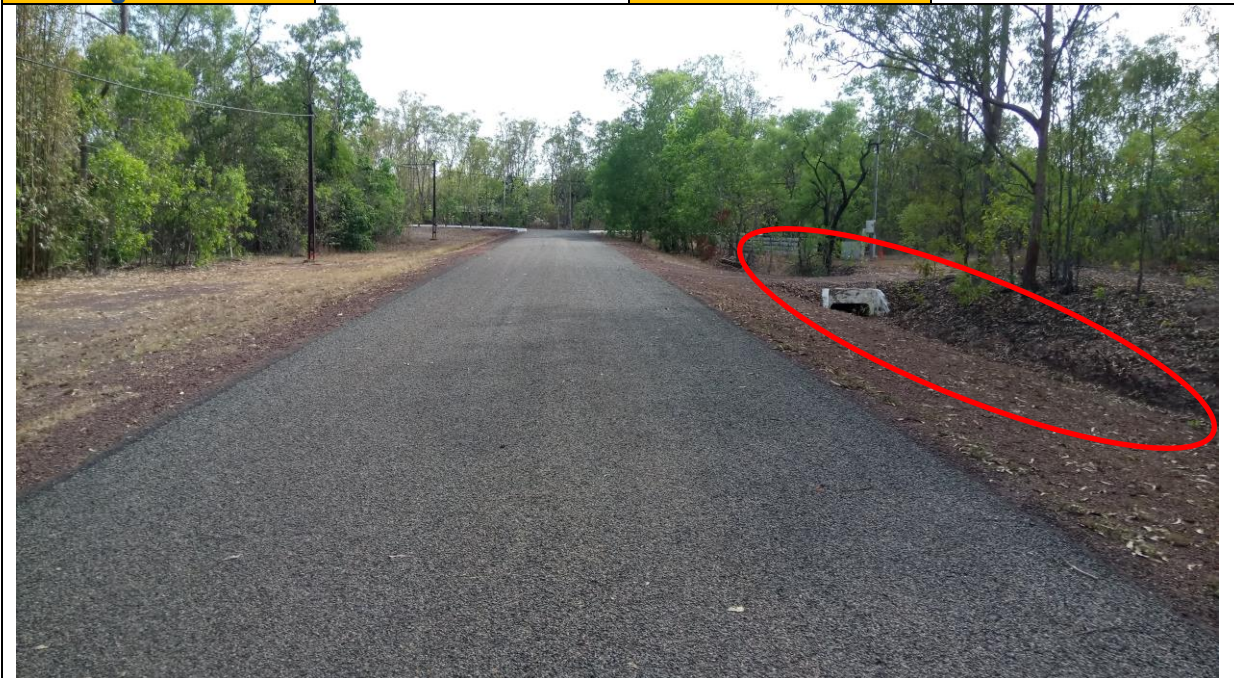
Potholes	No	Affected Area	NA
Unprotected Drainage Structures	Yes	Affected Area	CH0.05

Unprotected drain and driveway culvert at approximate chainage 0.05
