Road Network Investigation Report
For
Wagait Shire Council

Date: November 2018

Road Network Investigation Report for Wagait Shire Council

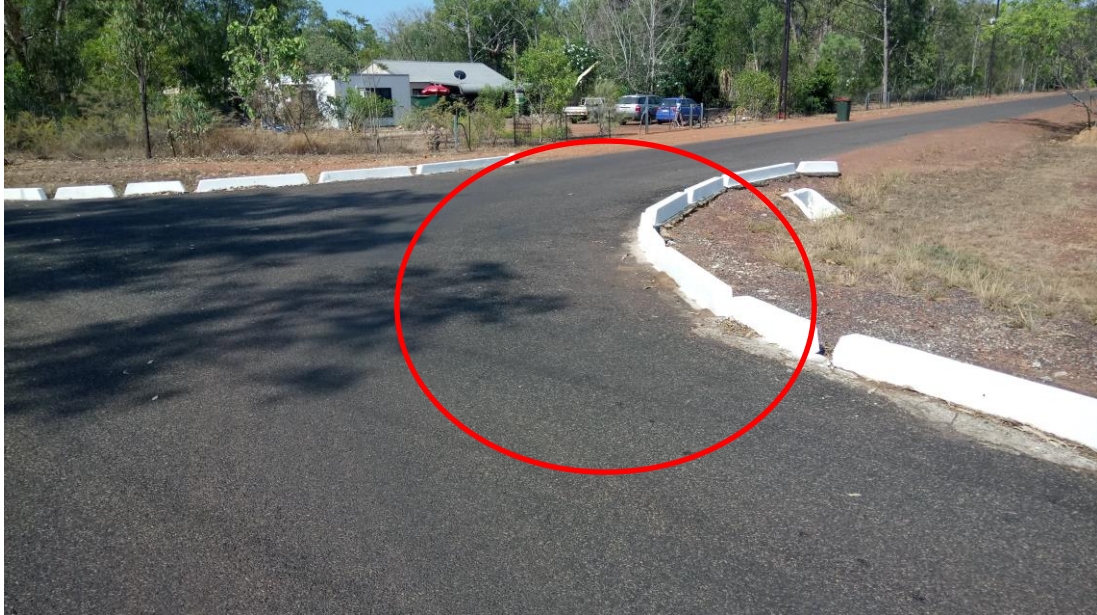
Ravelling Uhr Road Intersection

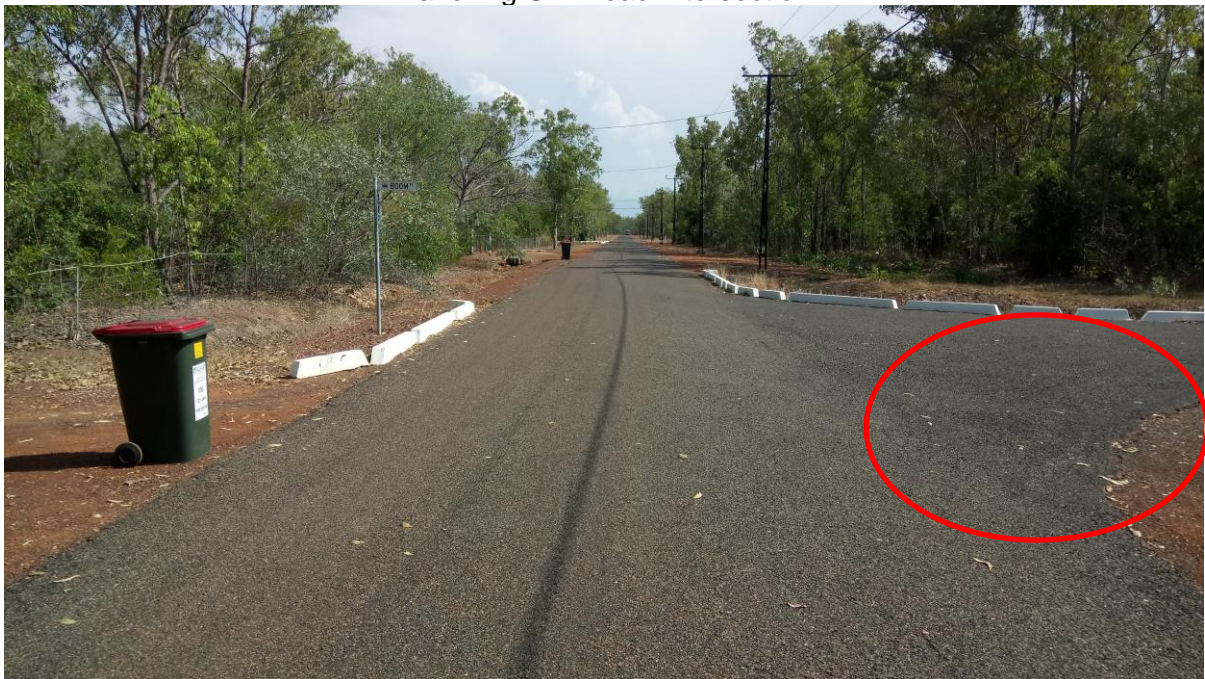
Ravelling Boom Place Intersection

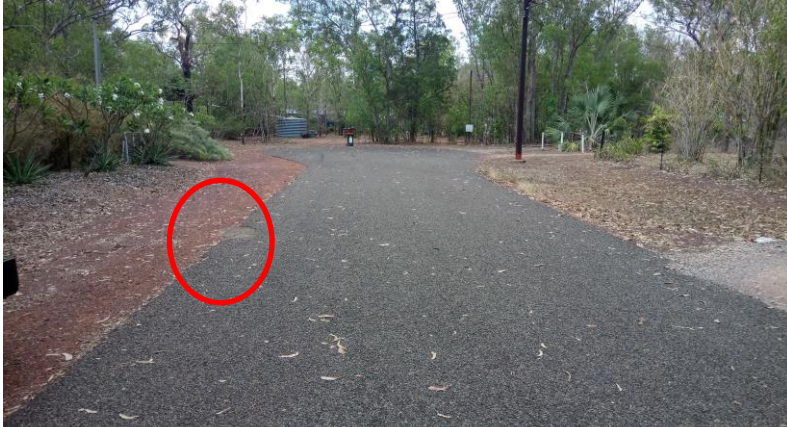
Edge break approximate chainage 0.1

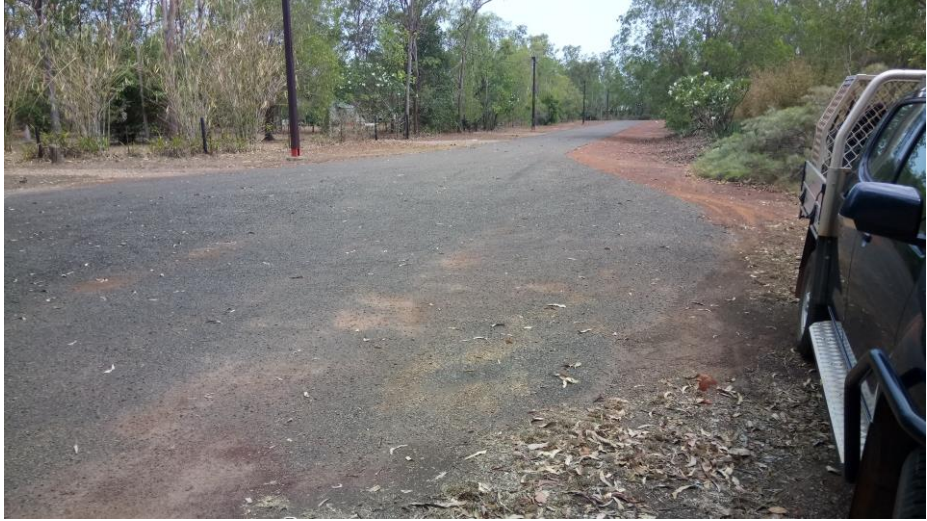
Ravelling at cul-de-sac

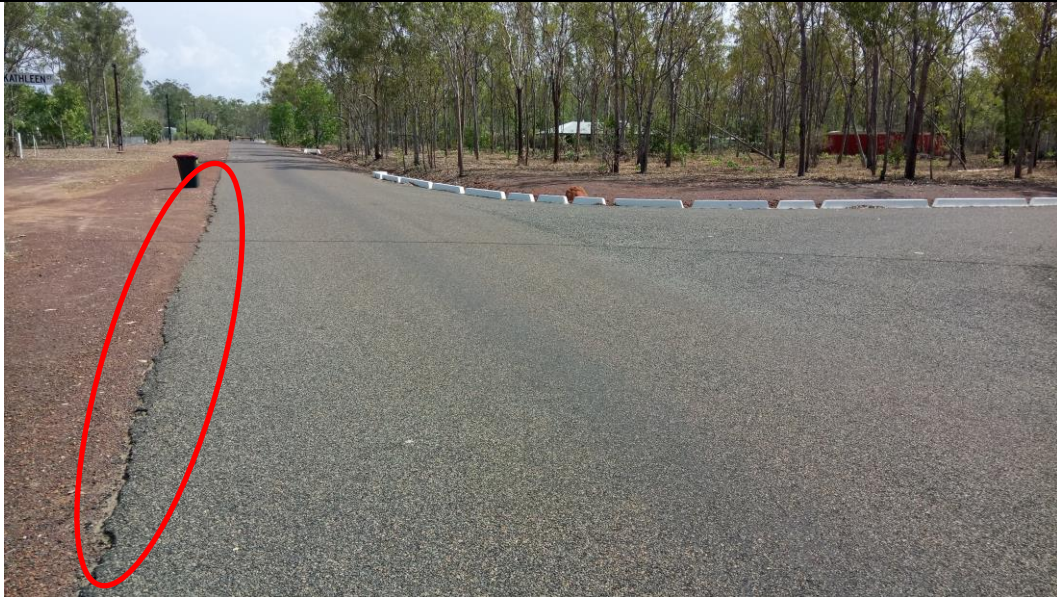
Edge Break between CH0.2-0.3

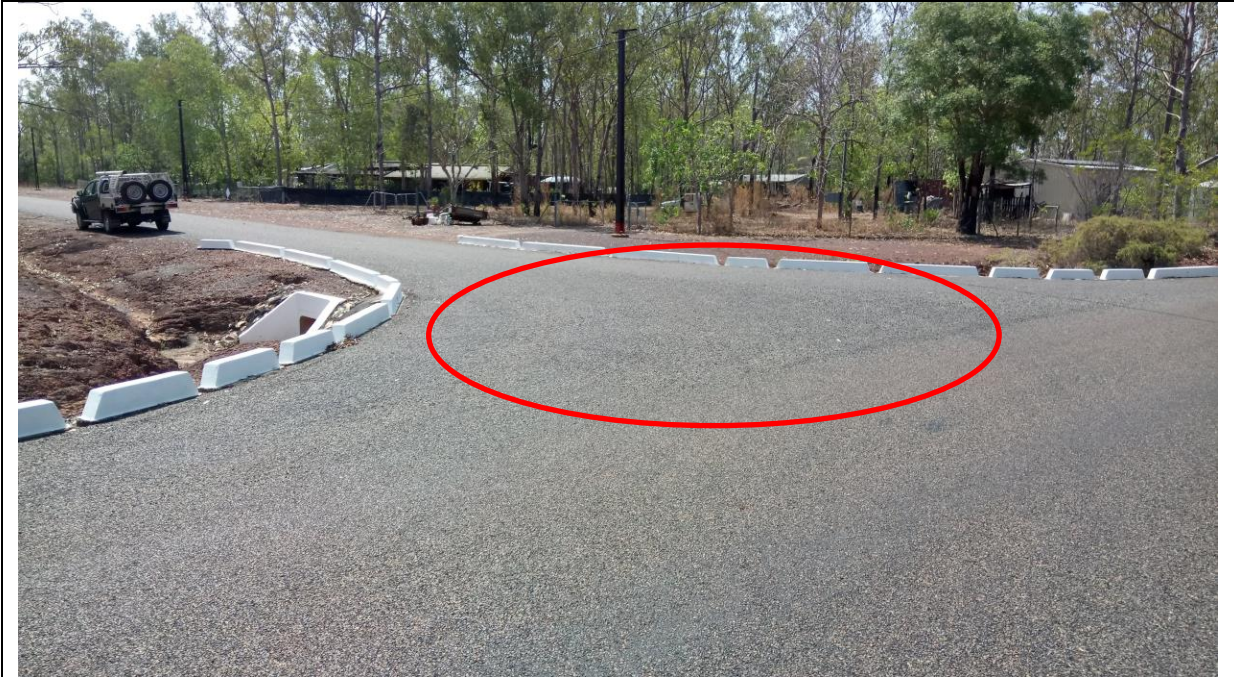
Ravelling at Kathleen Circuit Intersection

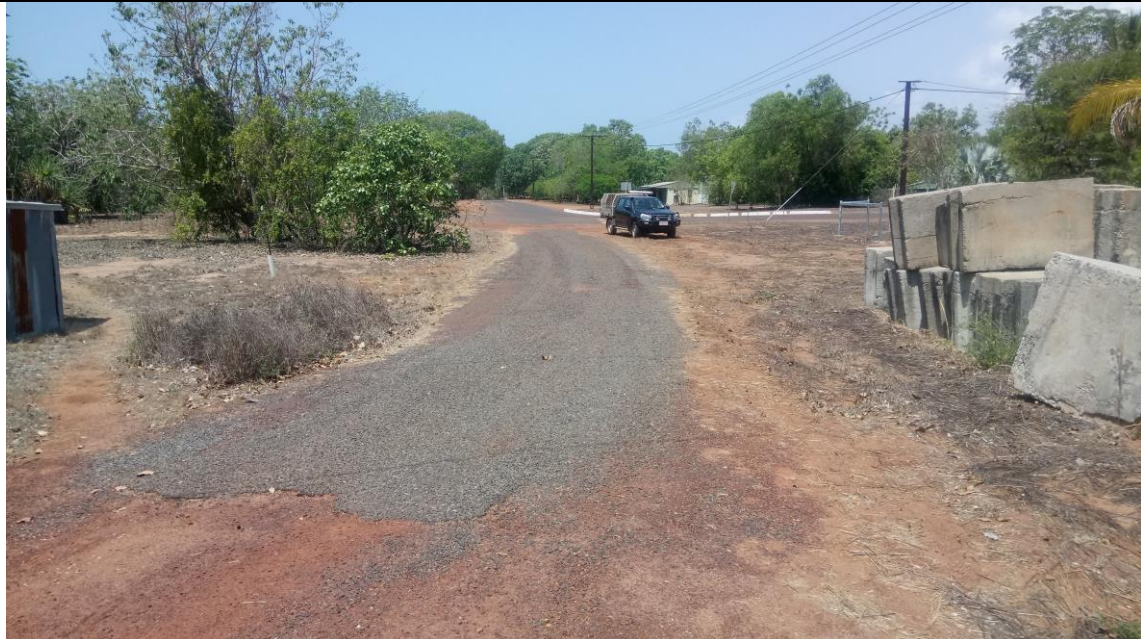
Ravelling at road section past Erickson Crescent

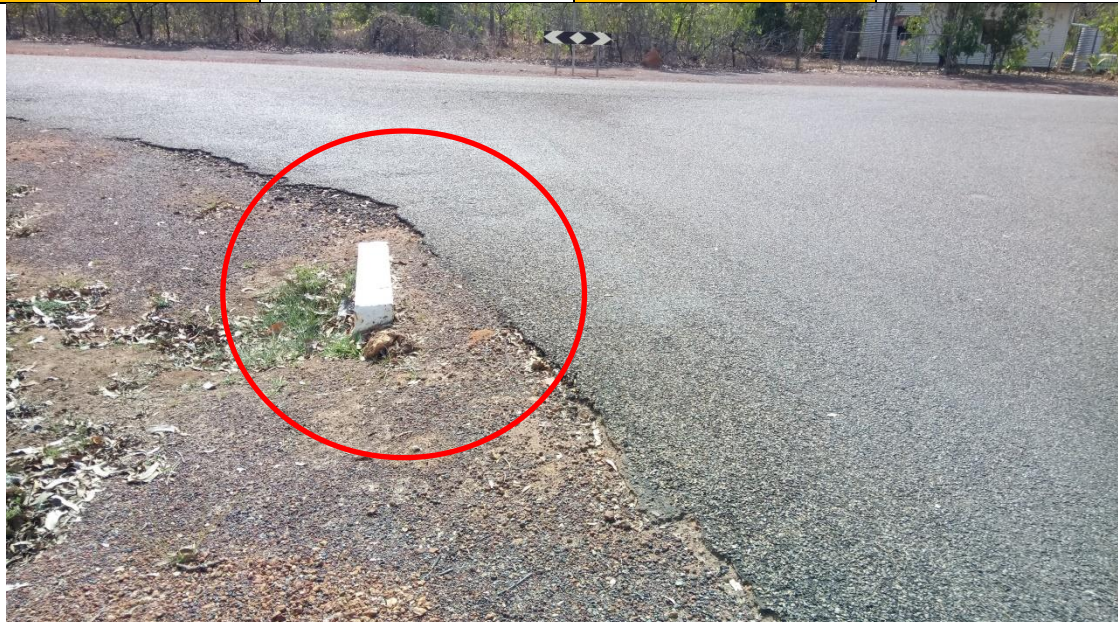
Potholes	No	Affected Area	NA
Unprotected Drainage Structures	Yes	Affected Area	Wagait Tower Road Intersection, CH0.15 and Baluria Road Intersection

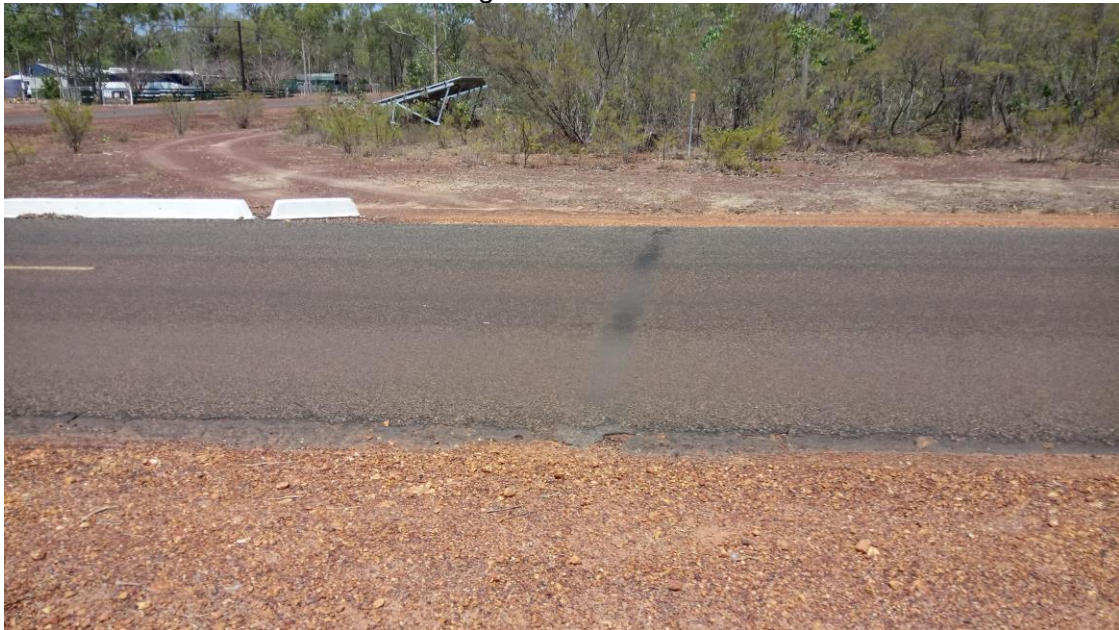
Service crossing Milady Street Intersection

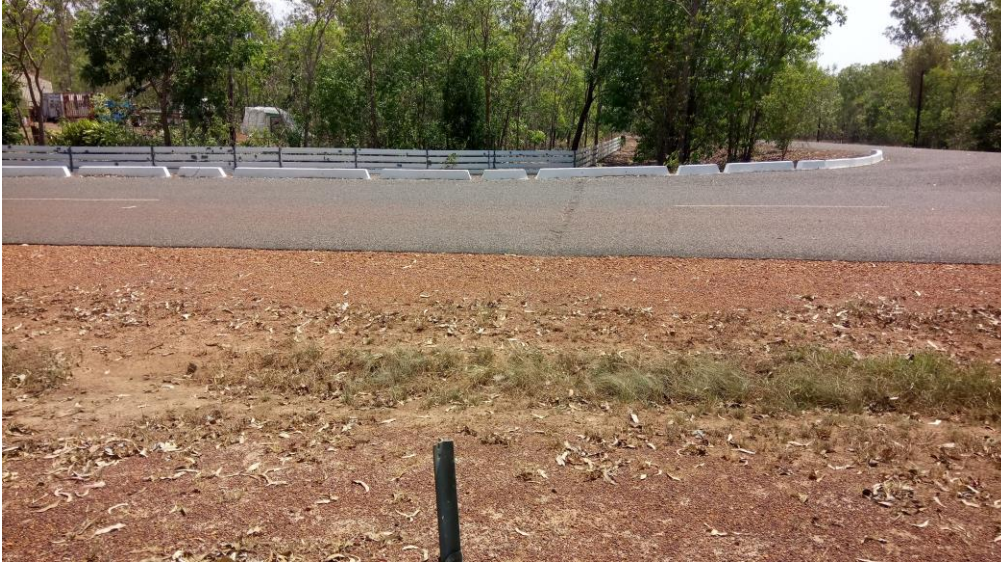
Service crossing Winnal Court

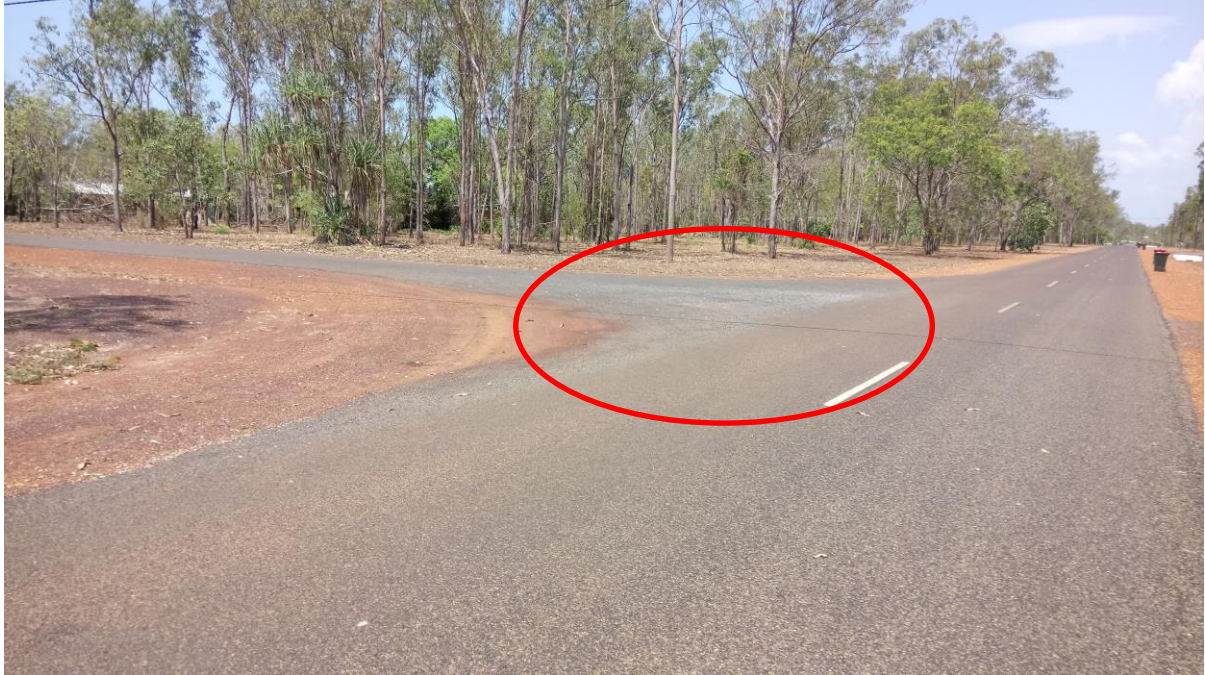
Raveling Massey Street Intersection

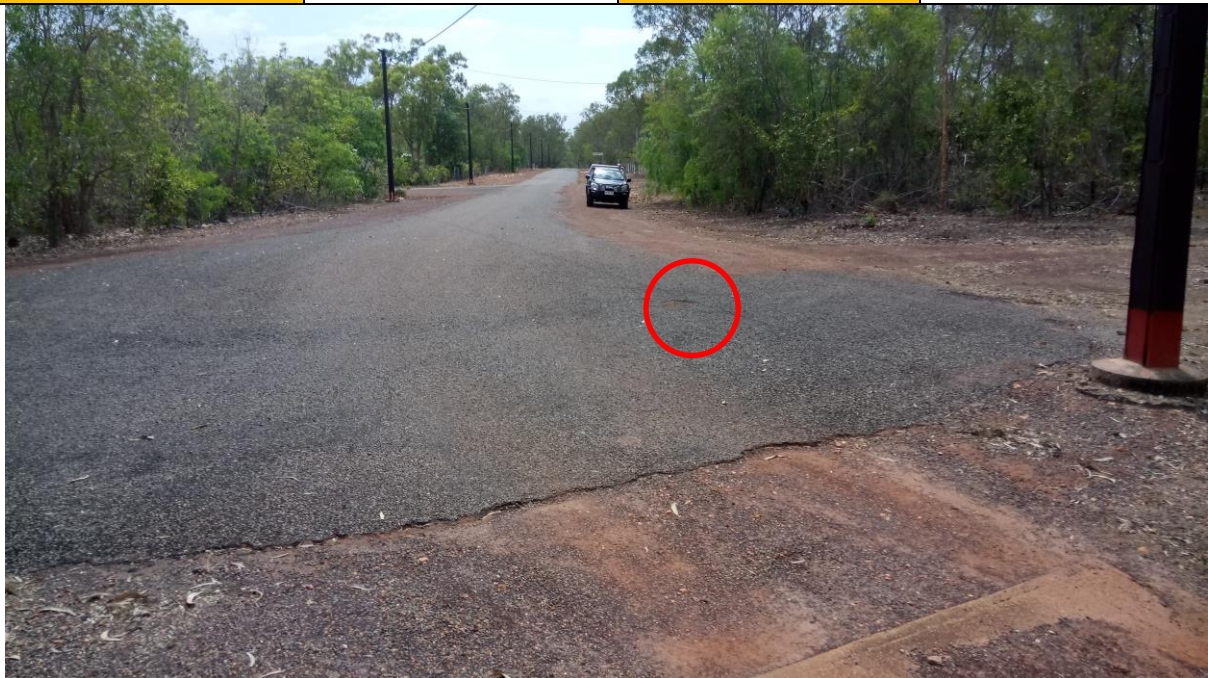
Potholes	Yes	Affected Area	Cul-de-sac
-----------------	-----	----------------------	------------

Pot hole at cul-de-sac

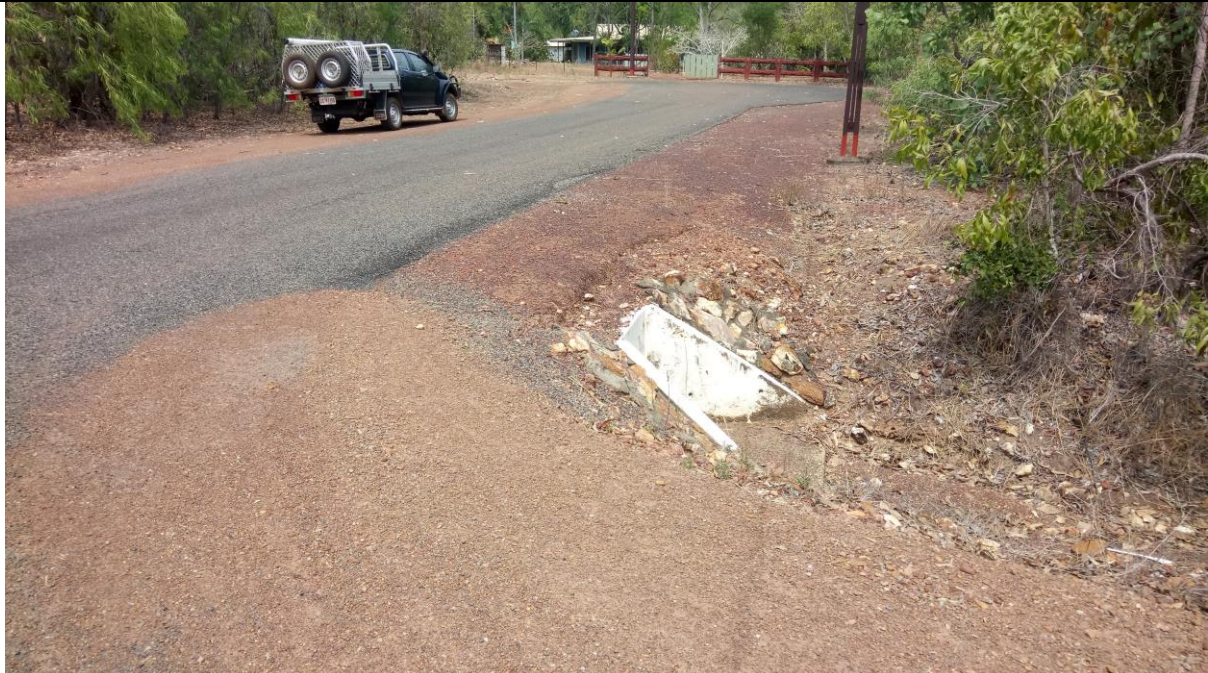
Unprotected Drainage Structures	Yes	Affected Area	Intersection at Dillon Place
--	-----	----------------------	------------------------------

Unprotected culvert crossing at Dillon Place Intersection

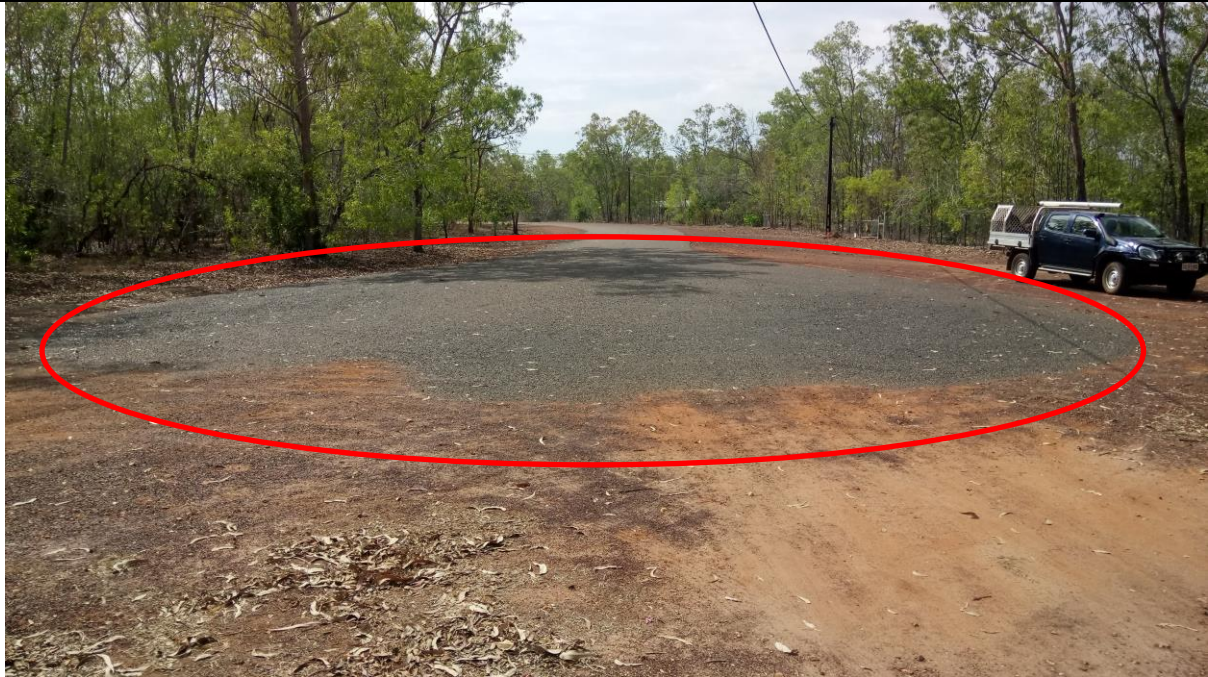
Raveling cul-de-sac
